# Strategies to Reduce Burro-Vehicle Collisions in the Lake Pleasant Area

SPR-753  
June 2022

**Published by:**  
Arizona Department of Transportation  
206 South 17th Avenue  
Phoenix, AZ 85007  
in cooperation with  
Federal Highway Administration

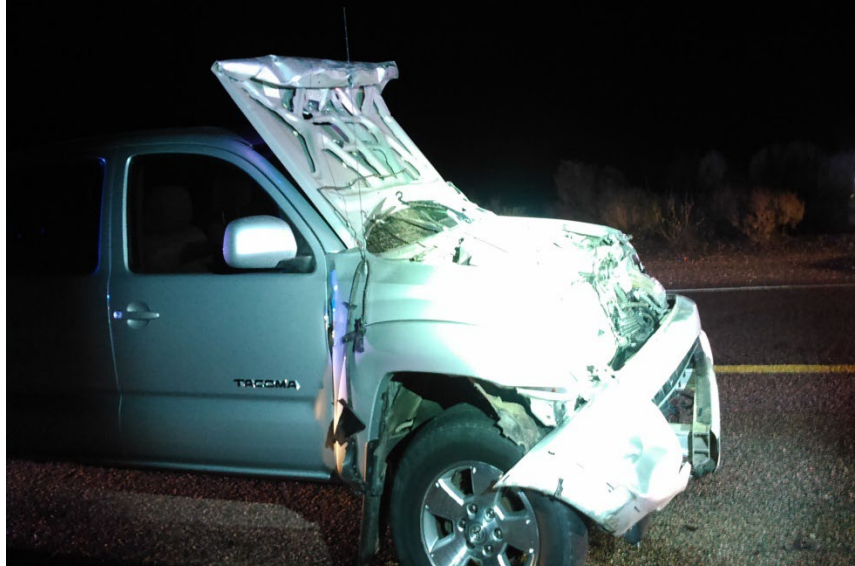
**Figure 2. Vehicle Damage Caused by a BVC**

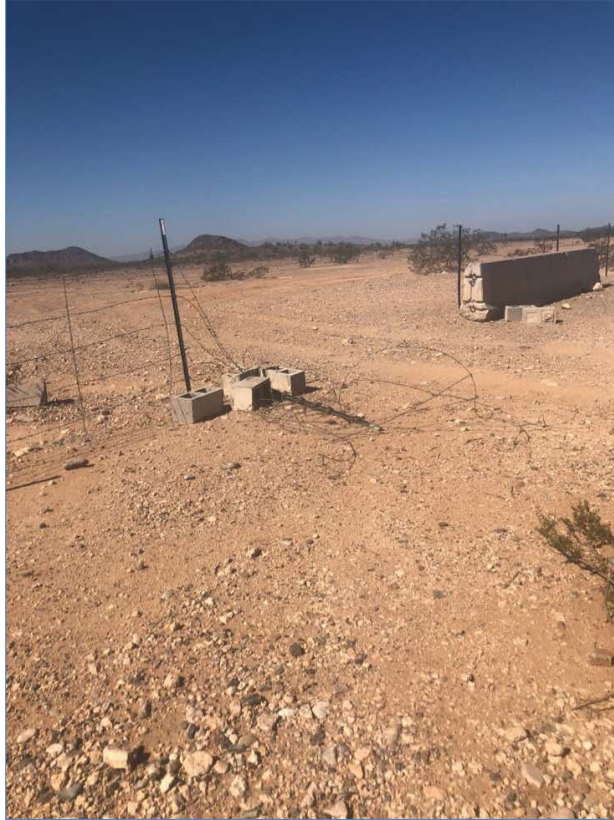
**Figure 34. Burro-ROW Access Point Located During a BVC Site Investigation**

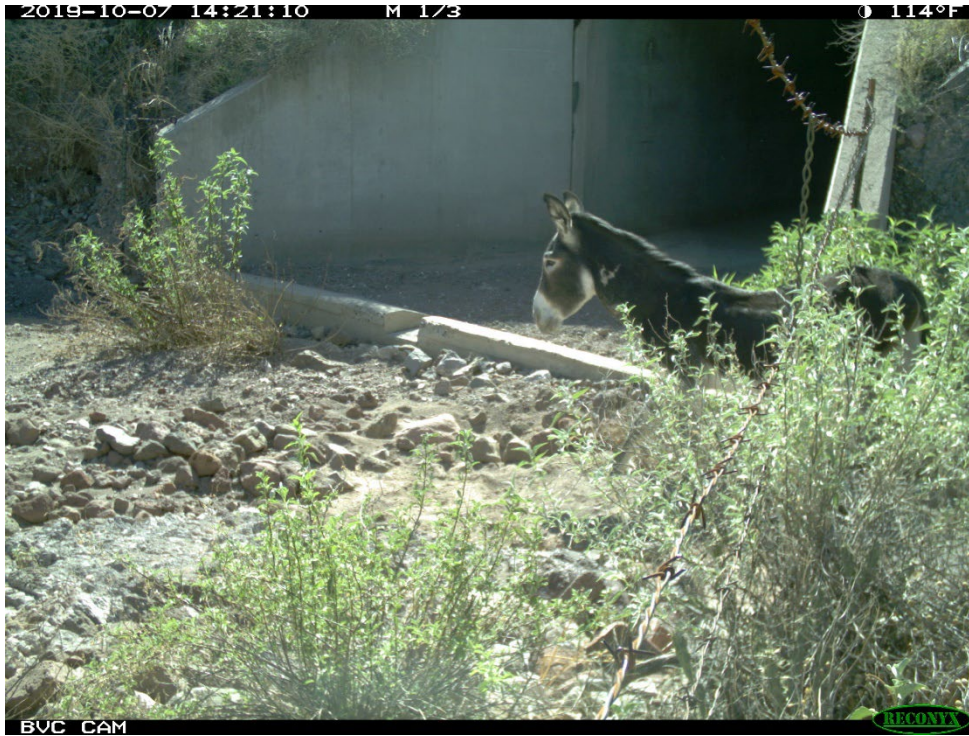
**Figure 41. Burro Leaving an ROW Through a Raised Bottom Wire Adjacent to a Below-Grade Crossing Structure**

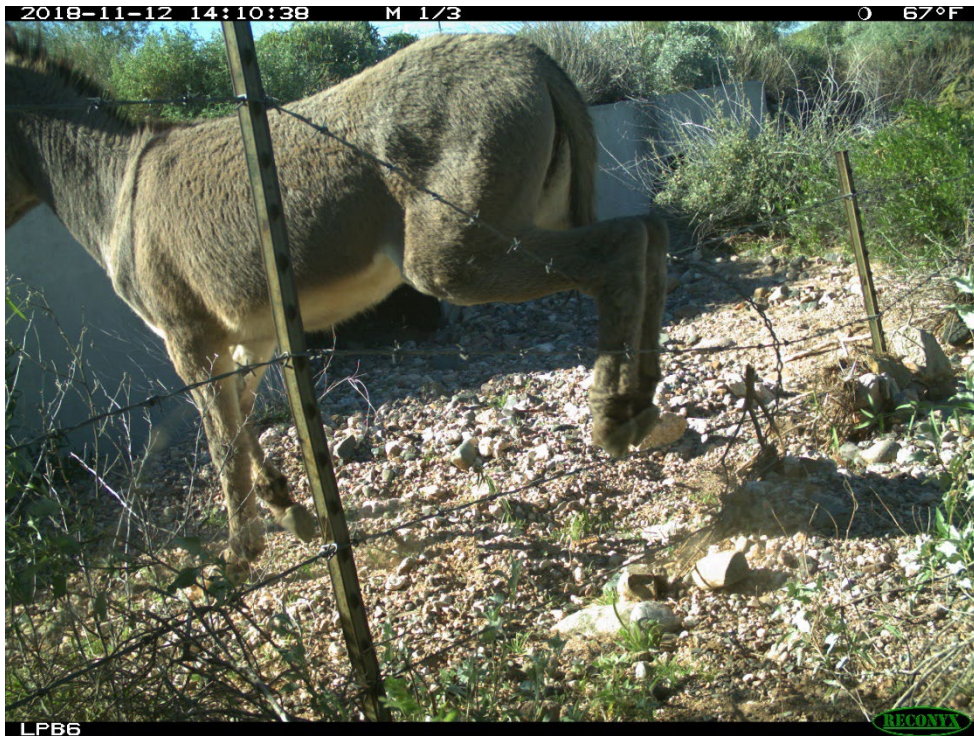
**Figure 42. Burro Crossing a Low Top Wire Access Point**

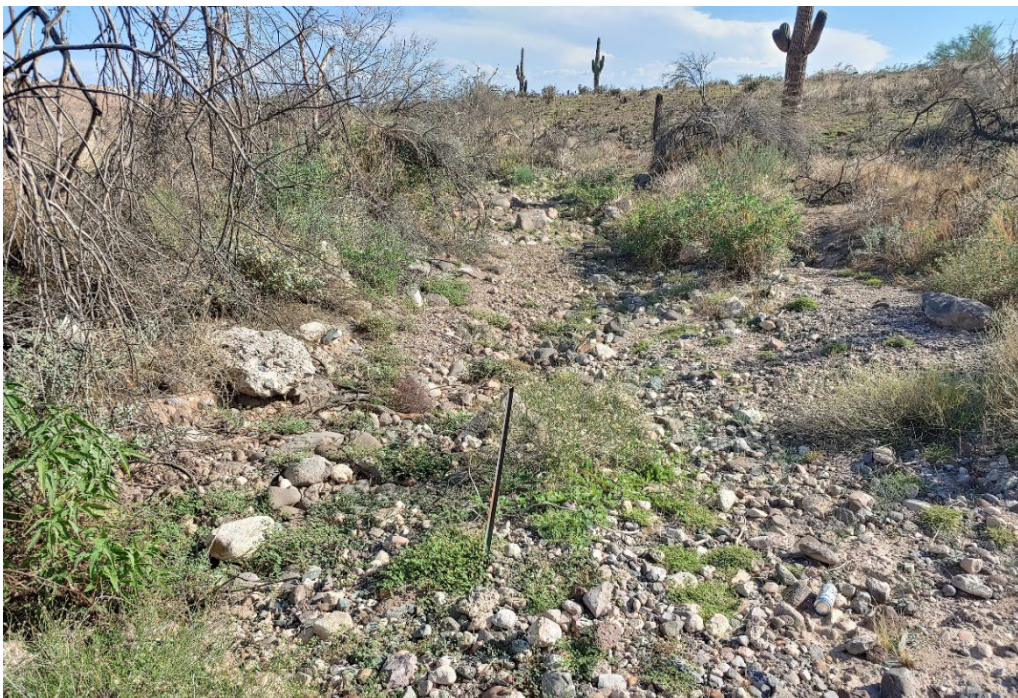
**Figure 58. ROW Fence Blowout Across a Wash Caused by a Flood**

ROW fence blowouts occur in areas with sporadic high-volume water flow, typically where fences cross washes. Debris becomes entangled in the fence, and the force of water acting on these obstacles can dislodge and destroy large sections of fence. Vegetation encroachment was also seen to lead to fence gaps where trees or cacti growing near ROW fence fall or drop limbs onto the fence and cause damage.

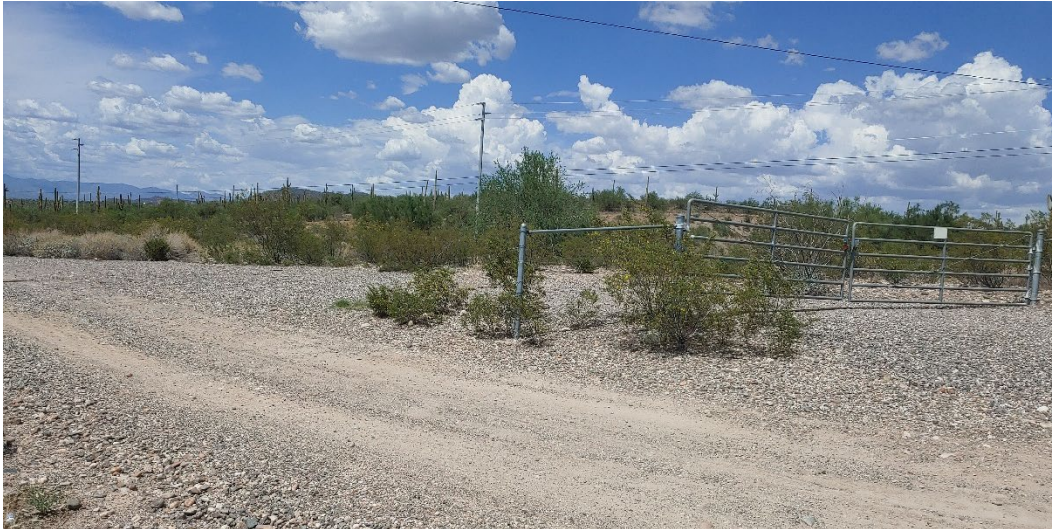
**Figure 59. Cut ROW Fence Adjacent to a Locked Gate**

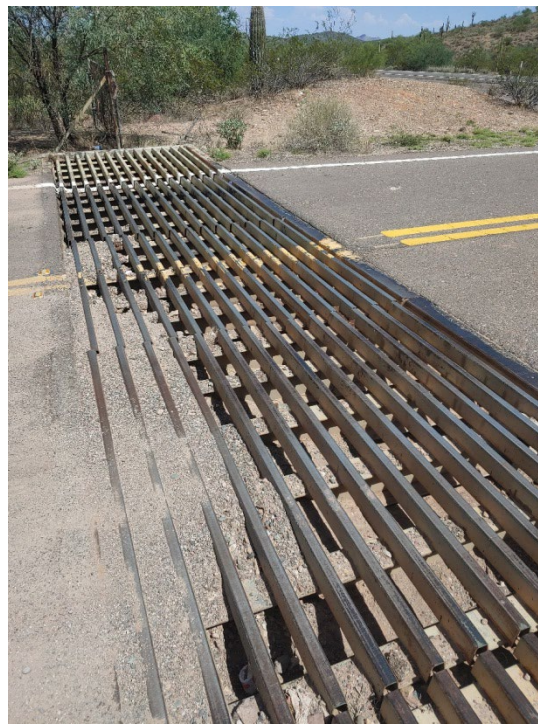
Single crossing guards with a width of 8 feet and vaults with less than 50 percent sedimentation effectively prevented burro-ROW access in all 26 instances documented by cameras. Burro movement data and BVC patterns did not suggest that burros entered ROW via crossing guards when sedimentation levels were maintained below 50 percent. At the beginning of the project, two crossing guards with more than 50 percent sedimentation were associated with BVC hot spots from the baseline period (2014 to 2016) (Figure 63). ADOT cleared these guards while repairing nearby fences. During the project period (2017 to 2019), these areas were no longer BVC hot spots. Previous studies also found that crossing guards with deeper pits present a more substantial barrier to ungulates than those with shallower pits (Huijser et al. 2015).

**Figure 63. Crossing Guard with More Than 50 Percent Sedimentation**

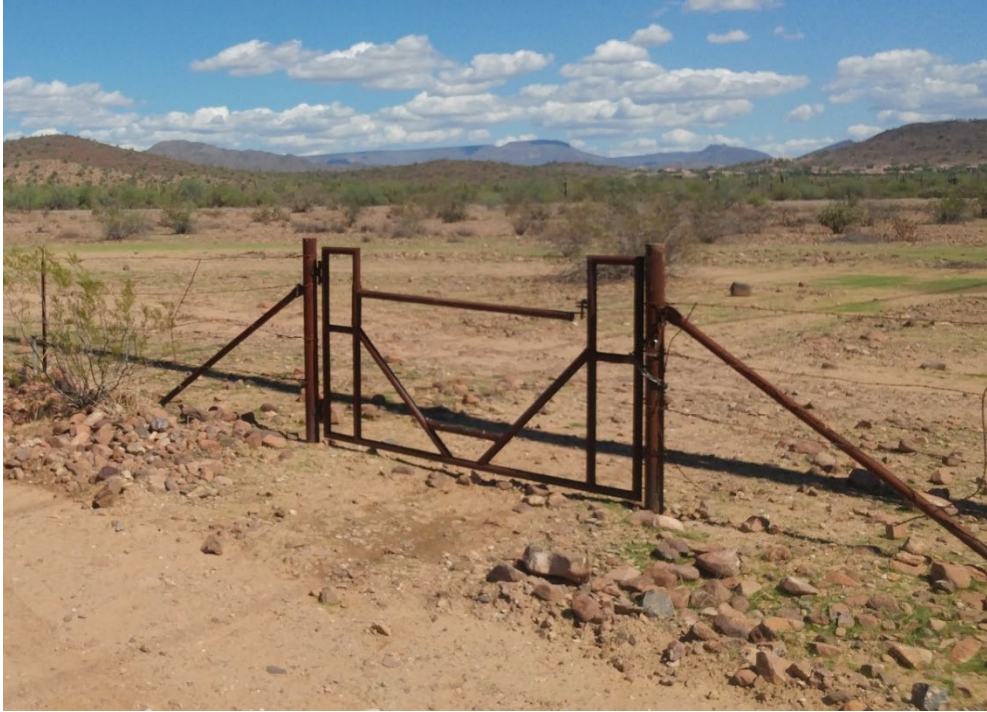
**Figure 65. Equestrian Gate with an Aperture Allowing Burro Passage**
