Appendix G

Geotechnical Engineering

GEOTECHNICAL APPENDIX
South San Francisco Bay Shoreline Study (SSFBS)

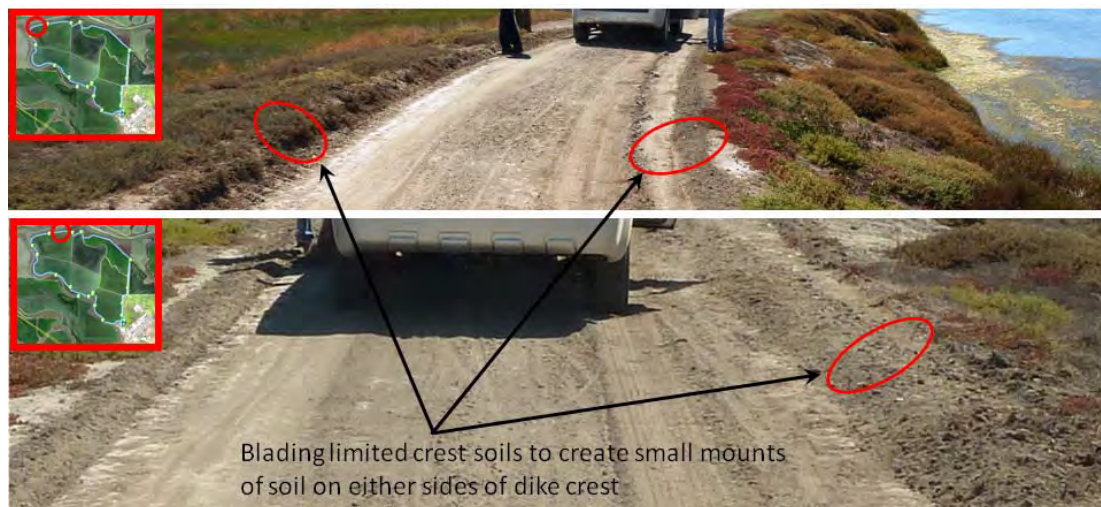
During the field inspection there is evidence that Cargel field operations would scarify or blade crest soil to the bay side of the crest as shown in Figure 6. The apparent purpose of blading was to generate a small temporary raised crest section as illustrated in Figure 7.

Figure 6 – Blading and scarifying dike crest silt to either side of the crest – to create limited crest elevation rise.

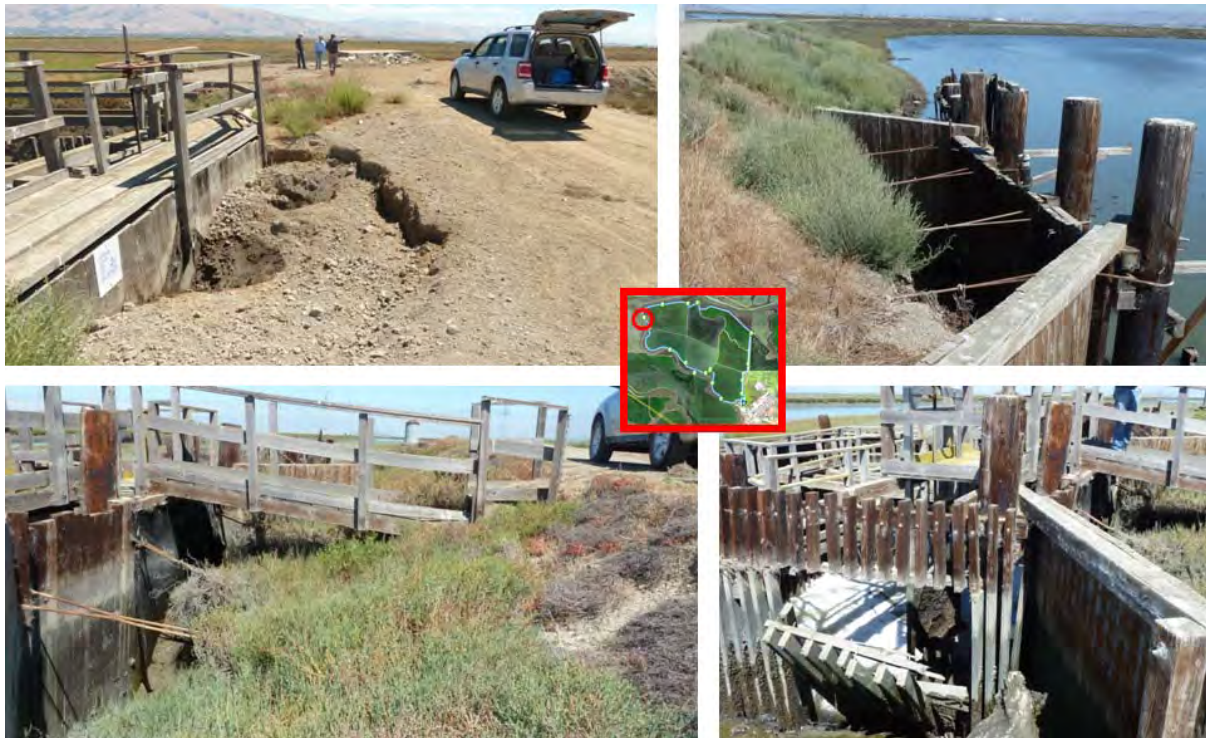
Figure 17 - Water Control structures are experiencing lose of soil issues

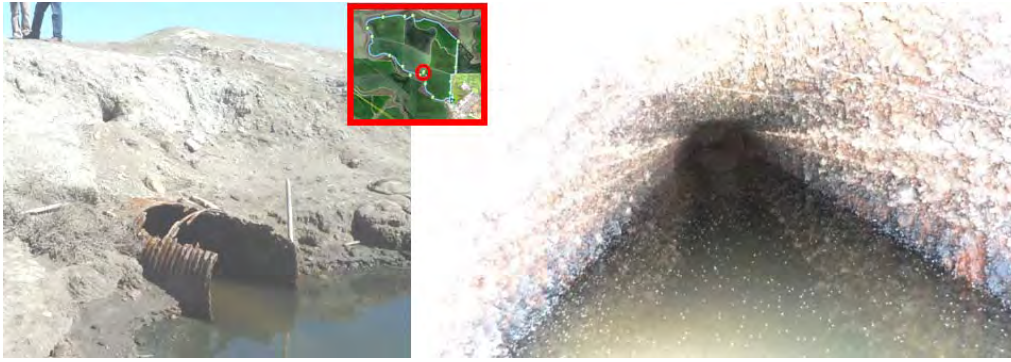
An isolated pipe through a dike section is shown Figure 18. The outside of this steel pipe has experienced severe rusting. The inside of the pipe (right side of Figure 18) shows rusting but the extent of rusting could not be observed.

Figure 18 - Pipes through the dike are likely having rusting issues
