**BEST MANAGEMENT PRACTICES FOR STORAGE OF
HISTORIC METAL TRUSS BRIDGES**

GDOT Research Project No. 12-05
Task Order No. 02-111

Final Report

Donald W. White, Jochen Teizer, Yihai Fang, Thanh V. Nguyen and Ryan Jarriell
Georgia Institute of Technology

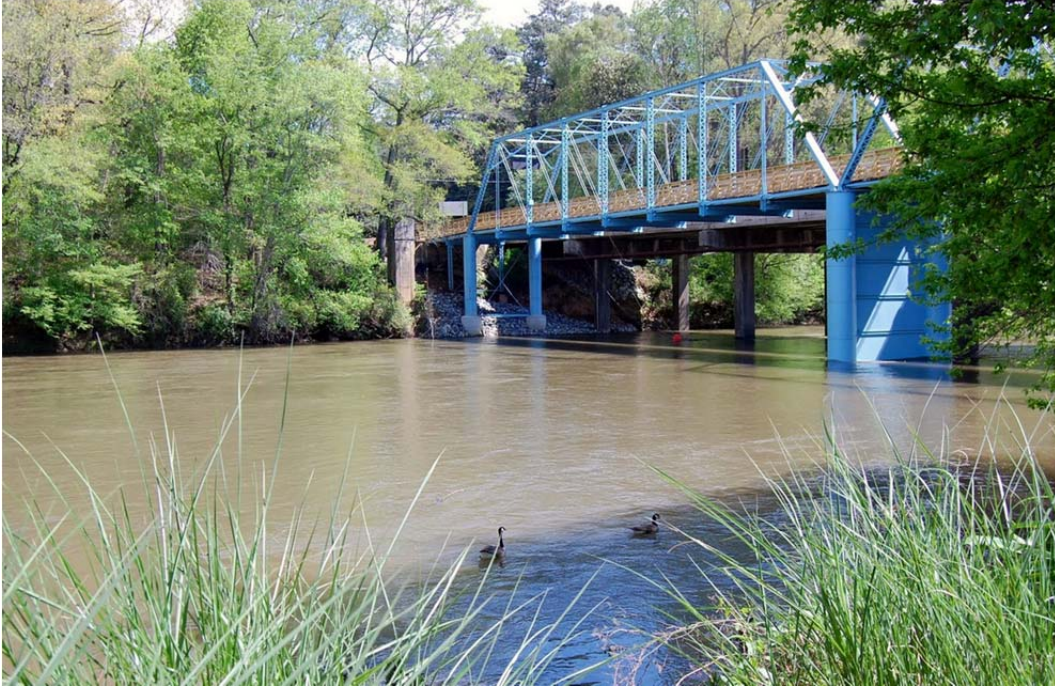
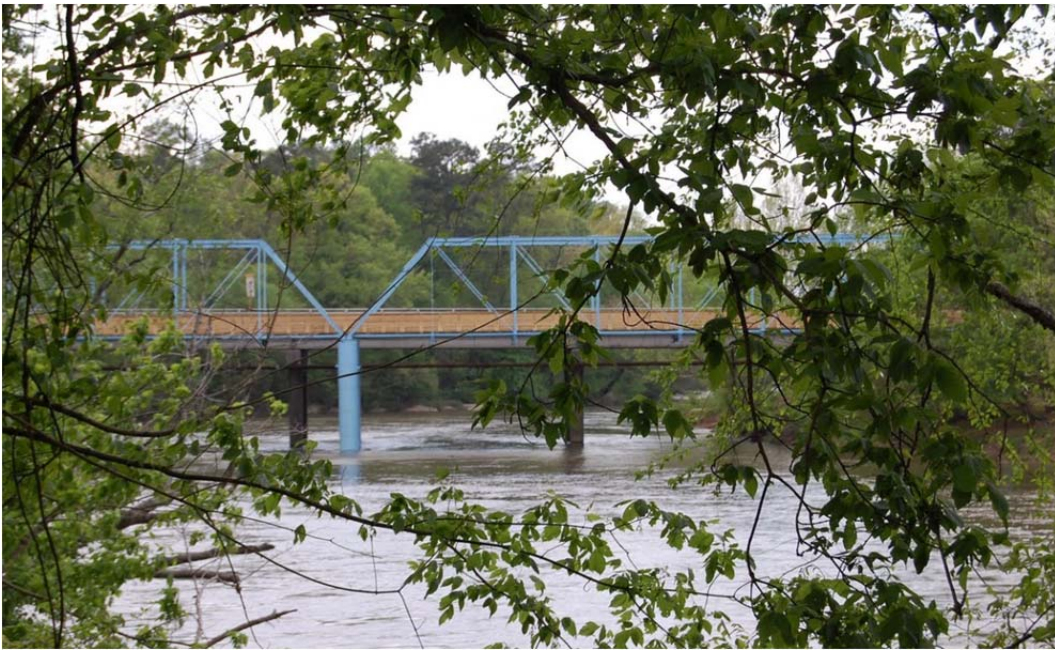
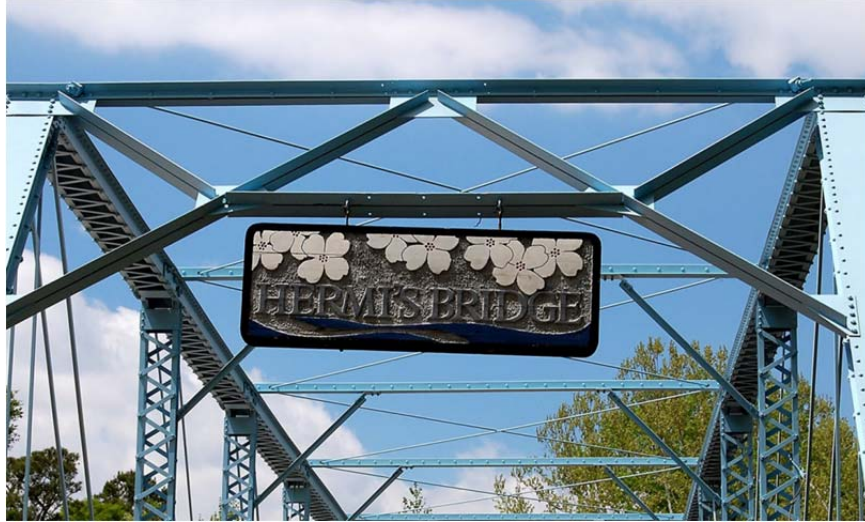
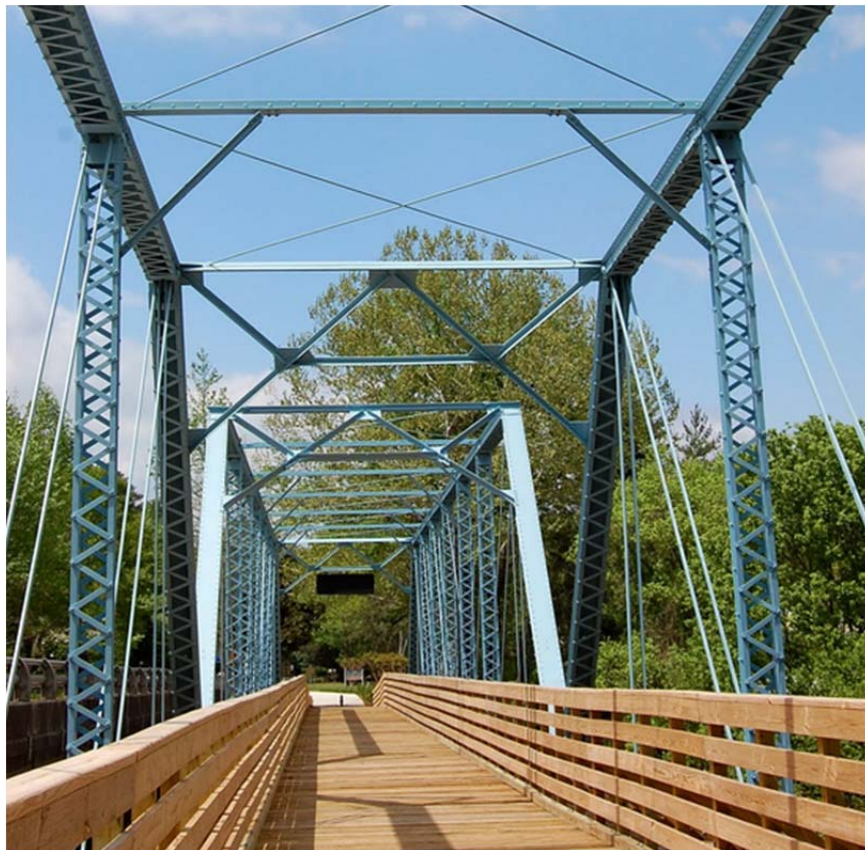
Figure 3. Hermi's bridge in Vinings, Fulton County.

One of the most beautiful and well regarded restored metal truss bridges is Hermi's bridge in Vinings, Georgia (**Error! Reference source not found.**). Hermi's bridge is an outstanding example of what can be done when individual, community, county and state interests, and capabilities converge to achieve the retention and restoration of a historic metal truss bridge. This bridge, constructed in 1904 by the Cotton States Bridge Construction Company, is a thru truss, meaning that the roadway (or now the pedestrian walkway) passes through the structure. Hermi's bridge has two identical 140 ft. spans of its main trusses.

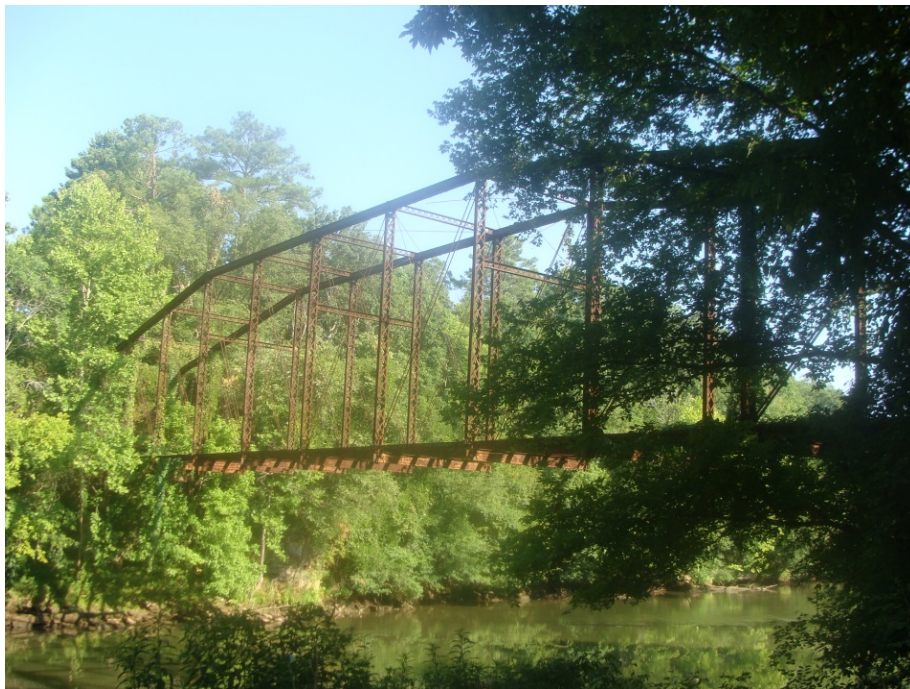
Figure 4. Camelback (pinned) thru truss in Bartow County, Bridge 015-9992 (GDOT 2012).

Figures 4 through 6 show several additional examples of historic thru truss bridges within the state. These bridges are all documented in the GHBS (GDOT 2012). The pin connected Camelback thru truss shown in Figure 4 is the Milam Bridge located in Bartow County and is the longest bridge of this type within the state. Constructed in 1912 by the Converse Bridge Company in Chattanooga, this bridge was closed to traffic in the 1970s. By perusing the GHBS as well as the web sites of private organizations that promote historic bridge preservation, such as HistoricBridges.org (Historic Bridges 2014) and BridgeHunter.com (Bridge Hunter 2014), more than a few bridges can be identified that are essentially stored in situ, although efforts to restore the bridges may or may not be continuing.

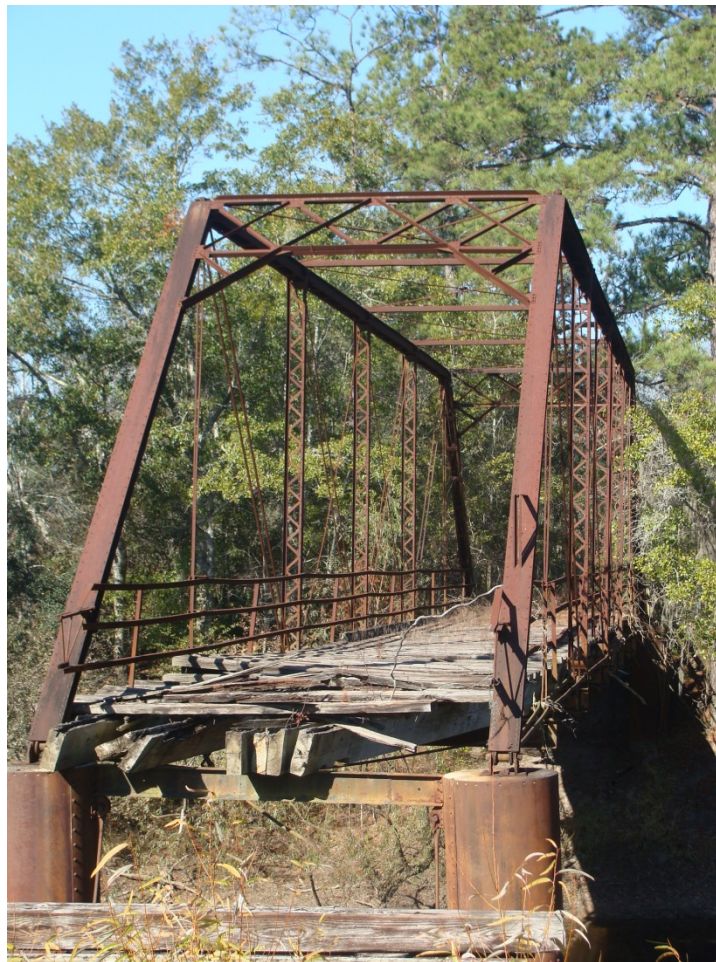
A 100 ft. span Pratt thru truss with pinned connections, built circa 1900 is located in Thomas County, east of US 19 / SR 3, near Dawesville, in a setting of planted pines (Figure 5). The bridge historically carried U.S. Highway 84 over the Ochlockonee River but was bypassed and moved five miles to this location in 1929 to carry U.S. Highway 19/SR 3. In 1959, the bridge was again bypassed and a new concrete bridge was built nearby to carry U.S. Highway 19/SR 3 over the river. The bridge's approach spans have been removed. One can see the disheveled wood stringers underneath the wood plank deck in the photo (Figure 5), supported by the floor beams spanning between the main trusses. Although the Pratt thru truss bridge type is relatively common, the location of this bridge, south of the fall line, is rare.

Figure 5. One-hundred ft. span Pratt (pinned) thru truss located in Thomas County, Bridge 275-9991 (GDOT 2012).

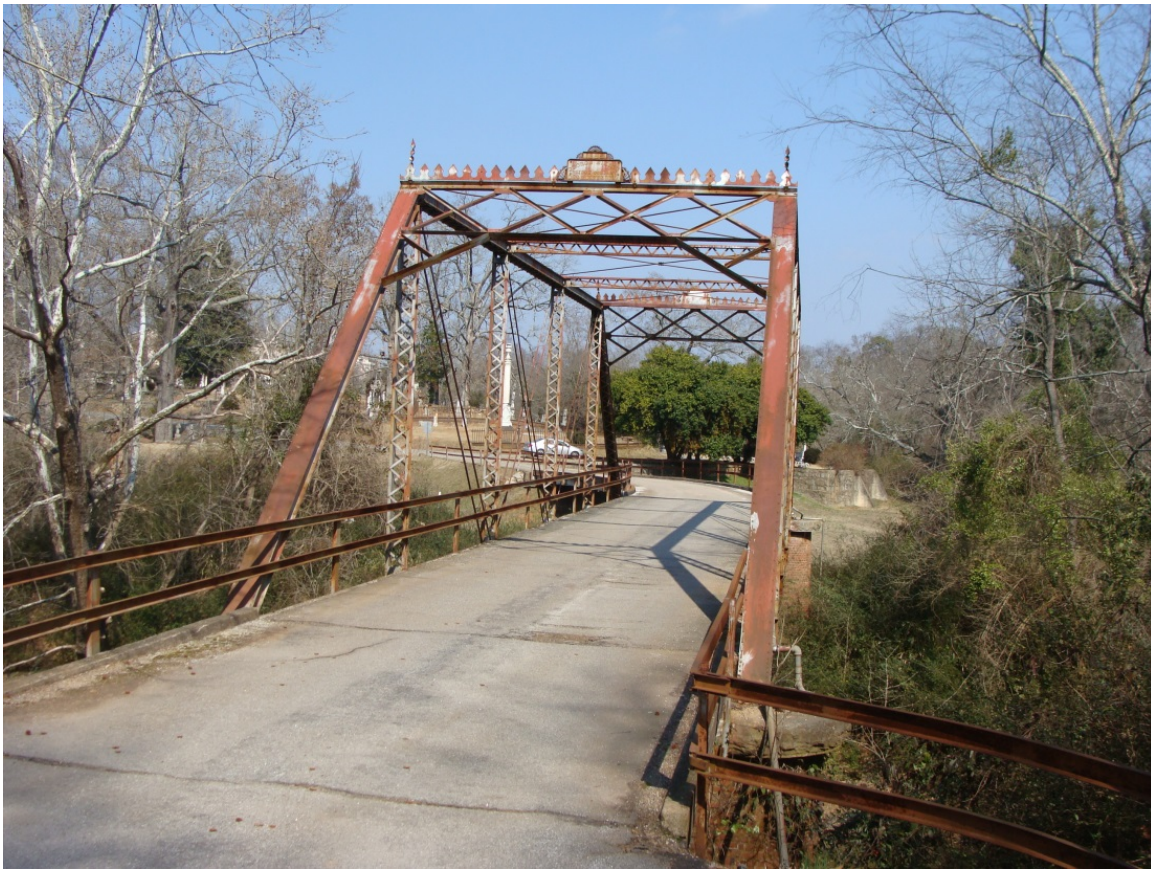
A beautiful Pratt thru truss that is still in service carries a one-lane cemetery road over the Oconee River in downtown Athens, GA (Figure 6). It is ranked by the GHBS as one of the “most complete” pin connected thru truss bridges in the state. In addition to its design integrity, it is a contributing feature of the surrounding historic Oconee Hill Cemetery, an outstanding example of a Victorian cemetery. The bridge was constructed in 1899 by the Geo. E. King Bridge Company of Des Moines, Iowa. It has a number of striking ornamental features on its end portals.

Figure 6. Pratt (pinned) thru truss Clarke County, Bridge 059-9991 (GDOT 2012).

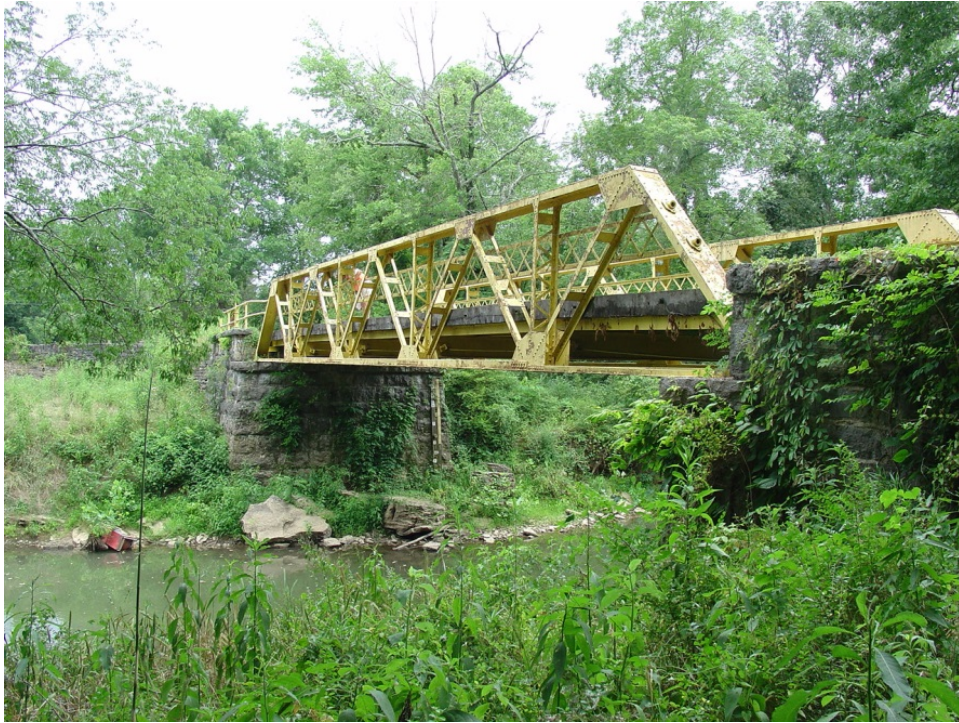
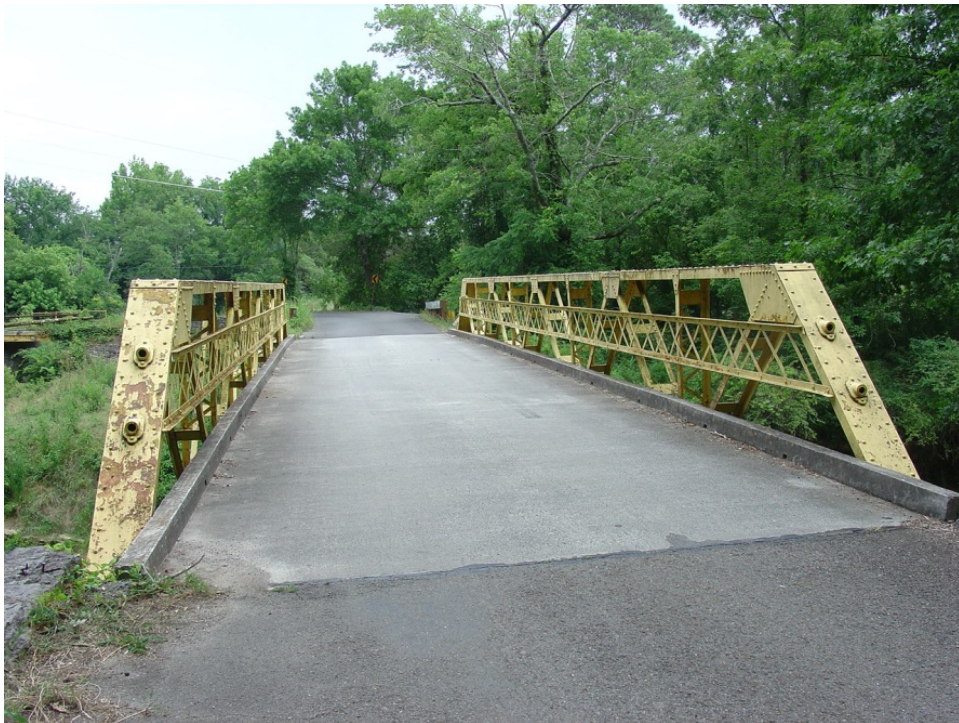
Figure 7. Warren (riveted) pony truss located in Catoosa County and owned by the National Park Service, Bridge 047-5004 in the GHBS (GDOT 2012).

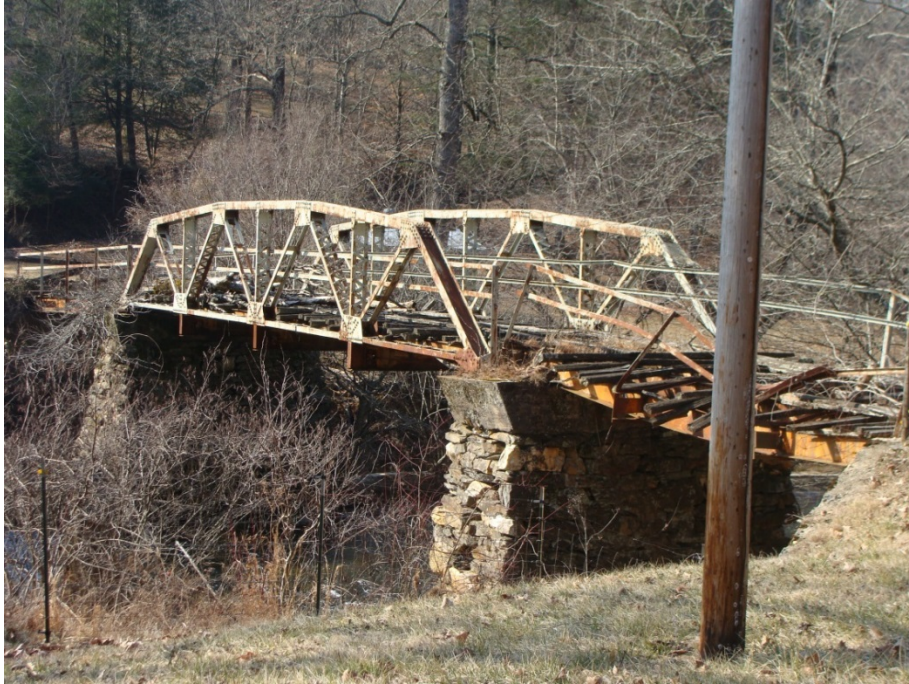
Figure 8. Pony Warren truss located in Fannin County, Bridge 111-9992 in the GHBS (GDOT 2012).

A later example of a pony truss bridge is located in Fannin County and was built in 1938 (Figure 8). This bridge has been bypassed and a new bridge constructed beside it. Its main span is a Warren truss with verticals, and its top chords are rolled H sections. The field connections in the bridge are bolted and all the other connections are riveted. One can observe from the photo that the bridge deck has been removed, and the approaches are mostly obliterated to limit unauthorized access to the bridge.

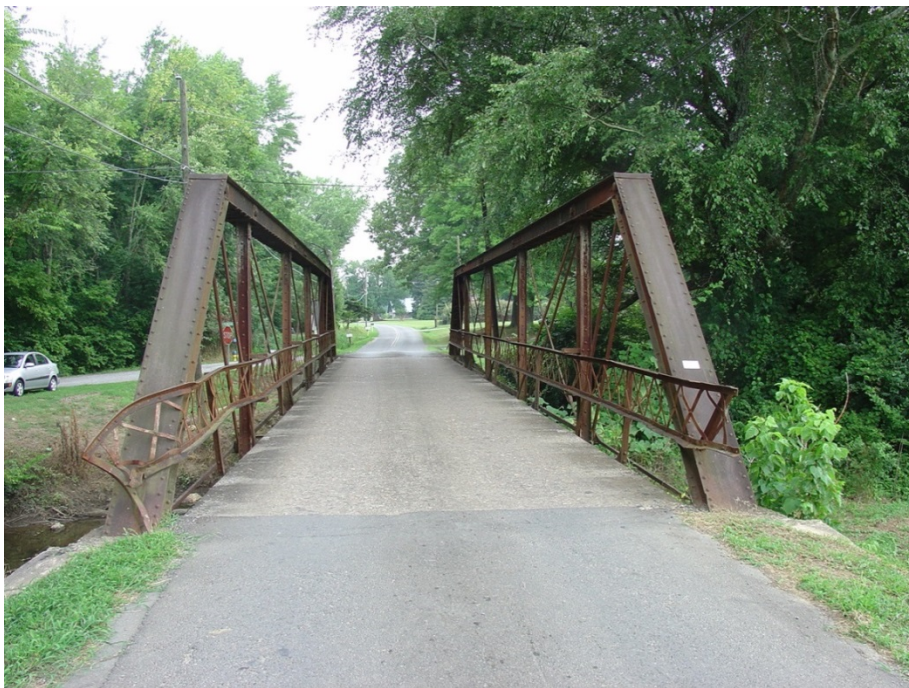
Figure 9. Seventy-nine ft. span Pratt (pinned) pony truss in Murray County, built in 1918 by the Champion Bridge Co., Wilmington, OH, Bridge 213-5007 in the GHBS (GDOT 2012).

Last, Figures 9 and 10 show an excellent example of a pin-connected Pratt pony truss bridge. This is one of only a few of these specific types of bridges remaining in the state. The bridge is a 79 ft. span carrying a one-lane road over a stream in a sparsely developed area in Eton, near the Chattahoochee National Forest. This bridge retains its original lattice railings.

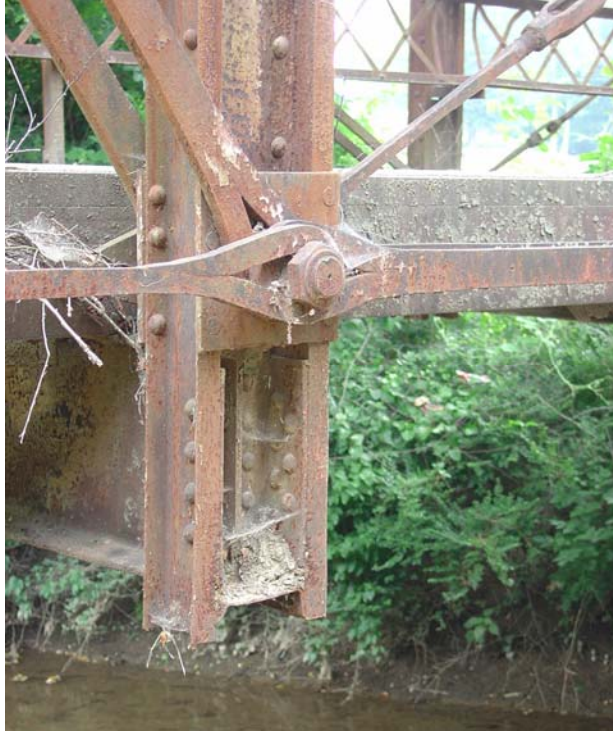
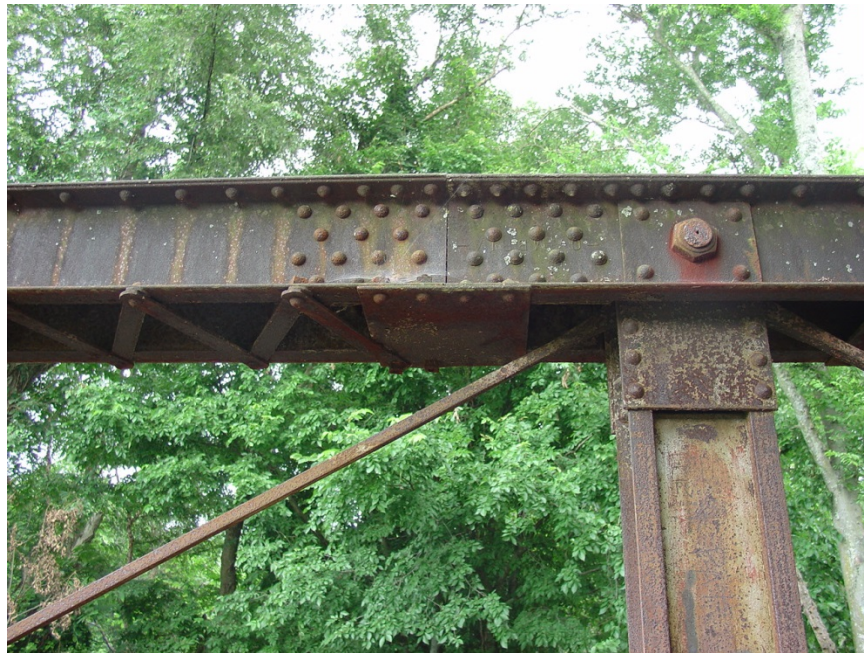
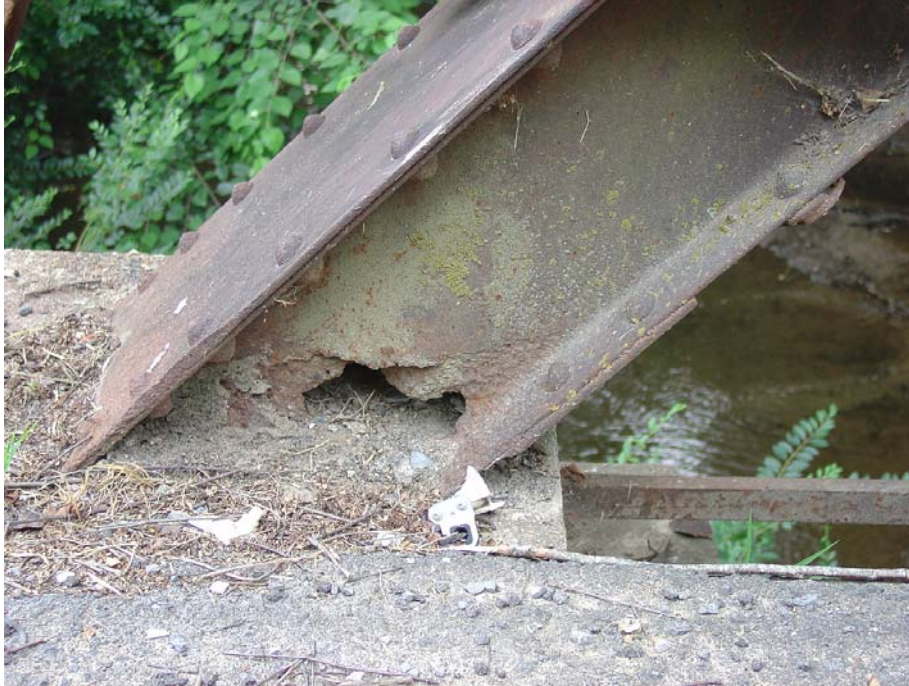
Figure 10. Bridge 213-5007 details.

(a) Pin and eyebar member detail at a bottom chord joint, with a floor beam framed into the truss vertical member at the joint.

(b) Detail at top chord joint

(c) End post detail at the bridge abutment showing some loss of the cross-section due to corrosion

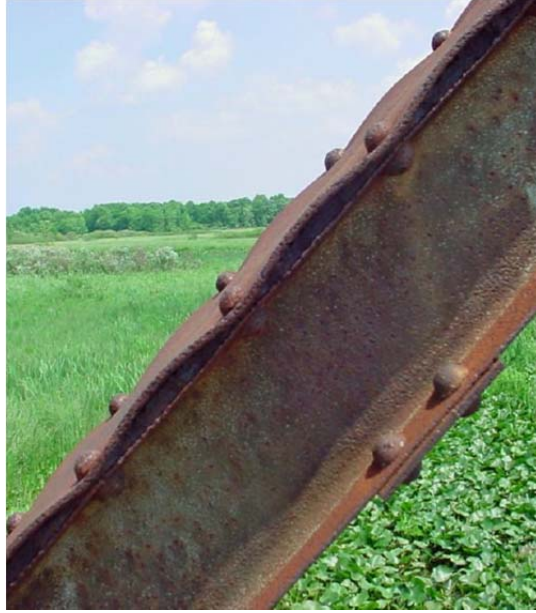
Rust can also occur between rivet- and bolt-connected members, a condition known as impacted rust or pack rust. Pack rust is usually characterized by buckling in one or more parallel metal plates as shown in Figure 11. If pack rust is not treated, the corrosion process may actually accelerate. Pressure washing or sandblasting will not remove the corrosion in inaccessible areas. The active corrosion cells are located within the crevices and include water, oxygen and hydrochloric, nitric, and sulfuric acids. This rust must be removed. Section 2.6.3.8 discusses its removal.

Figure 11. Pack rust (Mesler 2007a)

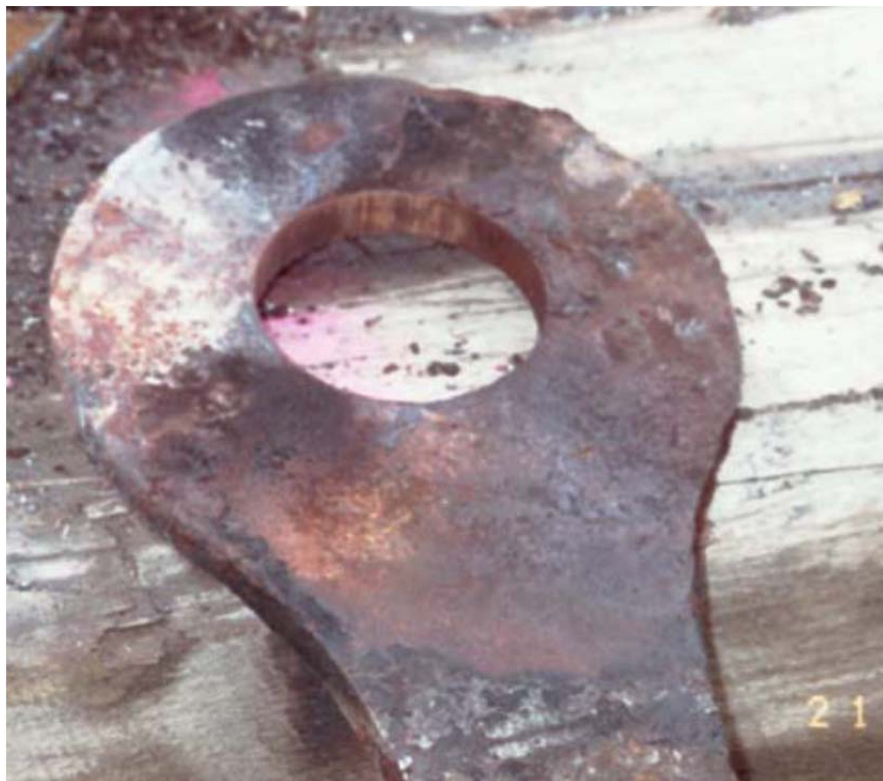
Figure 12, from Bowman and Piskorowski (2004), shows a corroded eyebar at its end connection, and Figure 13 shows this member after the above filler weld repair procedure was completed on this member. A detailed discussion of the above filler weld processes can be found also in (Mort 2008), where the process is referred to as padding.

Figure 12. Eyebar end connection showing heavy corrosion (Bowman and Piskorowski 2004)

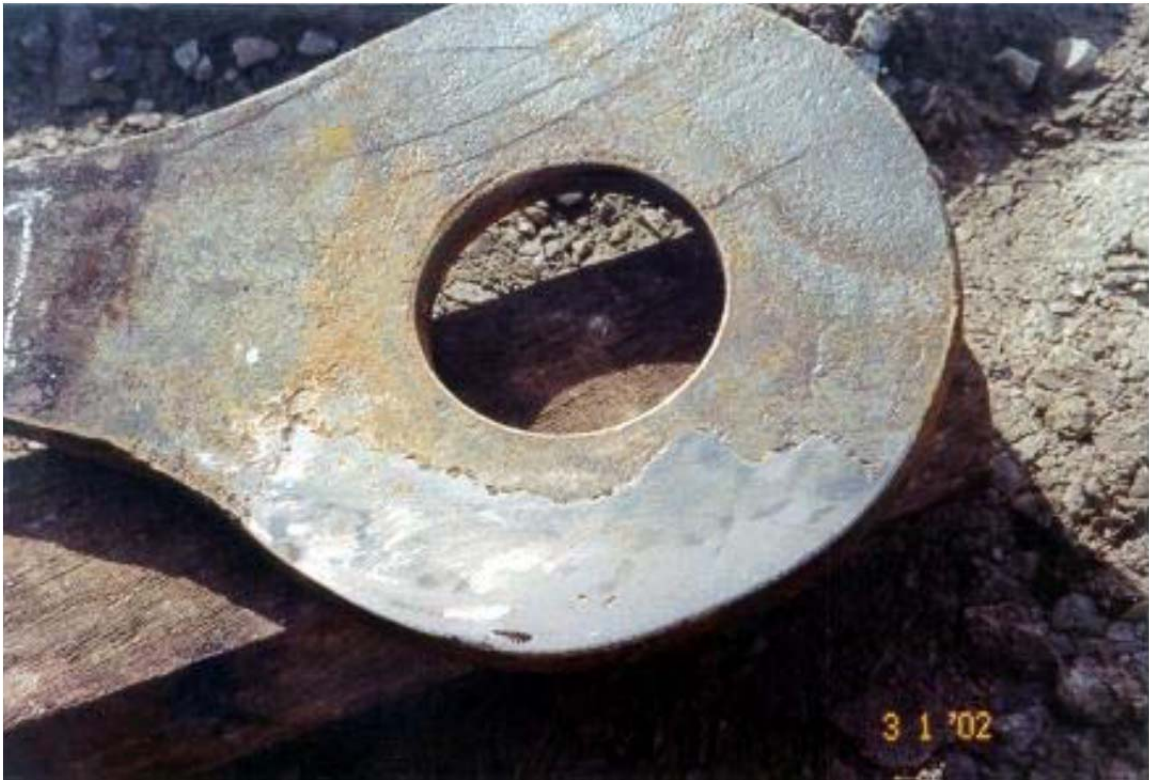
Figure 13. Eyebar end connection after repair by the filler weld procedure (Bowman and Piskorowski 2004)

With both of the above procedures, it is particularly important to give due attention to the welding process. Welders with experience and knowledge in welding historic metals should be used, and the process should be approved by a qualified professional engineer. It should be noted that these procedures are relatively obscure. The authors of this report were not able to locate any formal specifications for the processes in their literature search. Mort (2008) refers to Lincoln Electric Company (1933) and Jefferson (1990) for guidance on the welding processes. He indicates that successful repairs have been conducted by using low welding currents and fast travel speeds for steel with high phosphorus and by using low-hydrogen electrodes on steels with high sulfur.

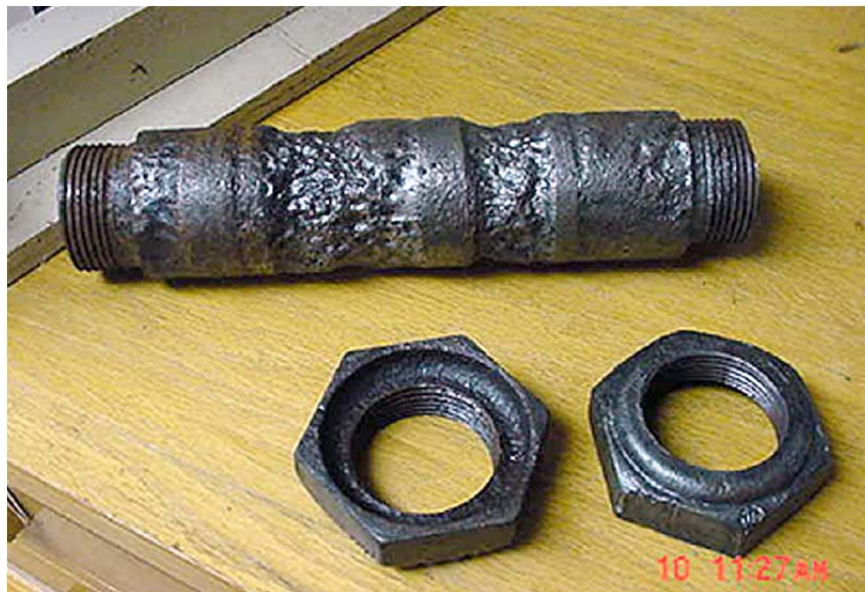
Substantial corrosion and section loss at truss pins, as shown in Figure 14, can result in an irregular cross-section that makes their removal difficult. Jacking may be necessary to separate members at the panel points if heavy corrosion has occurred. In some cases, it has been necessary to pierce the pins through their centers with a torch and collapse them (Figure 15). Care must be taken to support the remaining members after the removal of the pin.

Figure 14. Example of a heavily corroded pin (VDOT 2006).

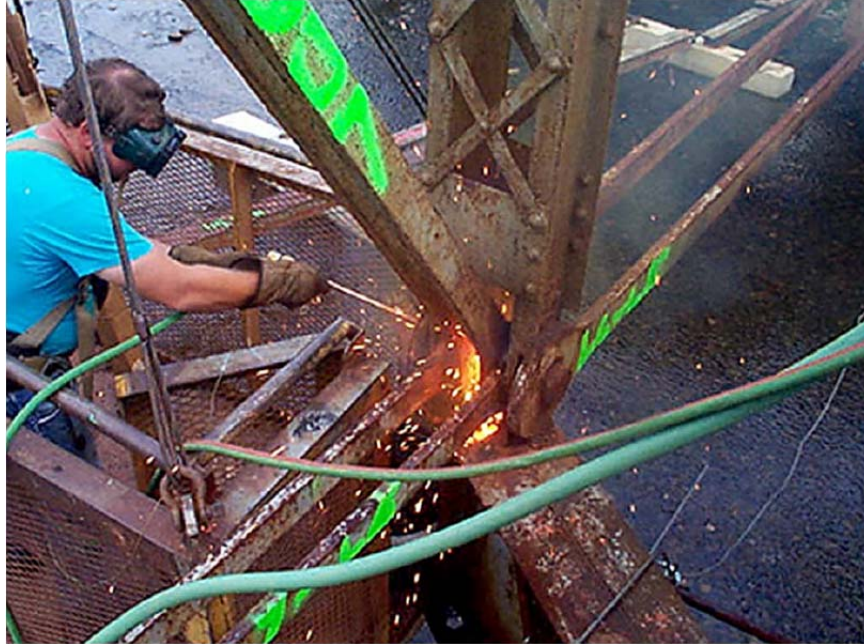
Figure 15. Piercing the center of a pin (VDOT 2006).

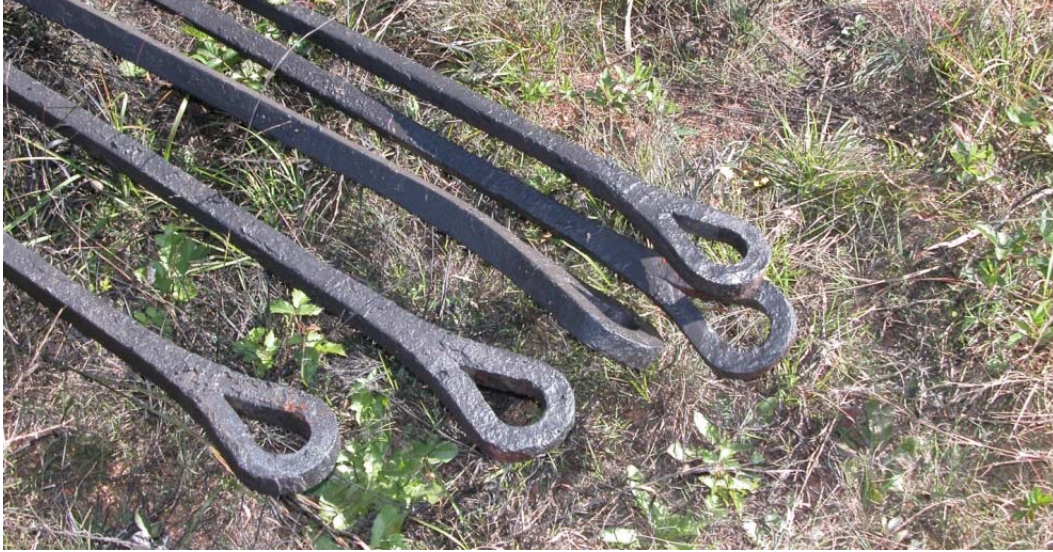
Historic metal truss bridges often use loop or loop forge welded eyebars (Figure 16) as tension members. These members were formed by bending the bar to form a loop and welding the end into a notch in the straight section of the bar. Failure of these types of members has been noted during inspections of historic truss bridges (VDOT 2006), and their design use has long been prohibited (Urquhart 1930). There are no current standards to guide the assessment of these member types. Because of the uncertainty, Virginia DOT replaced all of the loop eyebars in its preservation of the Goshen Bridge (VDOT 2006). However, Hatfield (2001) points to research by Ellerby (1976), in which fatigue tests were conducted on these types of bars that suggested that they could have remained in highway service for many more decades. Nevertheless, these researchers found that fracture may occur at a forge weld rather than in the body of the bar, sometimes at a load much less than the design strength of the bar. The investigators speculated that repeated flexing of the loops was a critical factor and noted the deleterious effect of a poor fit of the pin. Hatfield (2001) recommends the practice of inspecting eyebars and forge welds visually and by ultrasonic and dye penetrant methods, grinding out cracks, and building back bars to their original profile by filler welding. He points to Ellerby (1976) for evidence that this process restores the full strength.

Figure 16. Forge welded loop eyebars from the City of Griffin 6th St. Bridge.

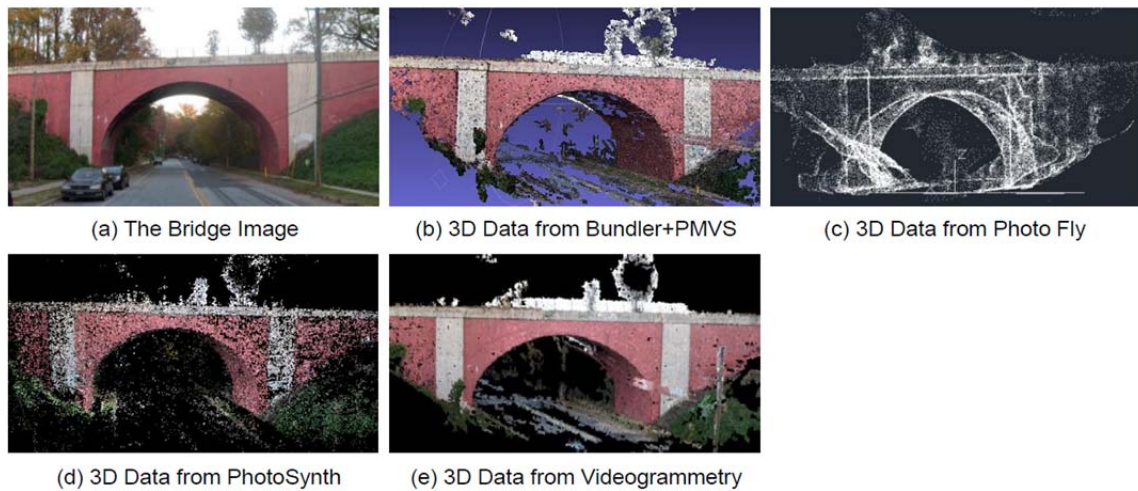
Figure 18. Photogrammetry and videogrammetry as point cloud data acquisition approach (Dai et al. 2013)

Although point clouds from laser scanners can be collected easily and in little time, they often require multiple set up locations. Such manual surveying is labor-intensive, can be costly, and potentially exposes the surveyor(s) to road hazards. For these reasons, photogrammetric range point cloud data acquisition techniques using inexpensive photo or video cameras (Dai et al. 2013) and Unmanned Aerial Vehicles (UAV) (Seibert and Teizer 2013) may be better options. Figure 18 shows sample photogrammetry and videogrammetry data. Since photos or videos are routinely taken on projects, generating point clouds from such devices adds little additional cost. Some of today's computer algorithms provide point cloud data at low error rates. The results of many photo or videogrammetric data acquisition and processing techniques provide accuracies within a few centimeters, but these are sufficient for many tasks in documenting historic bridges. Similar to laser scanning, point cloud values in photogrammetry and videogrammetry are always colorized. Figure 18 shows multiple colorized point clouds generated by different software. The choice of software and its corresponding output is dependent on the needs of the user.

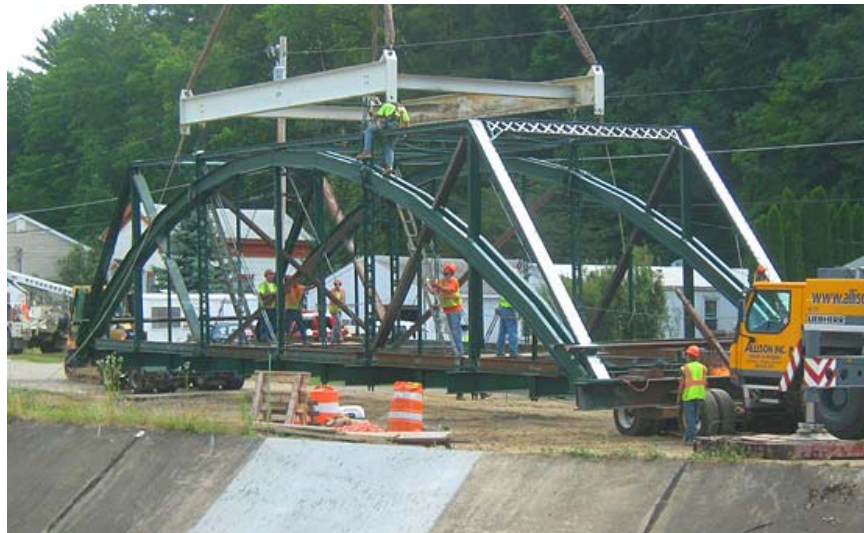
Figure 23. Relocation of the 7th Street Bridge in Coudersport, Pennsylvania (Larson Design Group 2011).

The best candidates from bridge relocation are truss and girder bridges (ConnDOT 1991) due to their design and fabrication. More specific, the best candidates for relocation treatment are pony and thru truss bridges (NYSDOT 2002; Haberling and Leary 2004), such as illustrated in Figure 23.

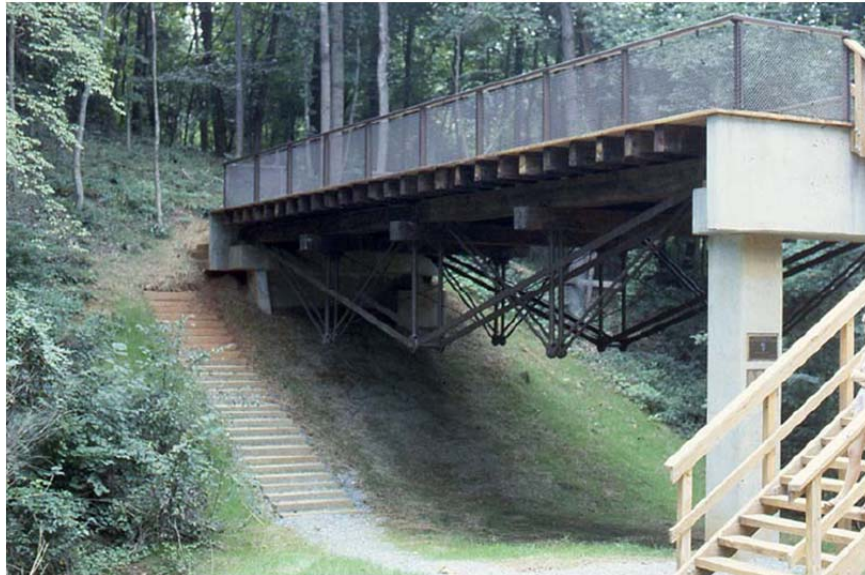
Figure 25. Fink truss relocated as an exhibit in a park (VDOT 2006).

The above specification focuses on leaving the entire metal truss bridge intact and moving it as one unit to an alternative location. Many small truss bridges can be handled in this way and there are records of bridge spans with lengths slightly larger than 100 ft. being relocated intact. Figure 24 shows an example of a rare Fink truss bridge in Virginia before it was taken out of service. Virginia DOT relocated this 52.5 ft. long, 13 ft. wide, and 7.5 ft. deep bridge, intact, to a nearby park (Figure 25) by removing its deck and railings, and supporting the bridge on stanchions on a flatbed trailer (Figure 26).

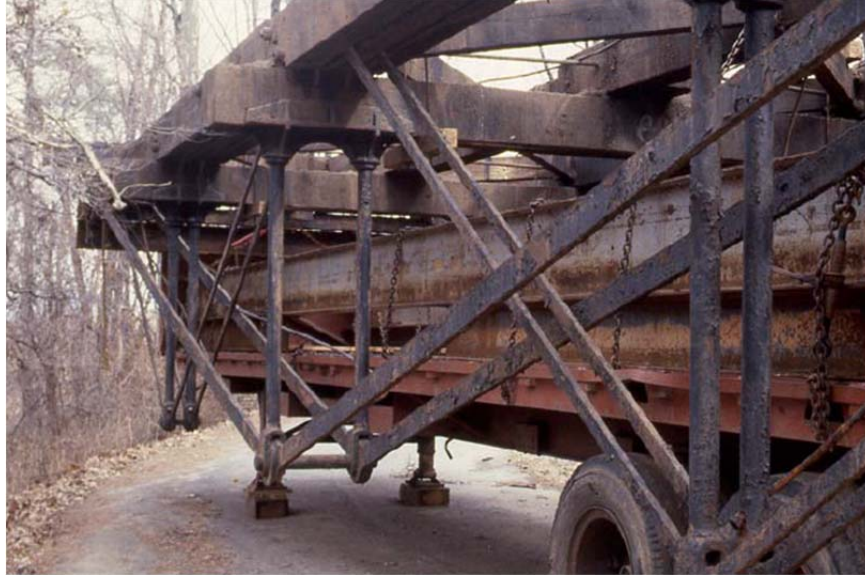
Figure 26. Transportation of Fink truss (VDOT 2006).

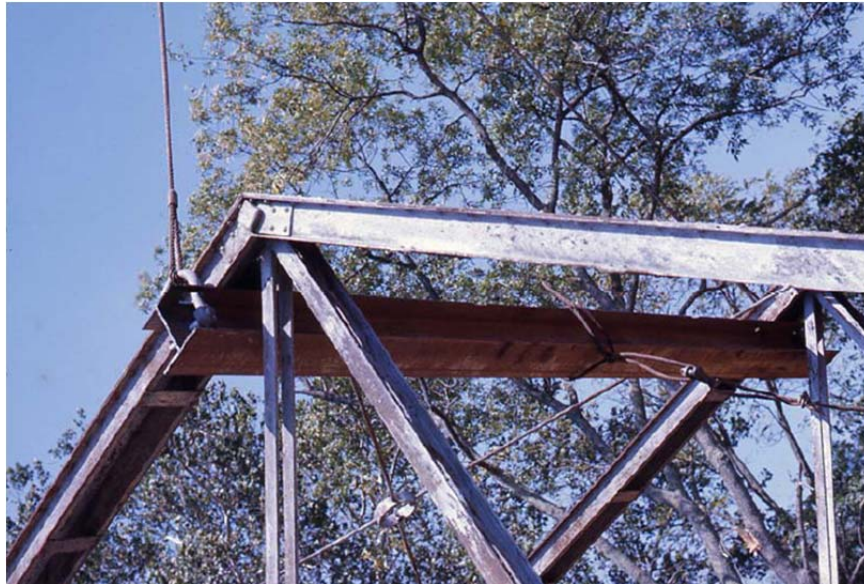
Figure 28. Lifting apparatus at hip joint of 106 ft span Pratt truss (VDOT 2006).

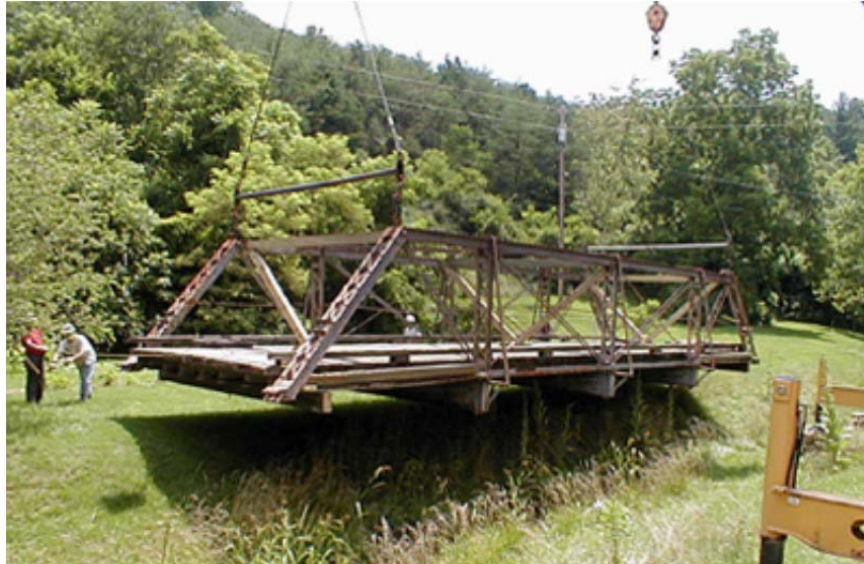
Figure 29 shows another example of moving a Pony truss bridge intact (VDOT 2006). The temporary struts have been placed between the trusses at the level of the top chord to prevent the potential of the top chords essentially folding inward during the lifting. In addition, the bottom chord has been reinforced by temporary struts for the lifting and moving operation. As previously discussed, lifting the bridge by rigging attached at the hip joints induces compressive forces in the lower chords.

Figure 29. Moving of a pony truss bridge intact (VDOT 2006).

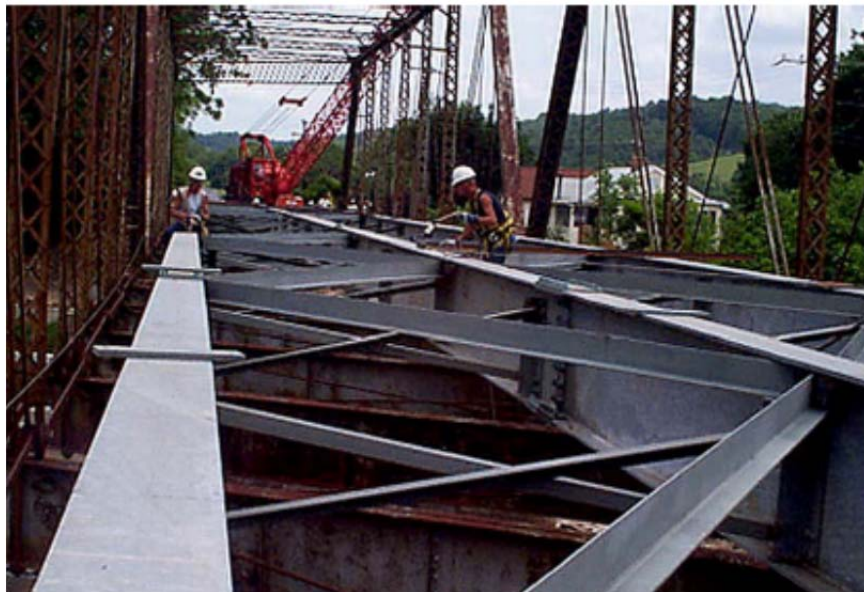
Because the Calfpasture River at Goshen carries runoff from a substantial mountainous drainage area, the river flows rapidly and floods frequently, carrying debris that posed a hazard to any temporary supports located in the river or the adjacent flood plain. For this reason, the VDOT design team decided to basically build a two-span, three-girder rolled beam bridge above the floor beams of the historic truss to serve as the falsework for the disassembly of the truss bridge. This continuous-span falsework bridge was supported on blocks on the floor beams of the truss bridge and then on temporary bents placed adjacent to the abutments and the middle pier. Figure 30 shows the Goshen bridge just prior to its disassembly, Figure 31 shows the installation of the three beams of the two-span continuous falsework bridge, and Figure 32 shows the temporary bent at the middle pier of the truss structure (three H-piles on concrete footings founded on firm material (1.5 tons/ft^2), and one pile beneath each of the beams of the falsework bridge). The two-span continuous falsework bridge was constructed with various cross-frames between its girders as well as a top flange lateral system, as can be seen in Figure 31.

Figure 31. Installation of the beams for the internal two-span continuous falsework bridge used for the disassembly of the Goshen Bridge (VDOT 2006).

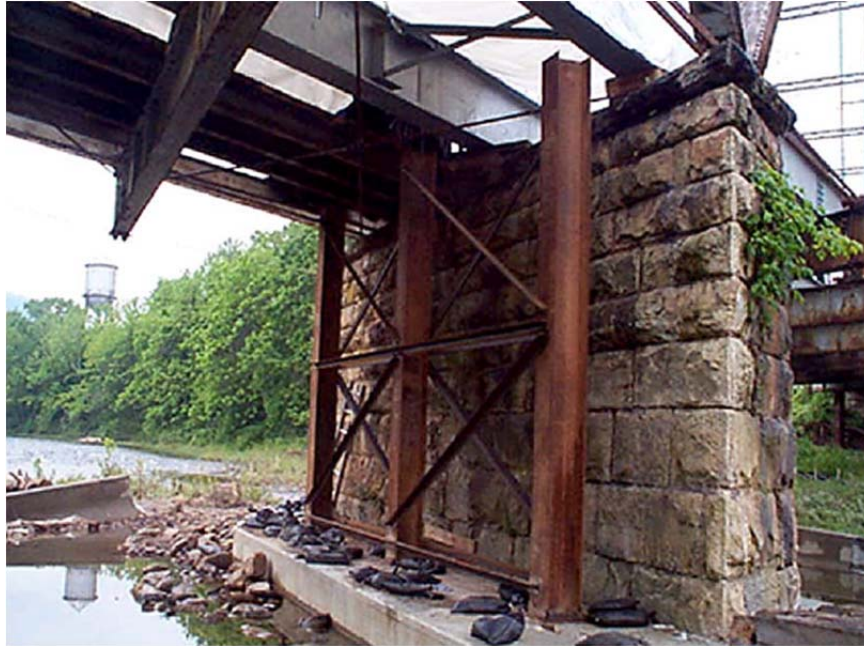
Figure 32. Temporary bent at the middle pier of the Goshen Bridge, with two lines of the falsework beams in place, from (VDOT 2006).

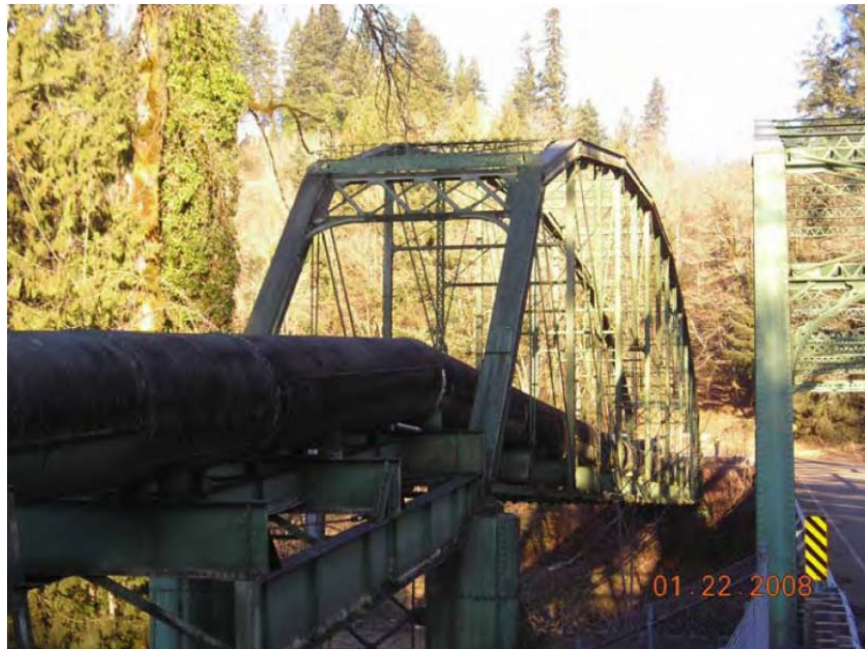
Figure 34. Conduit 2/4 Bridge over the Sandy River in Oregon (Parsons Brinckerhoff 2008).

The removal of the Conduit 2/4 Bridge over the Sandy River in Oregon provides other useful insights pertinent to best management practices for storage of historic metal truss bridges. The 300 ft. main span of this bridge was constructed in 1893 and is comprised of a steel pin-connected modified Pratt truss, approximately 16.5 ft. wide (Figure 34). The bridge carried the water supply for the City of Portland across the Sandy River. Several bridge issues were identified that placed the City’s water supply at some risk. As such, the conduits were removed from the bridge and placed in a tunnel underneath the Sandy River. Also, the bridge was to be removed and stored for potential reuse.

Temporary shoring was installed to transfer the dead load from the truss to the shoring (Portland Water Bureau 2007). This shoring significantly reduced stresses at the pins. The members could then be removed with relative ease. The report suggested three removal options:

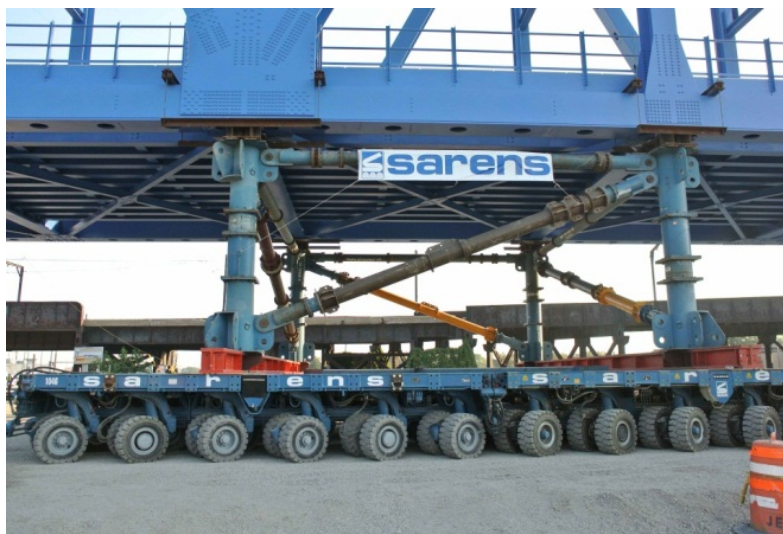
Figure 35. A SPMT moving the Torrence Avenue truss bridge into its erection site in Chicago, Illinois (Transportation Nation 2012).

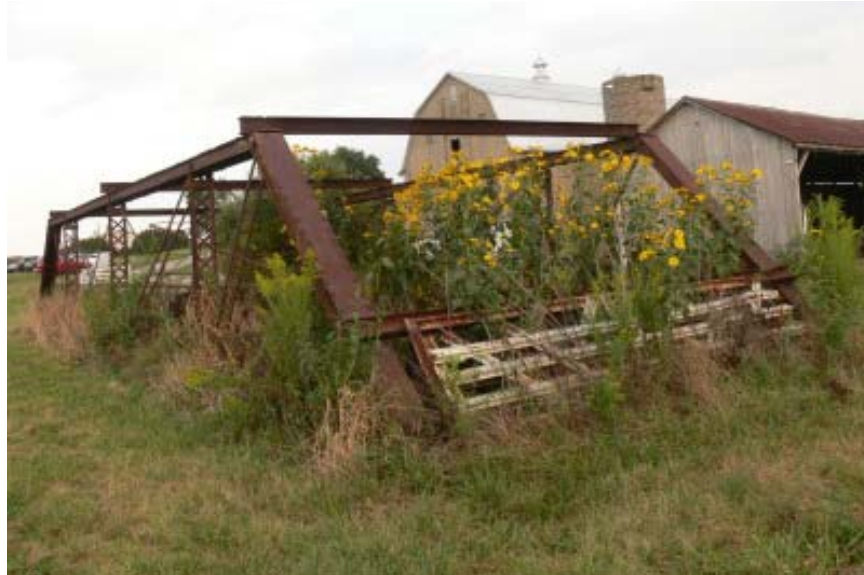
Figure 37. The Big Slough Bridge in storage in Bartholomew County, IN (Bridge Hunter 2013).

Without an active management and effective reuse plan, the stored bridges can be forgotten and become overgrown with vegetation. Figure 37 emphasizes the important need for vegetation

control at any outside storage location, either by placing the structure on concrete or providing some type of vegetative barrier.
