**BEST MANAGEMENT PRACTICES FOR STORAGE OF
HISTORIC METAL TRUSS BRIDGES**

GDOT Research Project No. 12-05
Task Order No. 02-111

Final Report

Donald W. White, Jochen Teizer, Yihai Fang, Thanh V. Nguyen and Ryan Jarriell
Georgia Institute of Technology

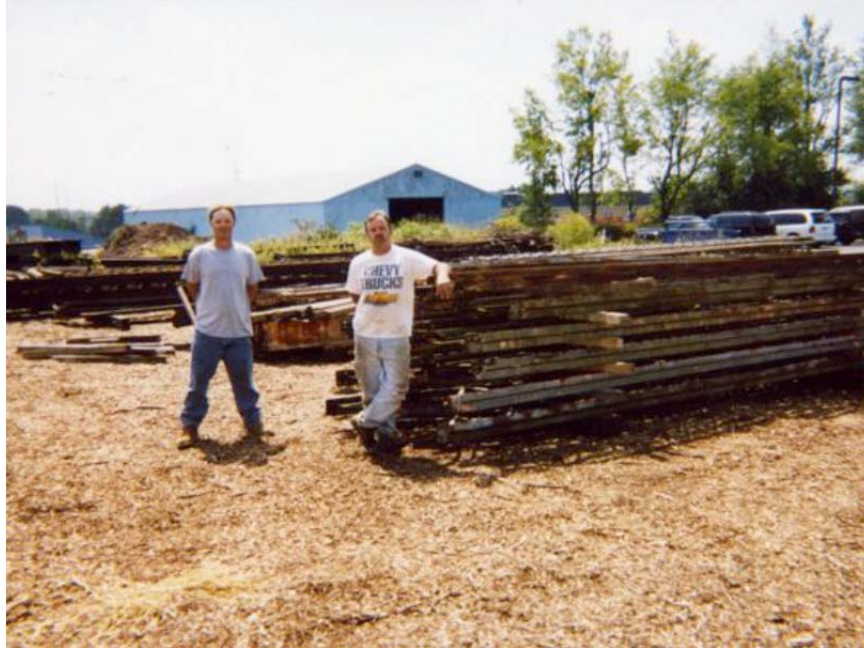
Figure 40. Historic bridge storage area in Marshall, Michigan (Mesler 2007b).

In addition to the five bridges situated in the park, the park has acquired several historic truss bridges for storage. These bridges are now stored in a specific storage area in Marshall, Michigan, as shown in Figure 40. The disassembled structures are stored outdoors.

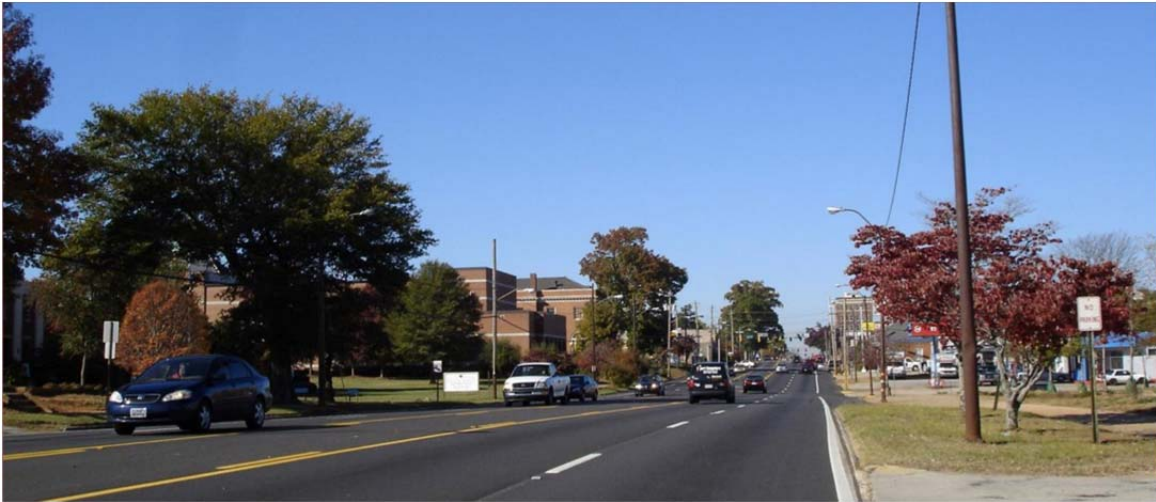
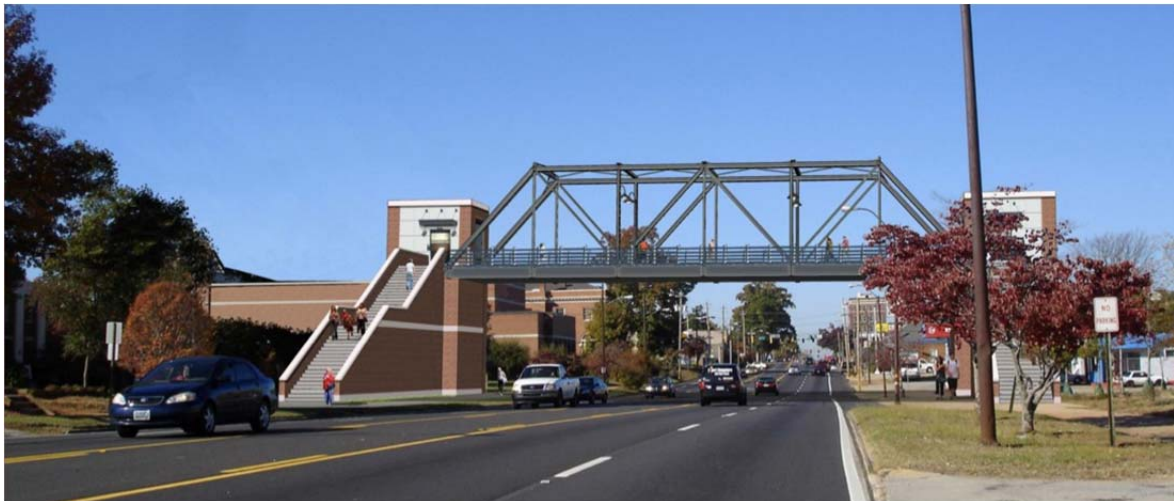
Figure 45. Taylor Street and 5th Street (PBS&J 2011).

Figure 46. Taylor Street and 5th Street with 3D sketch of bridge added (PBS&J 2011).

When deciding how best to repurpose a bridge, a basic 3D sketch can help in the visualization of its new use at the new location. 3D sketches can also be integrated into photographs to help stakeholders visualize the sizing, placement, community impact, and overall aesthetic appeal of different options. Atkins prepared seven reuse options for the 6th Street Bridge in January 2011. The seven reuse options were compared on the basis of the evaluation criteria discussed in the study. Included in each option was a visualization comparison. Figures 45 and 46 show an example of the visualization presented to the City for one of the seven options.

All reuse options included in the report incorporated similar before/after comparisons showing how quickly and effectively a 3D sketch can be utilized as a visualization tool. A basic 3D sketch can be further used as a marketing tool on a website describing available truss bridges within the state. A 3D sketch of this kind that can be quickly created will aide potential users in a more meaningful way than photographs and drawings. The ability to manipulate and implant a 3D sketch into different locations and settings will help stakeholders understand and assess the various options.

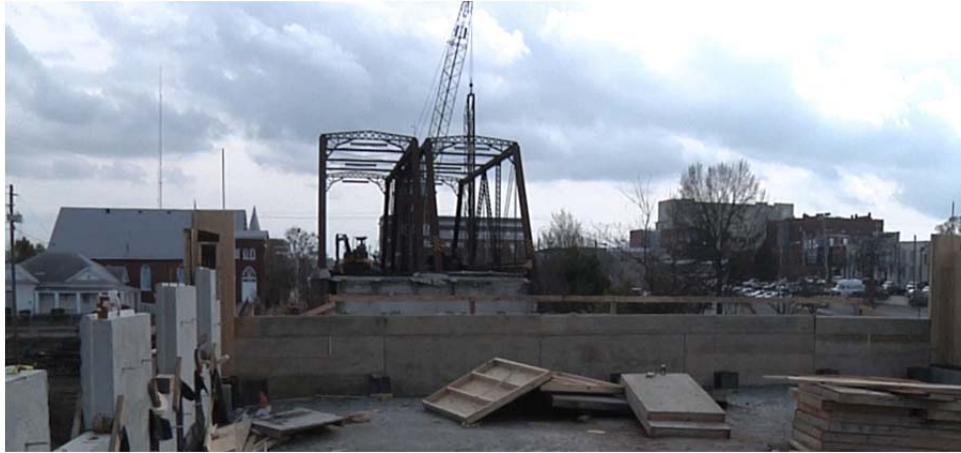
Figure 48. New construction approach spans (Courtesy of Sharman Southall, GDOT).

- 1) Removal of approach spans to allow immediate construction of new wider approach spans (Figure 48);

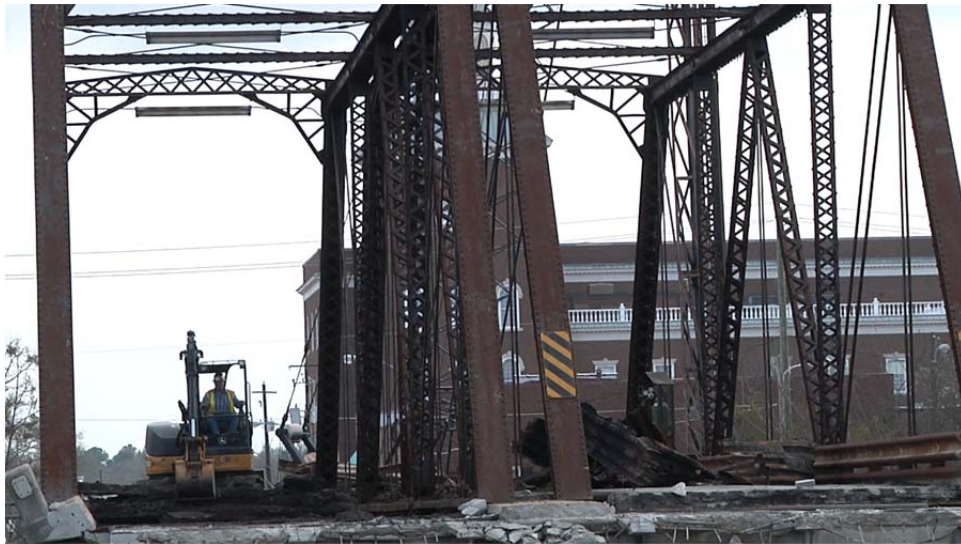
- 2) Removal of concrete deck as well as the timber stringers below (see Figure 49);

Figure 49. Removal of concrete roadway and timber stringers (Courtesy of Sharman Southall, GDOT).

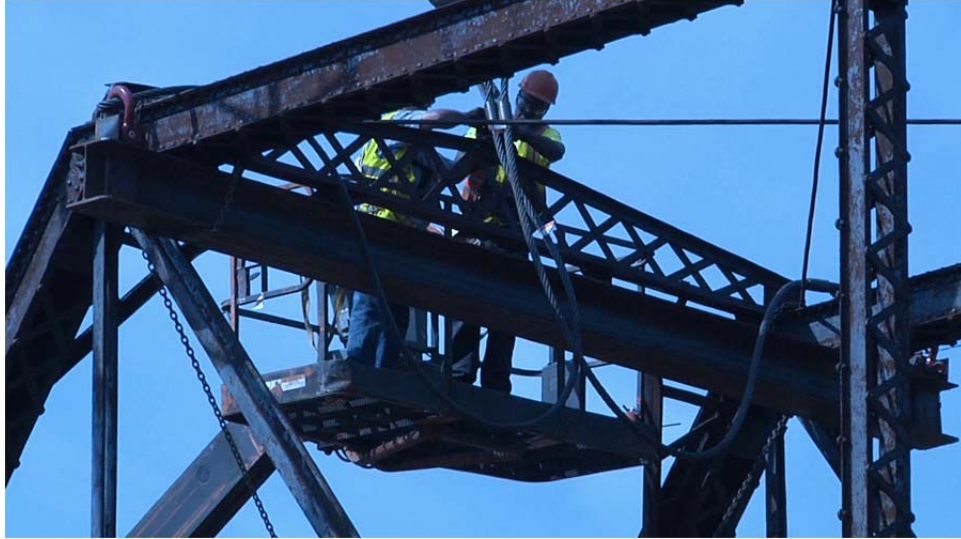
Figure 50. Lateral and horizontal bracing at the upper chord to accommodate the crane lift points (Courtesy of Sharman Southall, GDOT).

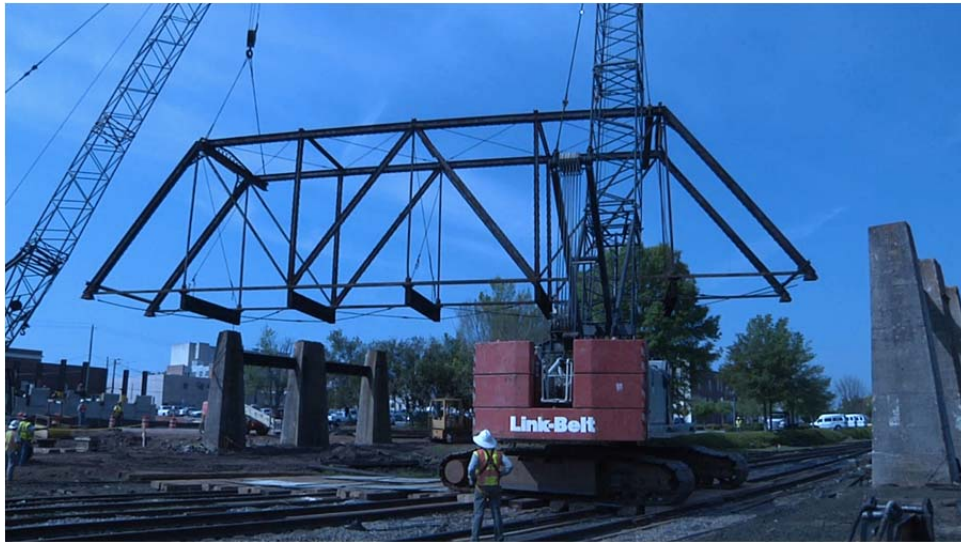
Figure 51. Two cranes working together to lift the 100 feet span (Courtesy of Sharman Southall, GDOT).

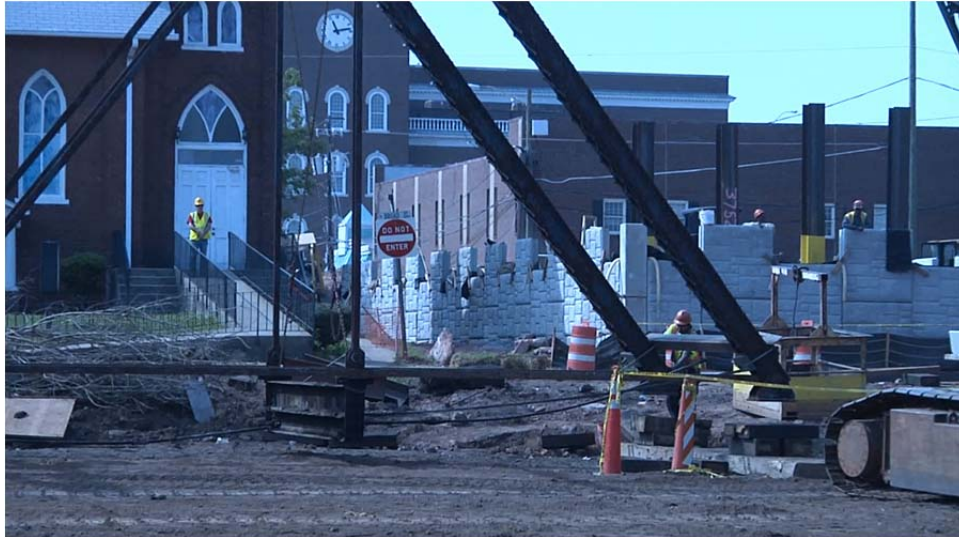
Figure 52. Trusses placed on cribbing at each of the four corner supports to ensure that the five truss verticals remained elevated (Courtesy of Sharman Southall, GDOT).

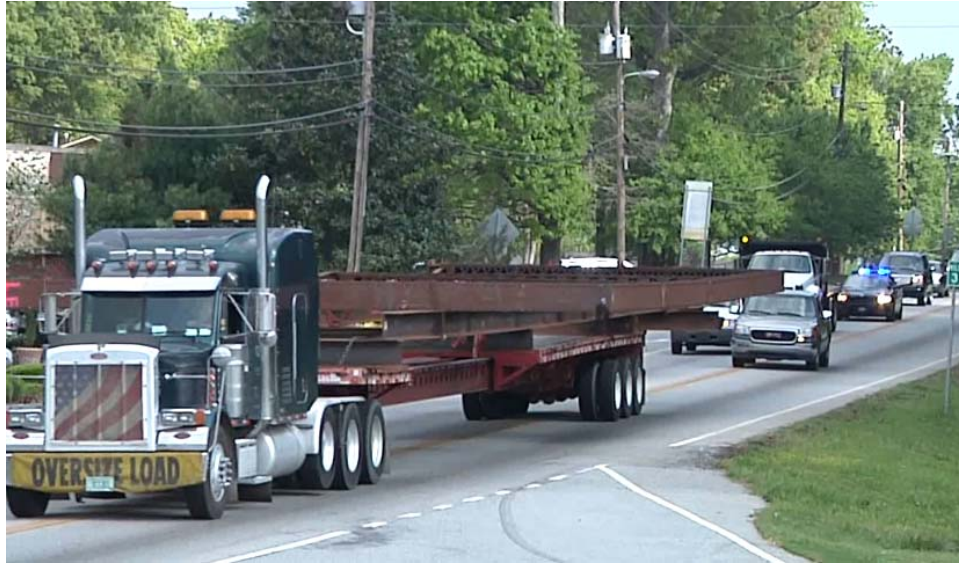
Figure 53. Transportation of one of the planar trusses on S. Hill Street, Griffin, GA, in route to the storage site at the Griffin airport (Courtesy of Sharman Southall, GDOT).

As described in Section 8.6, the 6th Street Bridge was disassembled into four planar trusses. These planar trusses were transported separately to the Griffin-Spalding County Airport, approximately two miles away. Figure 53 shows one of the planar trusses in-transit to the offsite storage location.

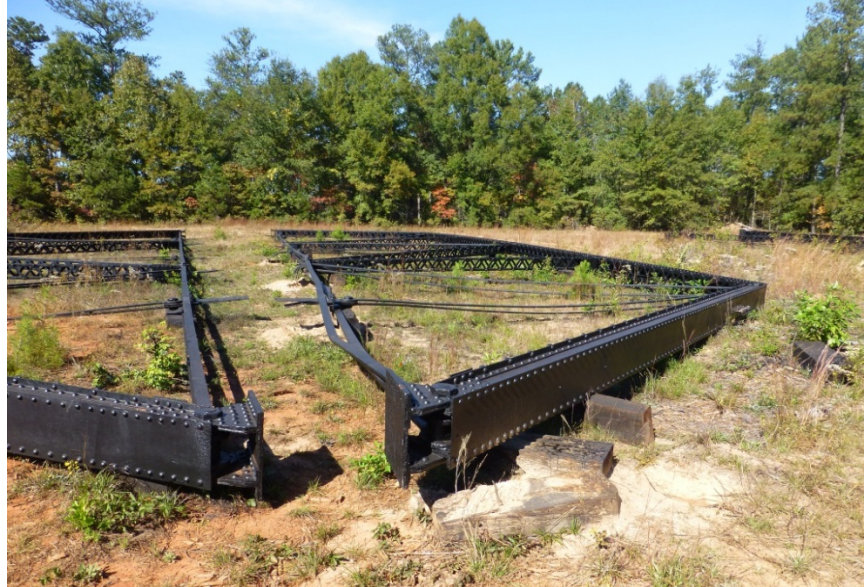
Figure 54. Planar trusses resting on their side on wood blocks at the Griffin-Spalding County airport storage site.

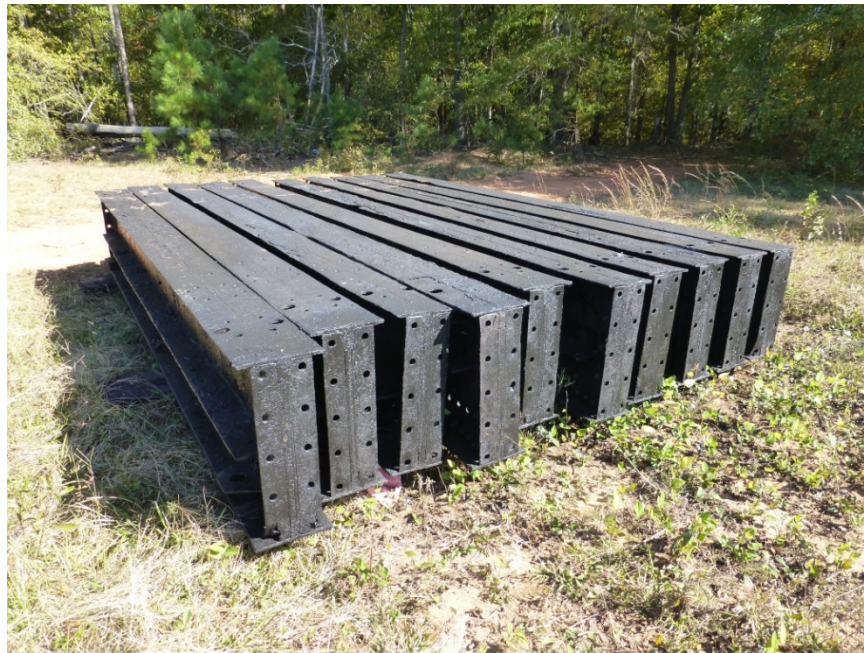
Figure 55. Floor beams in storage at the Griffin-Spalding County airport storage site.
