**EVALUATION OF ALTERNATIVE  
PEDESTRIAN CONTROL DEVICES**

**Final Report**

**SPR 721**

Oregon Department of Transportation

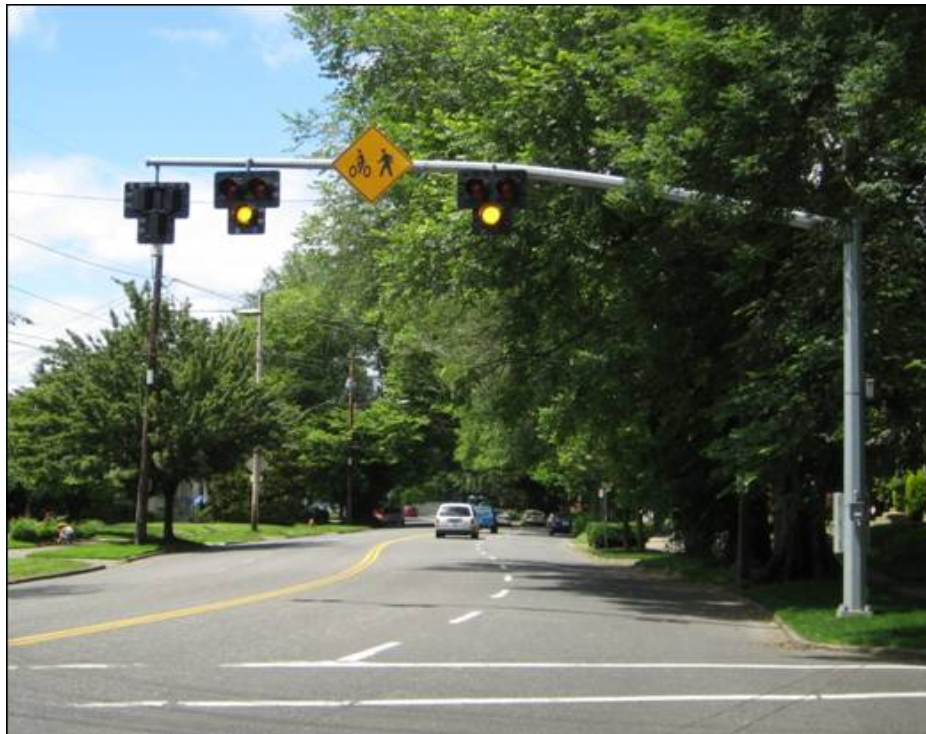
Figure 2.1: PHB installation at NE 41<sup>st</sup> Ave and E Burnside St in Portland, Oregon

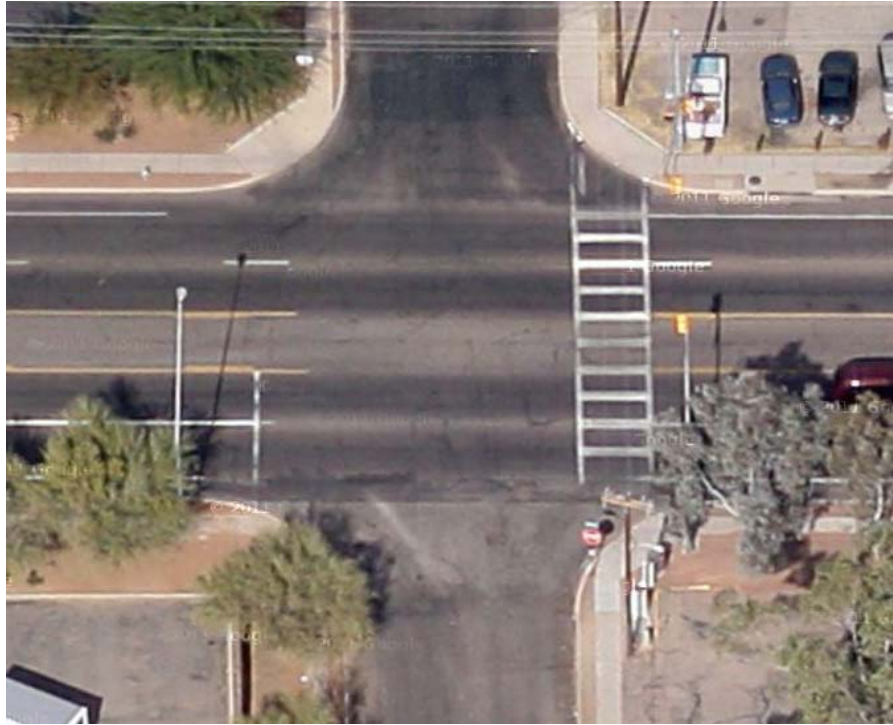
Figure 2.4: Aerial view of PHB installation at E 29th St & S Irving Ave in Tucson, AZ

All of PHB installations in Tucson feature one marked crosswalk, no matter where they are installed. Figure 2.4 is an aerial photo of a PHB installation at an intersection in Tucson and Figure 2.5 shows the driver's perspective at the same intersection.

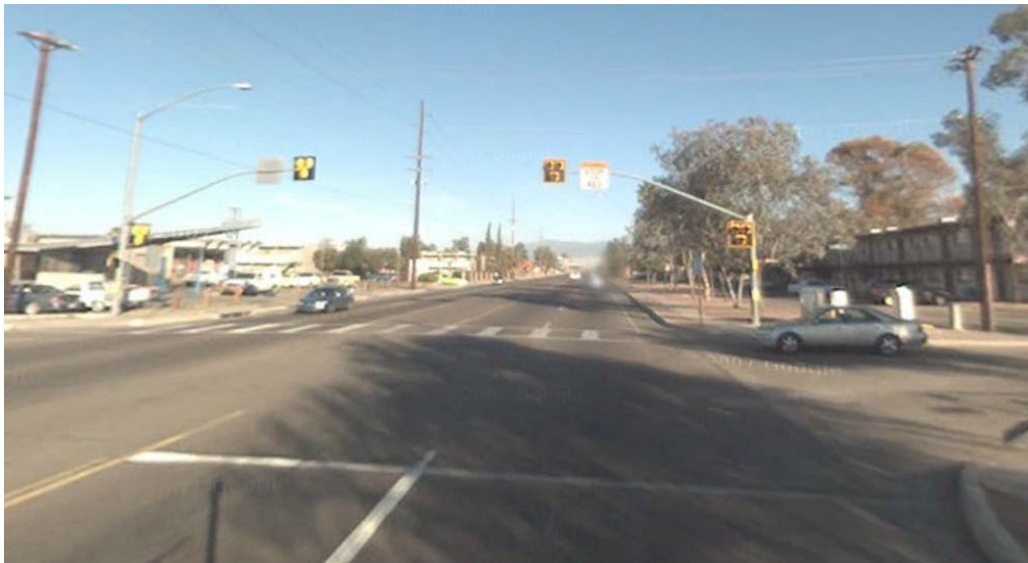
Figure 2.5: Driver perspective at PHB installation in Tucson, AZ

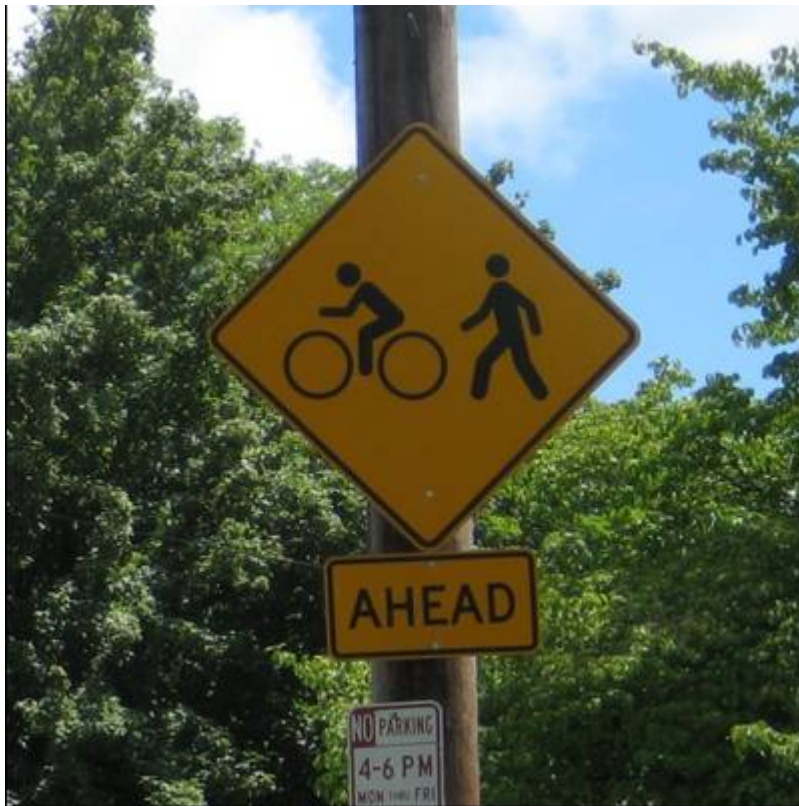
Figure 2.6: Advance warning sign for a bike and pedestrian crossing at Portland PHB

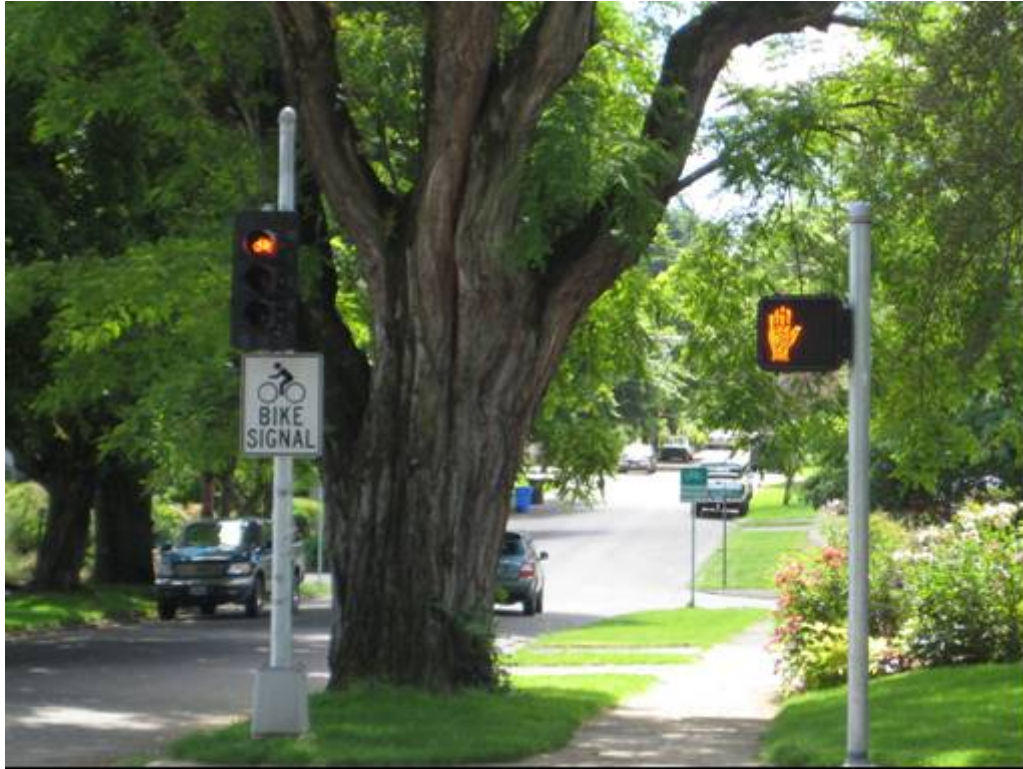
Figure 2.7: Bicycle signal and pedestrian countdown signal at a Portland PHB

The City of Portland has made changes to a PHB to accommodate bicyclists. Portland uses signal phasing for their PHBs that varies from the phasing given in the MUTCD. By not using the flashing red phase, Portland is able to safely use a PHB for heavy bicycle traffic. Portland also uses special advance warning signs showing a bicycle and a pedestrian (Figure 2.6) and a bicycle signal along with a pedestrian signal at the crossing (Figure 2.7).

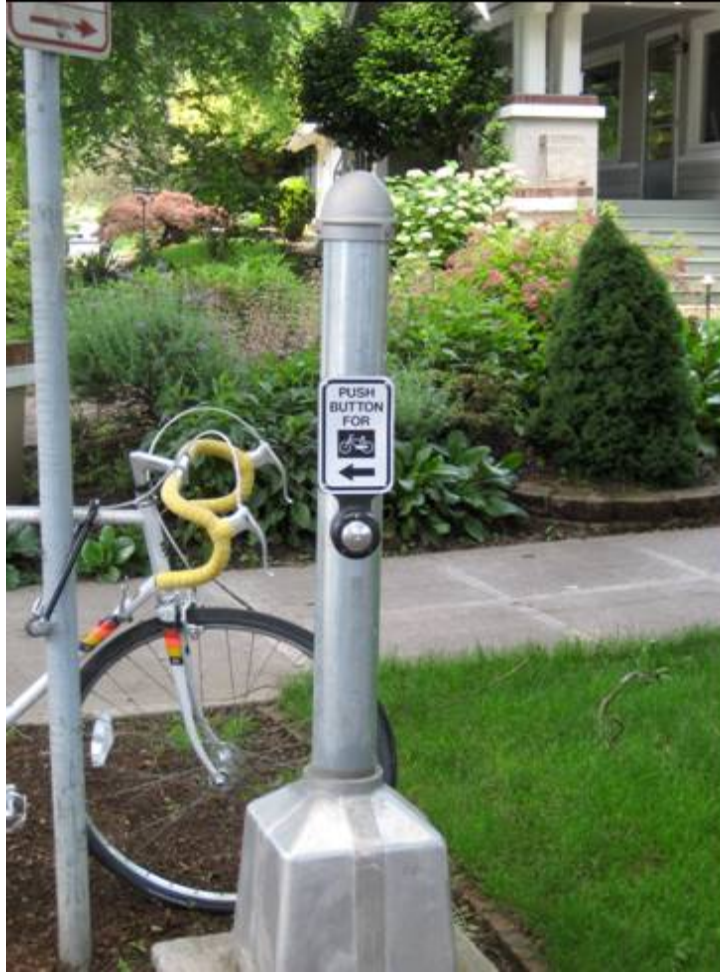
Figure 2.8: Activation button to accommodate bicyclists at a Portland PHB

As shown in Figure 2.8, a special bicycle signal activation button is located close to the roadway to make it convenient for bicyclists. As a result, a high percentage (74%) of bicyclists activate the system (*City of Portland Bureau of Transportation 2010*). This differs from a study in Florida regarding a popular bike crossing that did not make accommodations for bicyclists to activate an RRFB system. In the Florida study, the bicyclists made up 32% of all trail users, and pedestrians were noted as more likely to activate the system compared to bicyclists. (*Hunter et al 2009*).

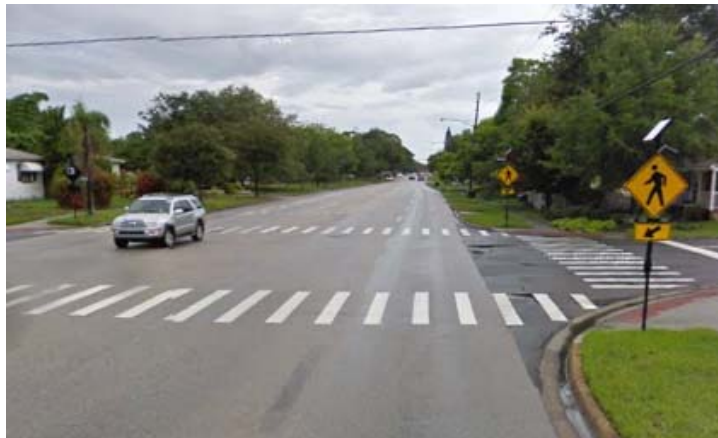
Figure 2.9: RRFBs at an intersection with two crosswalks in St. Petersburg, Florida (Google Maps)

RRFBs have been tested to be effective at mid-block and unsignalized intersection crossings on roadways with posted speed limits up to 45 mph (*Van Houten and Malenfant 2009; Hunter et al. 2009; Shurbutt et al. 2009; Ross et al. 2011*). RRFBs have also been tested on roadways with varying characteristics and implemented safety technologies. The majority of the installations that have been tested were at unsignalized intersections, featuring one or two crosswalks. Figures 2.9 and 2.10 below show a single and a double crosswalk at two unsignalized intersections with RRFBs.

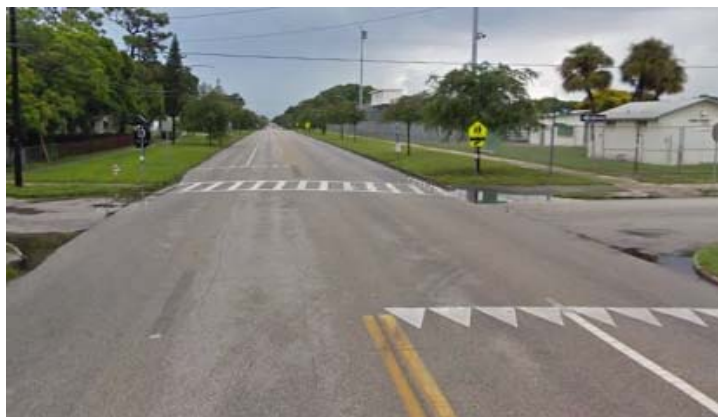
Figure 2.10: RRFBs at an intersection with one crosswalk in St. Petersburg, Florida (Google Maps)

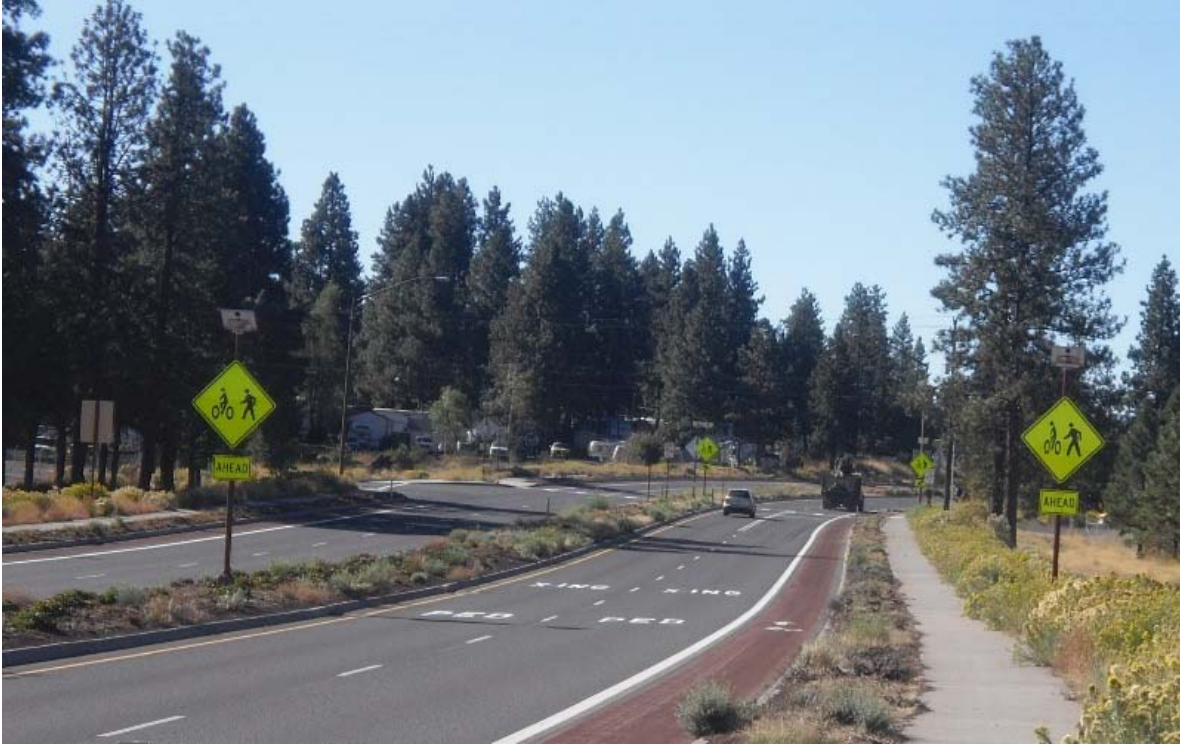
Figure 2.11: RRFB installation at the Reed Lane intersection on the Bend Parkway

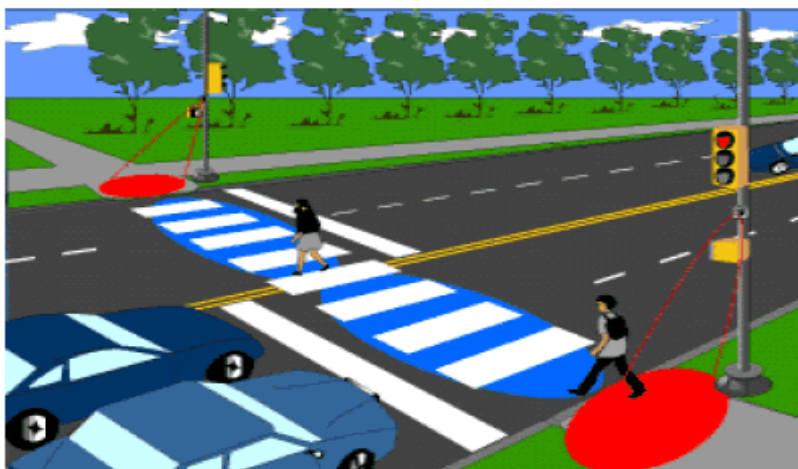
Figure 2.12: Pedestrian detection zones

There are two zones where it is desirable to detect pedestrians as shown in Figure 2.12. The zone located adjacent to the street on the sidewalk is the pedestrian waiting zone. Detection in this zone can be used to trigger a crosswalk signal or vehicle warning system and monitor if waiting pedestrians leave the zone indicating that they no longer need to cross the street. RRFB systems that feature this type of pedestrian detection are under development.

The second detection zone monitors the crosswalk. This is useful in crossings to ensure that pedestrians safely clear the street before vehicles are allowed to flow again. The MUTCD recommends that pedestrian crosswalks be timed according to a person walking at 3.5 feet/second. This timing may represent 85% of the population, but it may not give adequate time for the entire population, such as the elderly, to clear in time. A pedestrian detection device is able to monitor the crosswalk and change the signal for traffic to flow when the crosswalk is clear. This allows for faster signal timings when the intersection is cleared quickly and ensures adequate time for slower walkers.

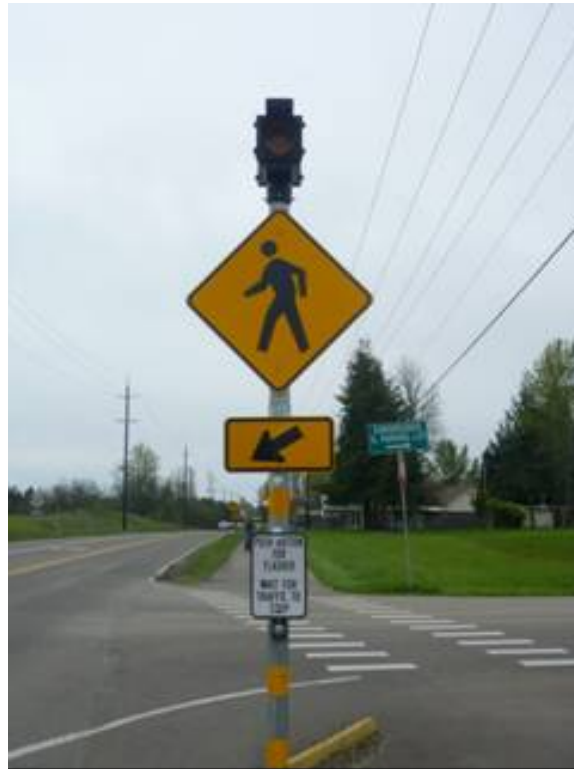
Figure 5.1: Single yellow beacon at 53<sup>rd</sup> Street, Corvallis, Oregon

This project identified beacon treatments that varied in the number of beacons used and their placement. A single beacon is shown in Figure 5.1, variations of two beacon systems is shown in Figure 5.2 and an overhead beacon is shown in Figure 5.3. The single beacon site was used for pilot data collection activities, but the results were not included in the study.

The overhead beacon treatment in the study is similar to Figure 5.3 and the side-mounted treatment is similar to Figure 5.1. The side-mounted treatments in this study are similar to the treatments shown in Figure 5.2. These treatments are similar to those studied by Shurbutt which showed compliance rates of about 15% for beacons and from 65 to 89% for RRFBs (*Shurbutt 2009*).

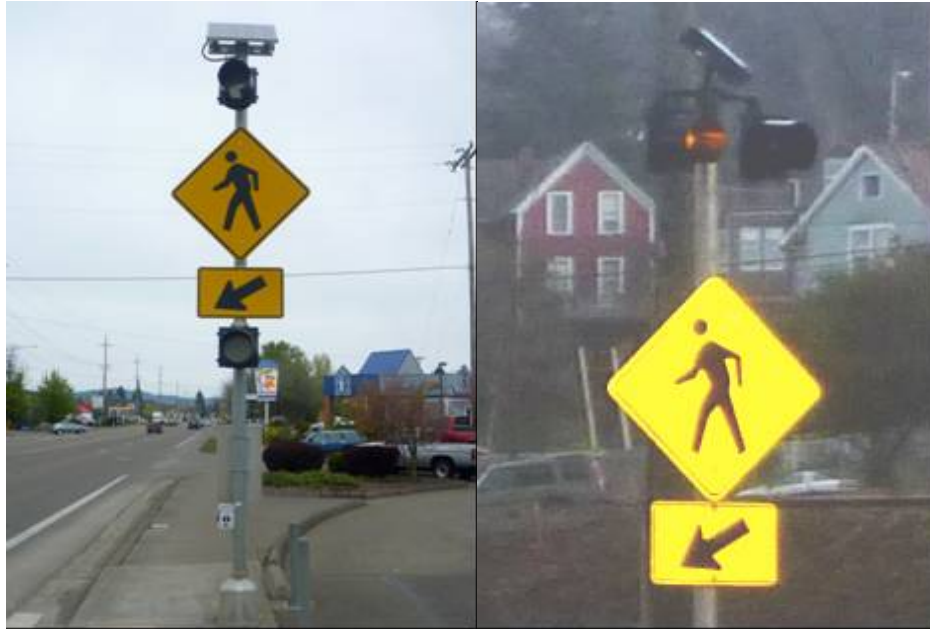
Figure 5.2: Variations of a double yellow beacon (Left: Corvallis, OR; Right: Astoria, OR)

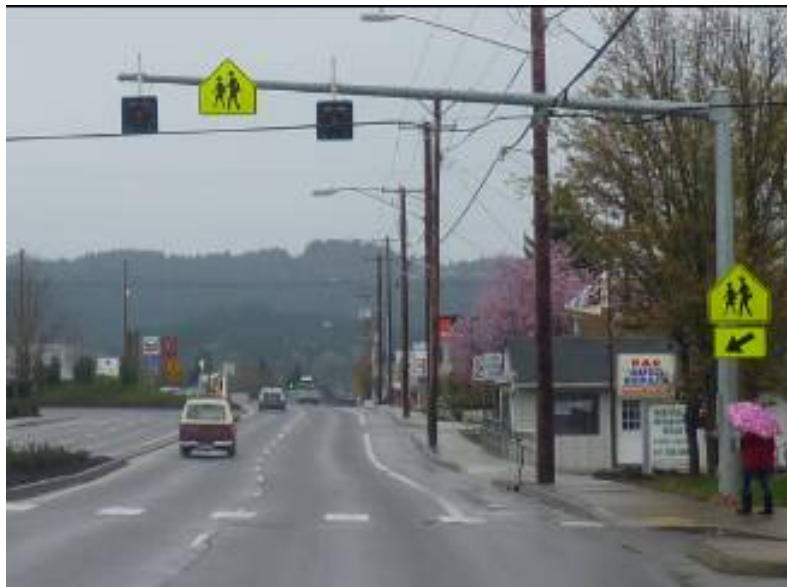
Figure 5.3: Overhead beacon installation in Philomath, Oregon

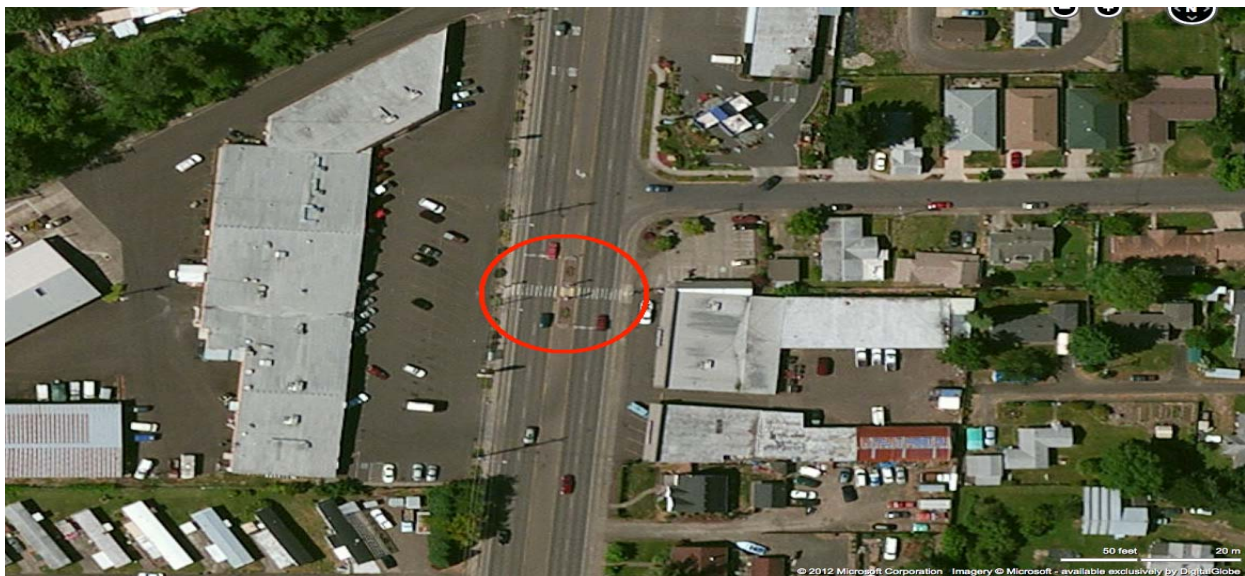
Figure 5.4: Location of beacon installation on Highway 99W, Corvallis

Figure 5.4 shows the location of the crosswalk in Corvallis.

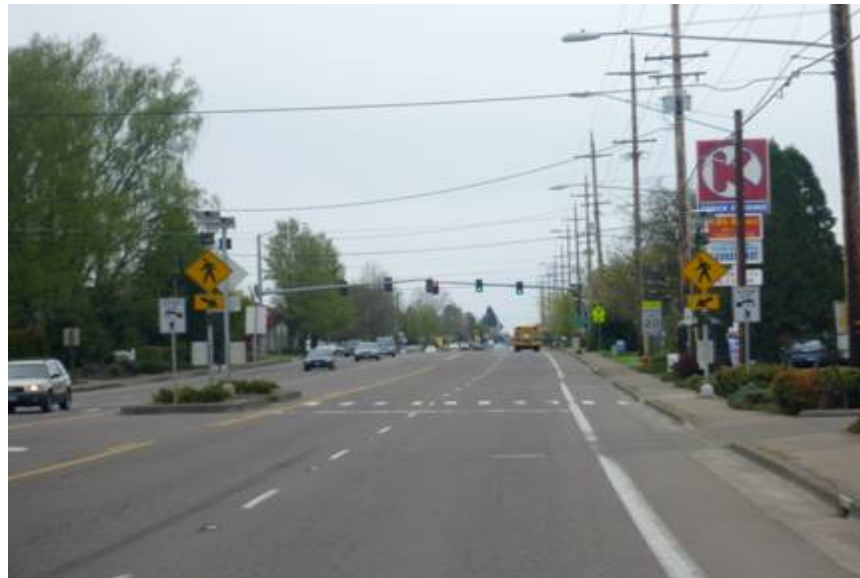
Figure 5.5: Driver view of beacon installation on Highway 99W, Corvallis

Figure 5.5 shows the intersection from a driver's perspectives; Figure 5.6 shows the pedestrian's perspective of the same intersection.

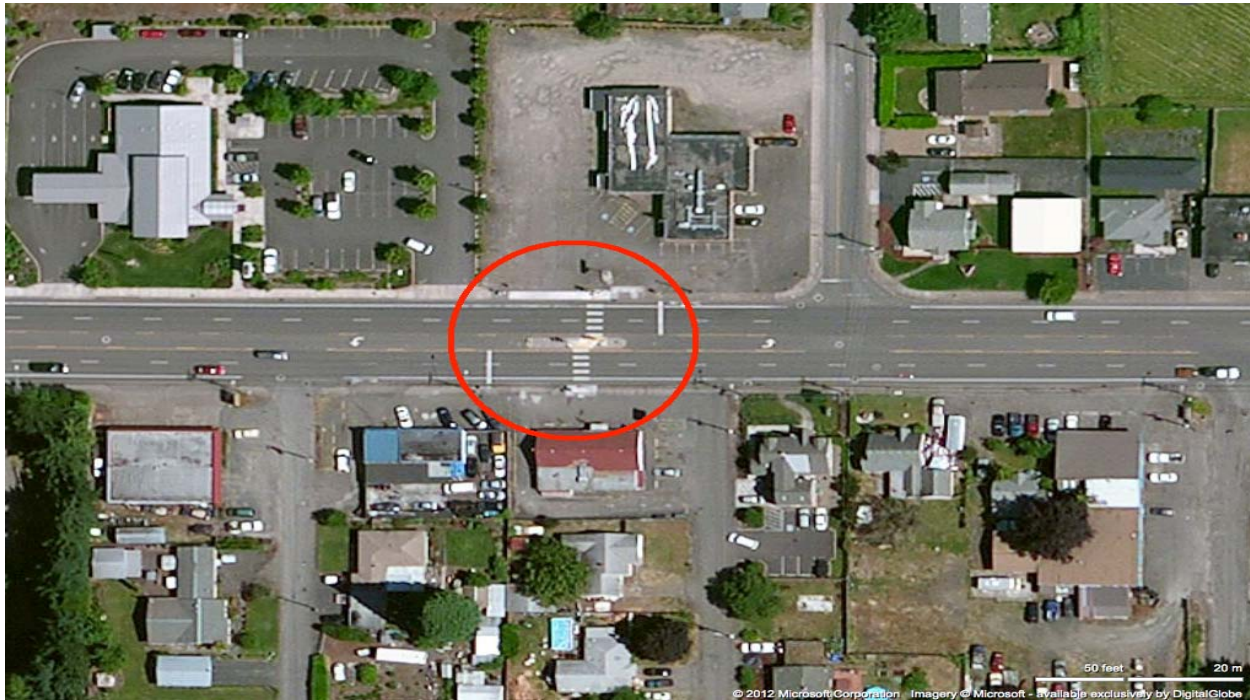
Figure 5.7: Location of RRFB installation on Main Street in Springfield

Figure 5.7 shows the location of the crosswalk in Springfield.

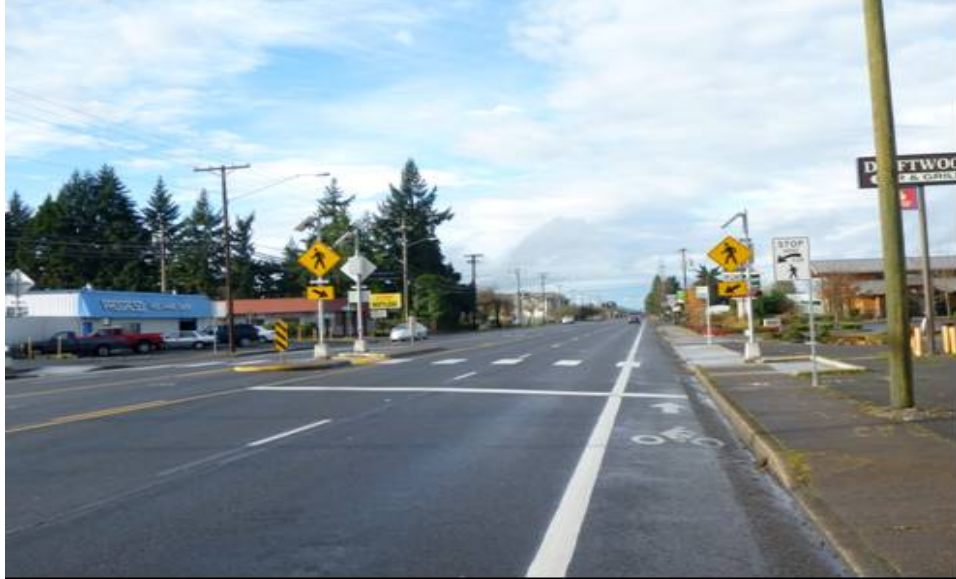
Figure 5.8: Driver perspective of RRFB installation on Main Street in Springfield

Figure 5.8 shows the intersection from a driver's perspective; Figure 5.9 shows the pedestrian's perspective of the same intersection.

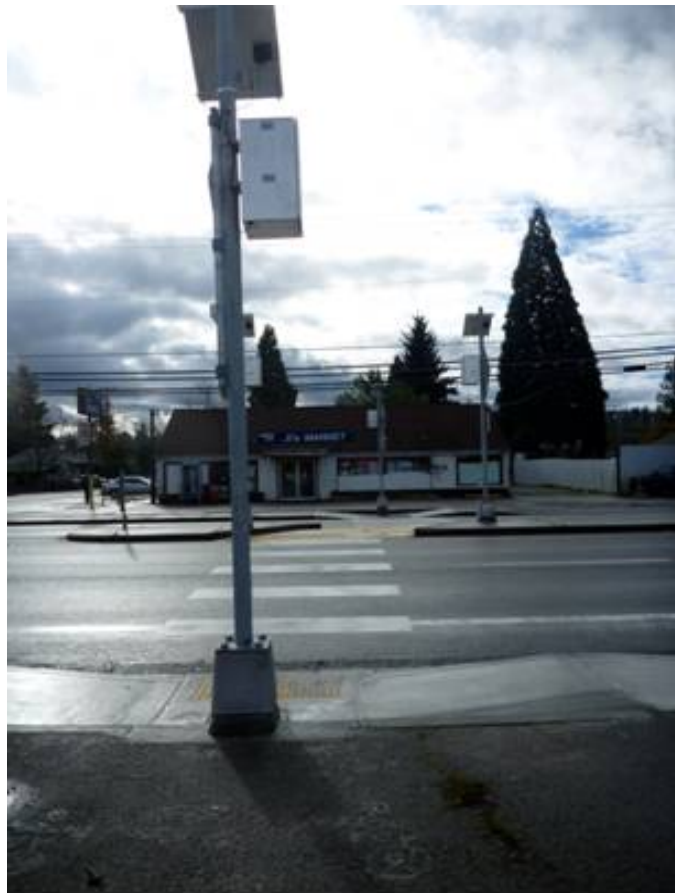
Figure 5.9: Pedestrian perspective of RRFB installation on Main Street in Springfield

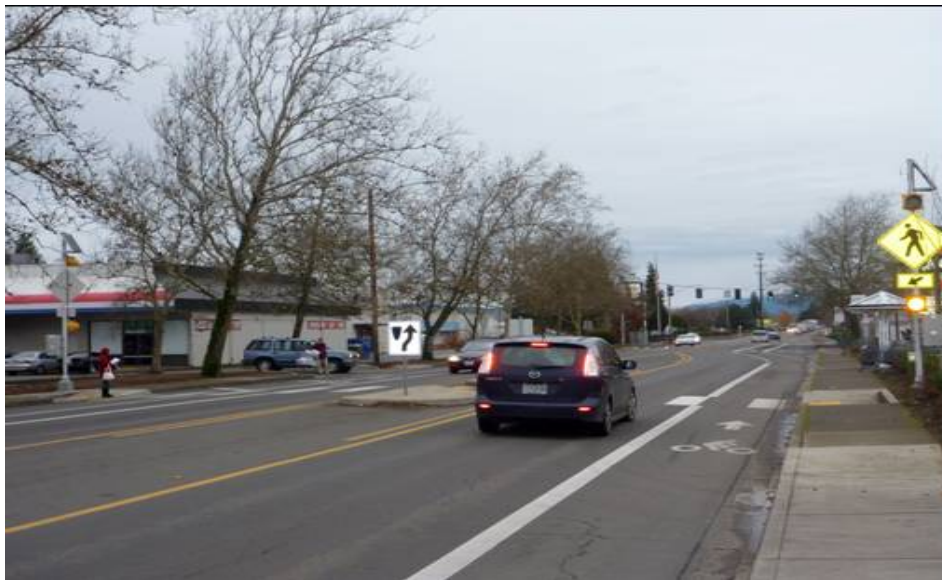
Figure 5.11: Driver perspective of beacon installation on Olympic Street in Springfield

Figure 5.11 shows the intersection from a driver's perspective; Figure 5.12 shows the pedestrian's perspective of the same intersection.

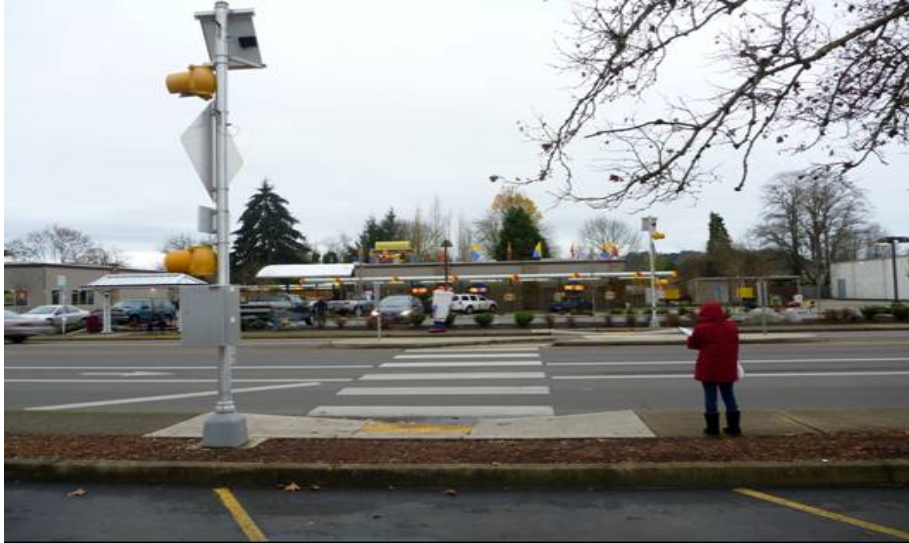
Figure 5.12: Pedestrian perspective of beacon installation on Olympic Street in Springfield

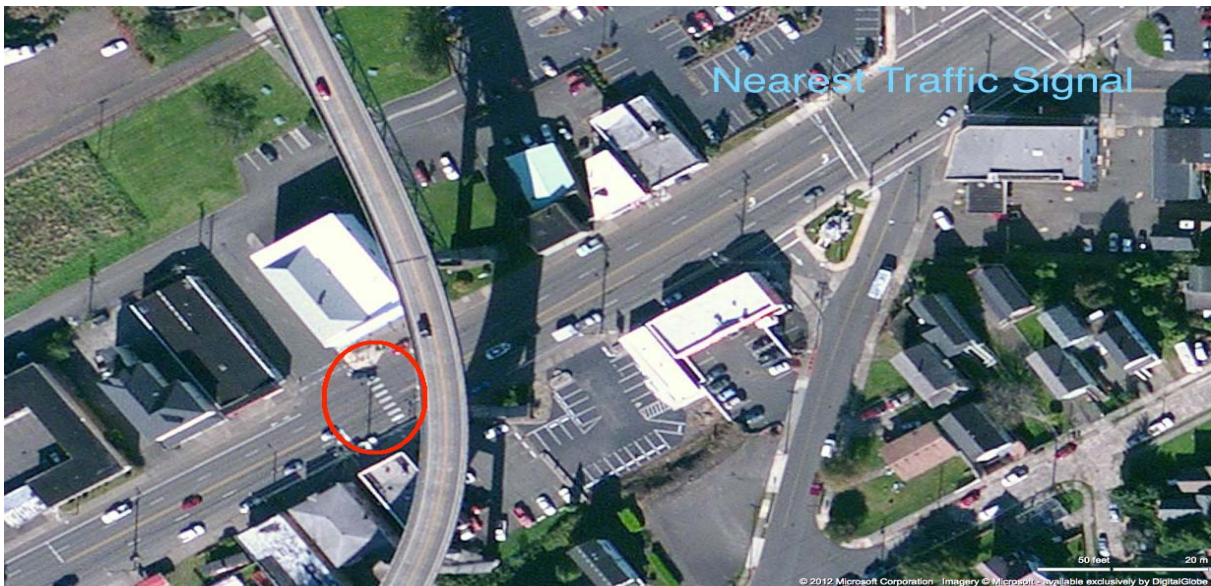
Figure 5.13: Location of beacon installation on W. Marine Dr. at Bay Street in Astoria

Figure 5.13 shows the location of the crosswalk in Astoria.

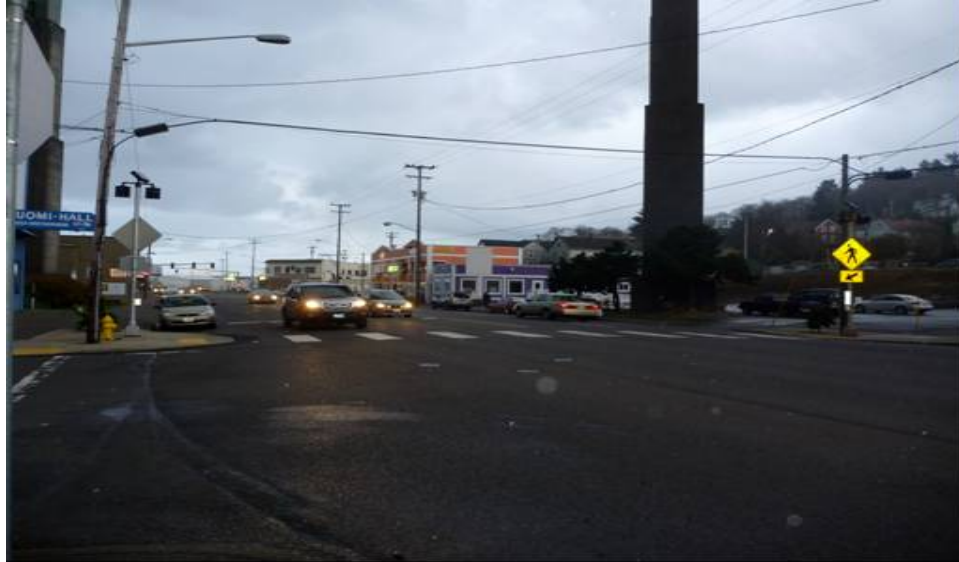
Figure 5.14: Driver perspective of beacon crossing on W. Marine Dr. at Bay St in Astoria

Figure 5.14 shows the intersection from a driver's perspective.

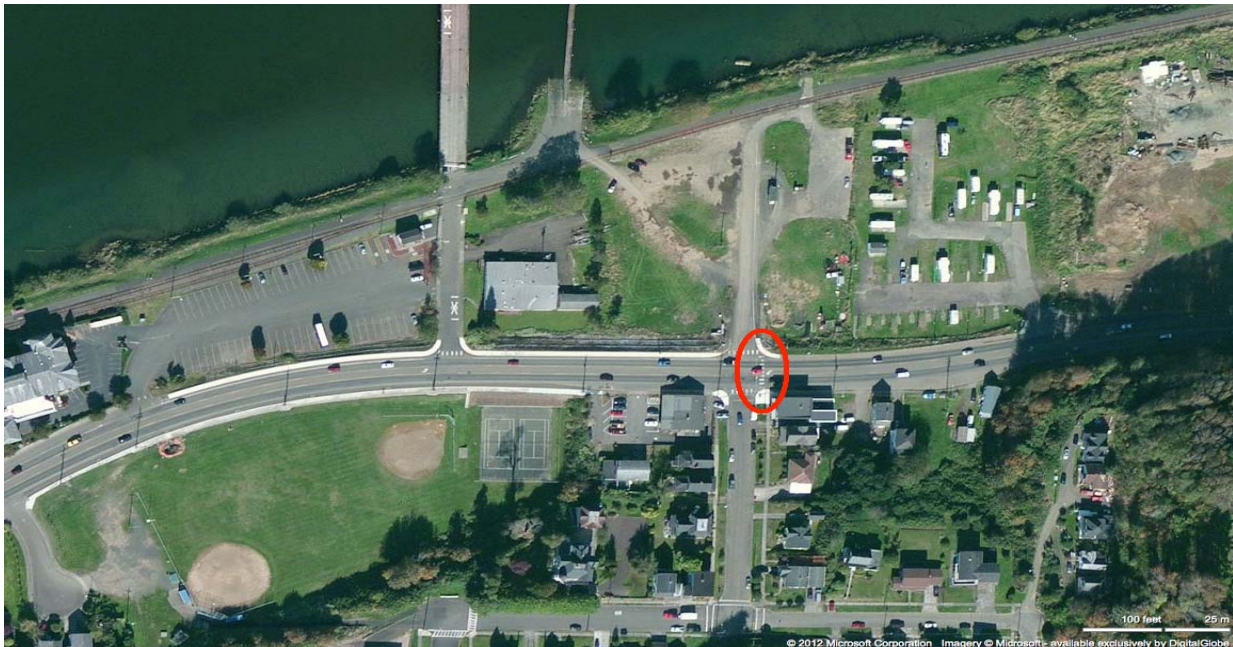
Figure 5.15: Location of RRFB installation on US 30 at 37<sup>th</sup> Street in Astoria

Figure 5.15 shows the location of the RRFB on US 30 at 37<sup>th</sup> Street in Astoria.

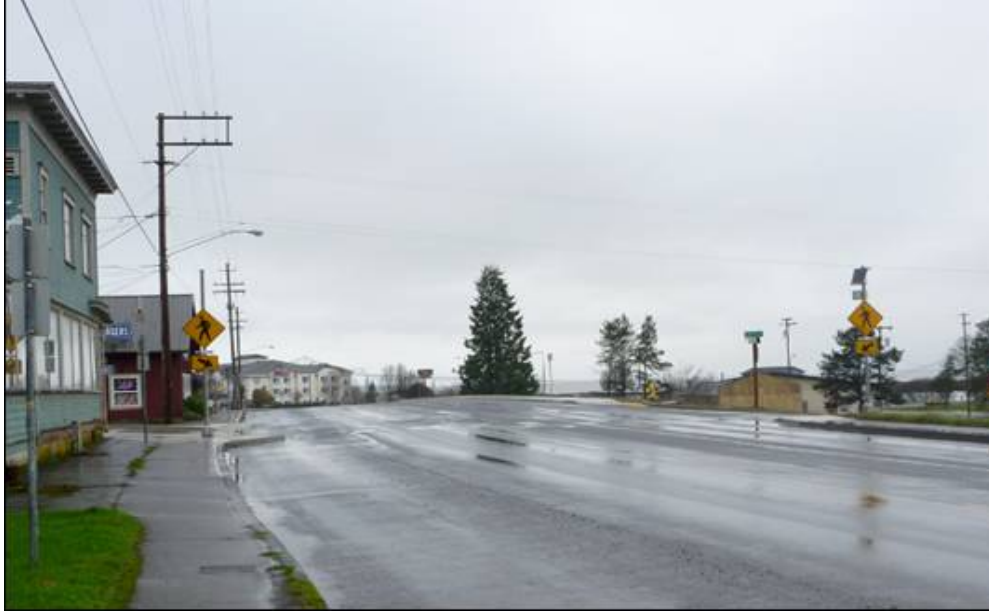
Figure 5.16: Driver perspective of RRFB crossing on US 30 at 37<sup>th</sup> Street in Astoria

Figure 5.16 is a photograph of the intersection showing the driver's perspective; Figure 5.17 shows the pedestrian's perspective.

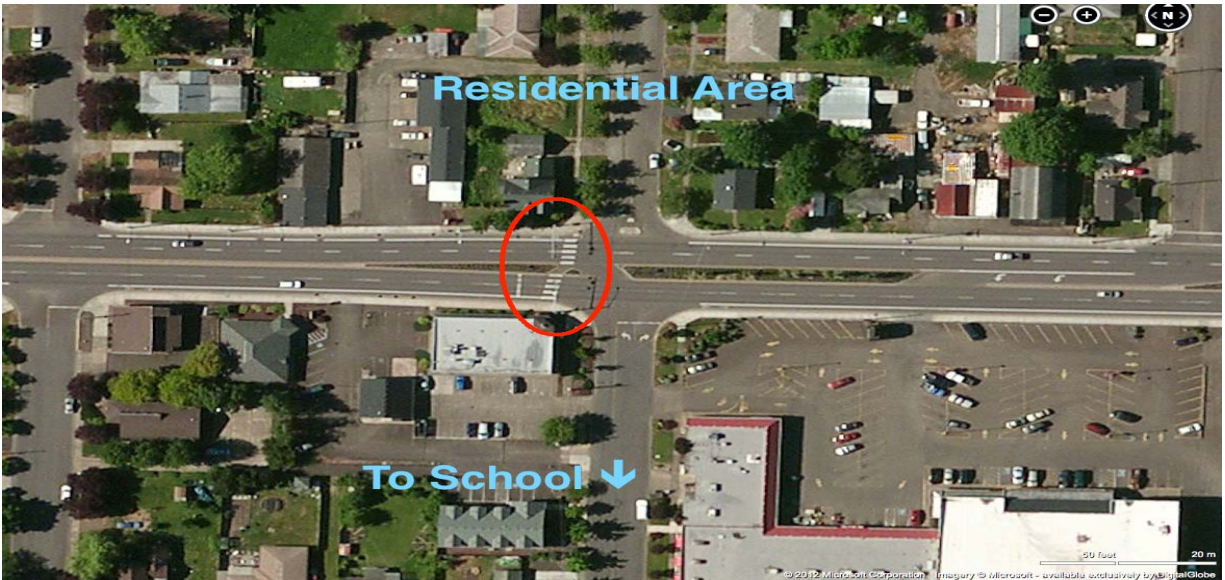
Figure 5.18: Location of beacon installation on OR 34 (Main Street) in Philomath

Figure 5.18 shows the location of the beacons in Philomath.

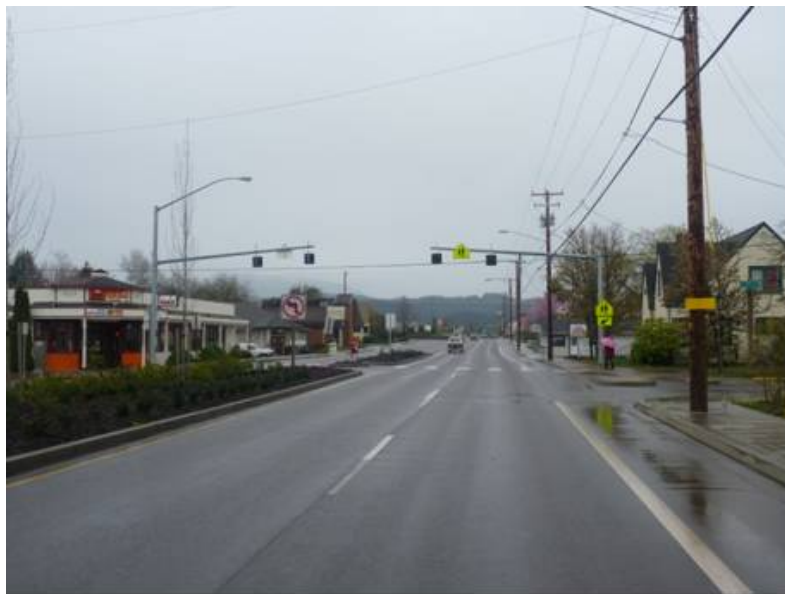
Figure 5.19: Driver perspective of overhead beacon crossing on OR 34 (Main Street) in Philomath

Figure 5.19 shows the crossing from the driver's perspective; Figure 5.20, from the pedestrian's perspective.

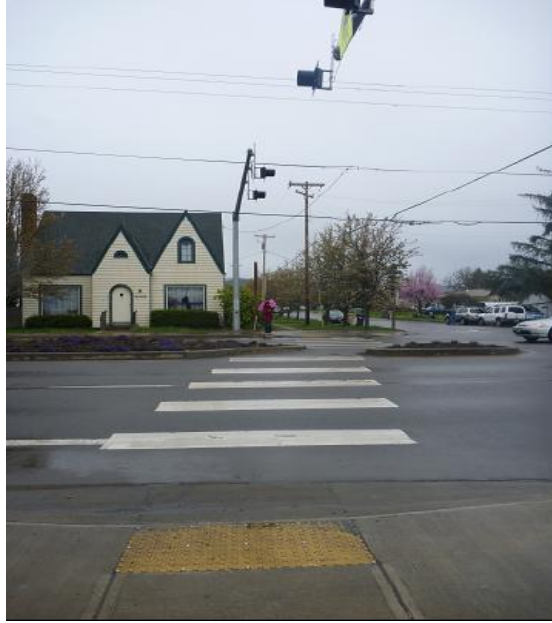
Figure 5.20: Pedestrian perspective of overhead beacon crossing on Main Street in Philomath

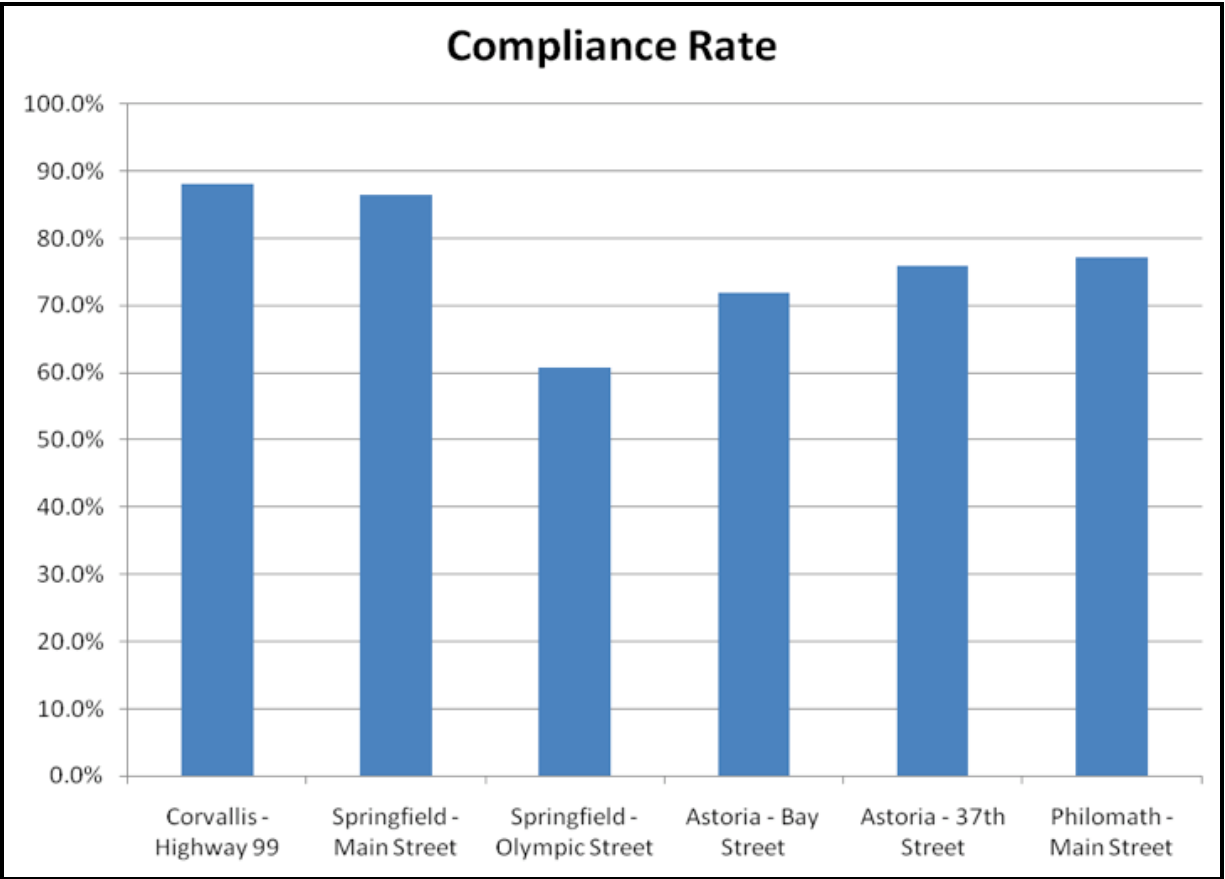
Figure 5.21: Average compliance rates

Following established research procedures by others (*Fitzpatrick et al. 2008*), the average compliance rate for each crosswalk was calculated and is shown in Figure 5.21 below.

As shown in the graph, the compliance rates are all fairly high. The Corvallis side beacons had the highest compliance rate at over 88%; the side beacons at Olympic Street in Springfield had a compliance rate of 61%, which was the lowest. The compliance rates are used to provide insight in addressing the research questions.

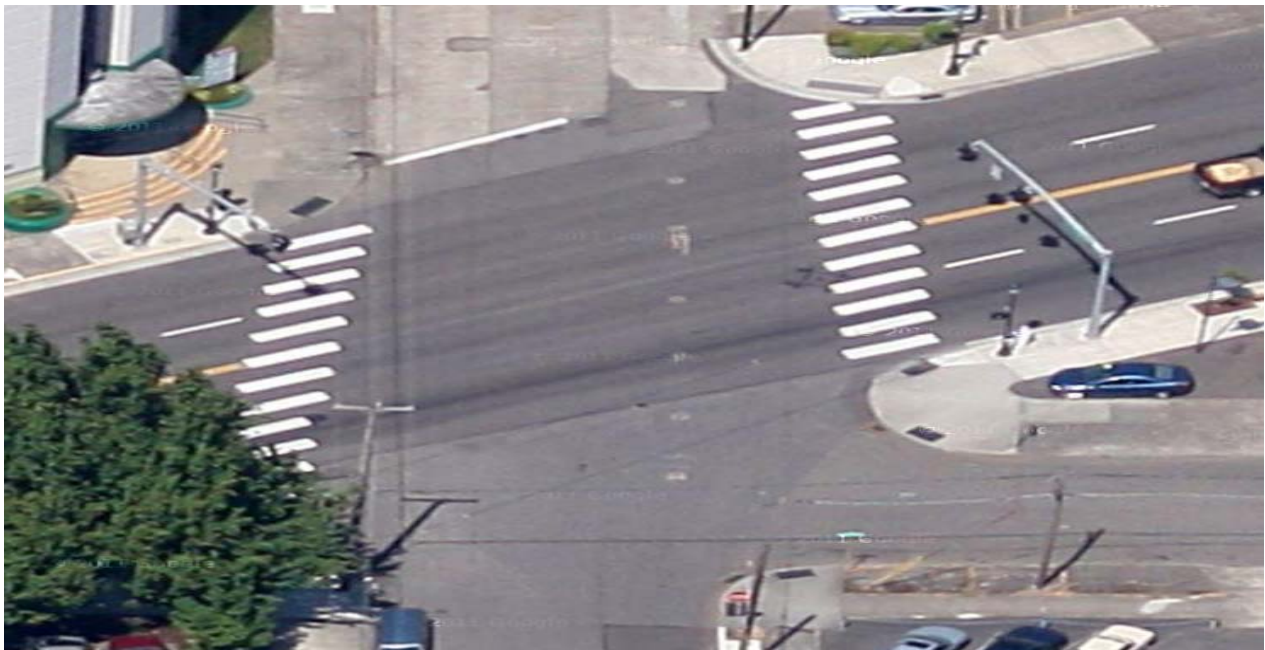
Figure 6.11: Aerial view of PHB at NE Sandy Blvd. and NE 18<sup>th</sup> Avenue in Portland, OR

The PHBs at this location were activated in September 2007 and replaced half signals. Sandy Blvd is a four lane arterial road. NE Sandy Blvd. at NE 18<sup>th</sup> Avenue is a skewed intersection as shown below in Figure 6.13.

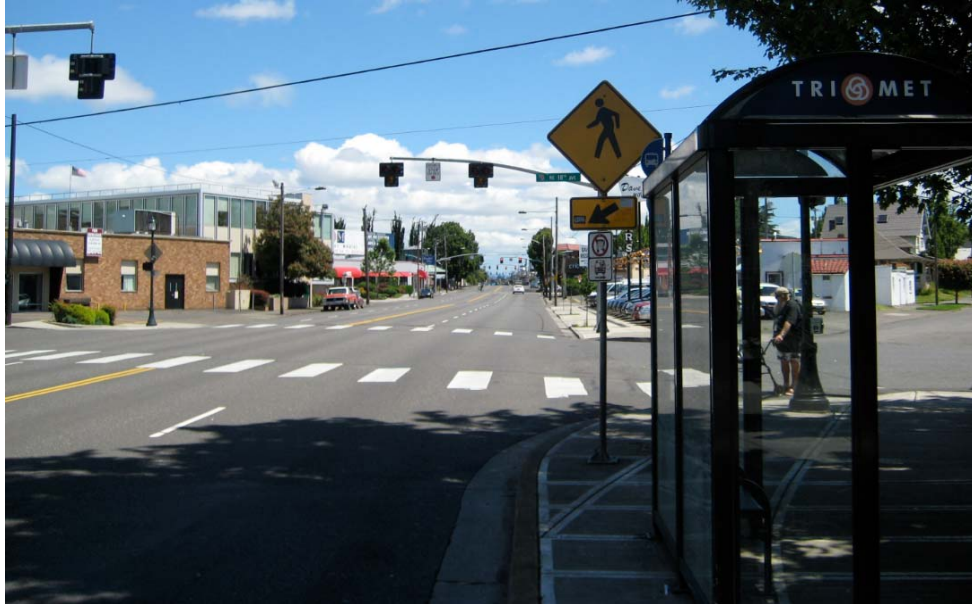
Figure 6.12: PHB installation at NE Sandy Blvd. and NE 18<sup>th</sup> Avenue looking east

Crosswalks are striped for each crossing and there are no advance stop bars. A mast arm with a PHB centered over each lane is installed over the far crosswalk from the driver perspective. A pedestrian crossing sign and diagonal downward pointing arrow sign are side-mounted at the near crossing for drivers as shown in Figure 6.12.

The beacon sequence utilizes a short Flashing Red indication between the Steady Red and Dark indications and vehicles mostly remained stopped during this indication. Some pedestrians cleared the crossing before the pedestrian clearance interval ended or activated the system and began crossing if no vehicles were in sight. This increased vehicle delay and decreased efficiency of the crossing by stopping and holding vehicles when the crossing was clear. The Alternating Flashing Red indication of the MUTCD sequence allows vehicles to precede if the crossing is clear, which reduces vehicle delay.

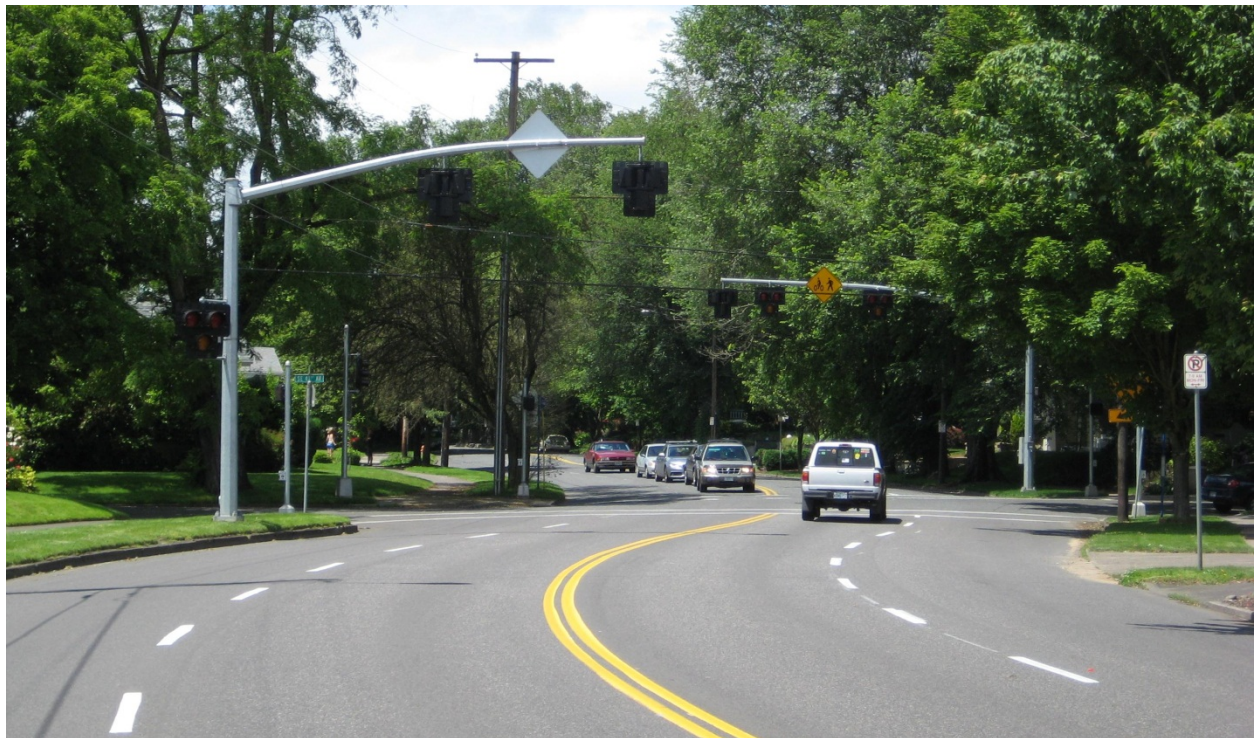
Figure 7.1: Winding road and trees along E. Burnside at 41<sup>st</sup> Avenue

For crossing treatments to be effective, they need to be placed in a location where drivers are able to see them. Several things can obstruct the visibility of a crossing or a treatment. Crossings located in visually-cluttered environments such as locations with a large number of signs or vegetation and roads with geometry that limits sight distance need to be designed ensure adequate visibility for motorists. The PHB at E. Burnside and 41<sup>st</sup> Avenue is located along a winding road with a large number of trees that obstruct the side-mounted signs, but the overhead PHB is still visible as shown below in Figure 7.1. Note the blocked sign on the right edge of the road.

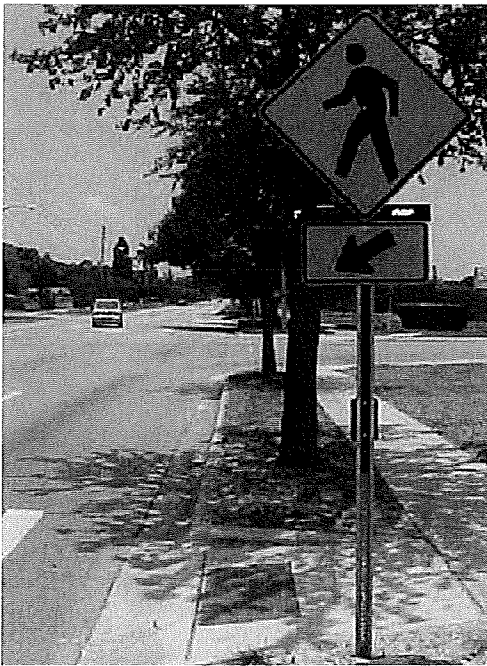
Example of RRFB with W1-2 sign and W16-7p plaque at crosswalk across uncontrolled approach. [Photo courtesy of City of St. Petersburg, Florida]
