**Maryland Department of Transportation**

### **RESEARCH REPORT**

# **LOW COST STRUCTURAL HEALTH MONITORING OF BRIDGES USING WIRELESS SENSPOT SENSORS**

**FINAL REPORT**

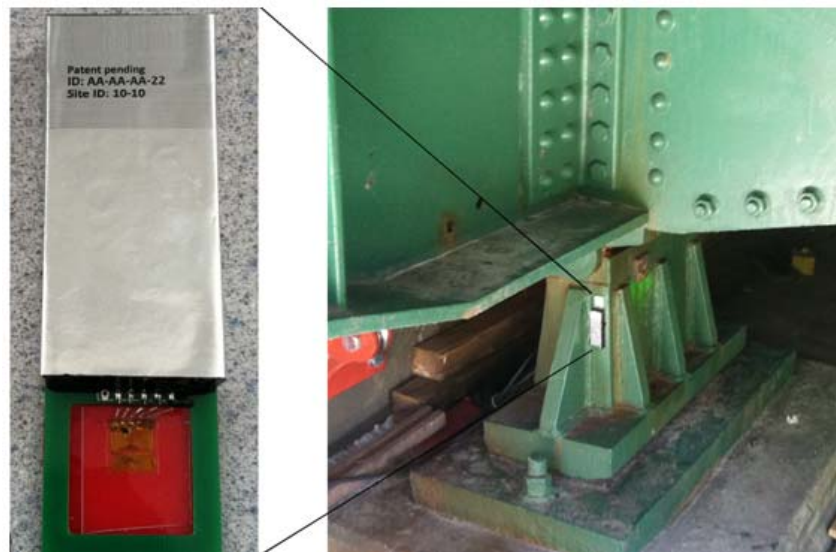
Figure 1: A SenSpot (left) and installed sensor on a bridge bearing (right) for tilt and loading monitoring.

Figure 1 shows a SenSpot sensor. This device is powered using a built-in prime lithium-ion battery which is designed to supply the energy needed by the device for 30 years. The device uses sensing, synchronization, and ultra-low-power wireless communication technology. A picture of a SenSpot installed on a bridge bearing is also shown in Figure 1. In this installation, the sensor monitors the tilt of the bearing as well as the load on the bearing through strain measurement. In addition, the sensor monitors changes in these parameters as the bridge expands or contracts as a result of temperature variations (please see the case studies in Section 5 for more details).

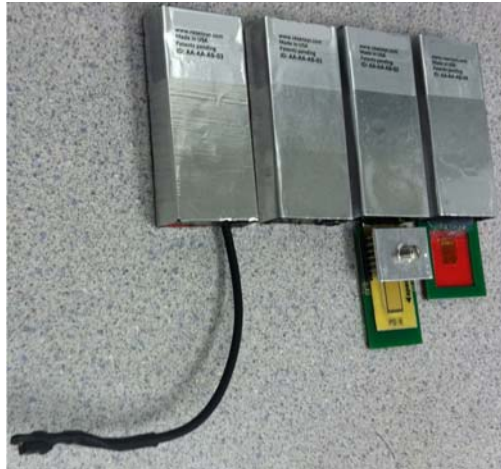
**Figure 2: Left to right: SenSpots for humidity, tilt, crack, and strain monitoring.**

Currently, SenSpot sensors offer a variety of features that meet the needs for monitoring bridges: strain, tilt, moisture and humidity, temperature, pressure, and crack width. A number of these SenSpot sensors are shown in Figure 2:

- The SenSpot on the left, which monitors relative humidity, has a special probe that is connected to the main body of the sensor through a variable-length cable.

- The second device monitors tilt (inclination) with a resolution of 0.1 degrees.
- The next device is a special SenSpot that measures crack activity (or crack-meter with a resolution of 0.1 mm (0.004 inches). When installed on an existing crack, it will monitor the activity and growth of that crack. The device can also be installed at locations where the development of a crack is a possibility (e.g., at welds, attachment points, etc.).

- The device on the far right offers the combined strain and tilt measurement, with accuracies of 0.1 degree and 2 microstrains for tilt and strain, respectively. A special application of this device is the combined monitoring of loading and tilt on bridge rocker bearings (please see case study 1 in the Appendix).

In addition to the aforementioned capabilities, all of the devices pictured have built-in temperature sensing capability with 0.1°C resolution.

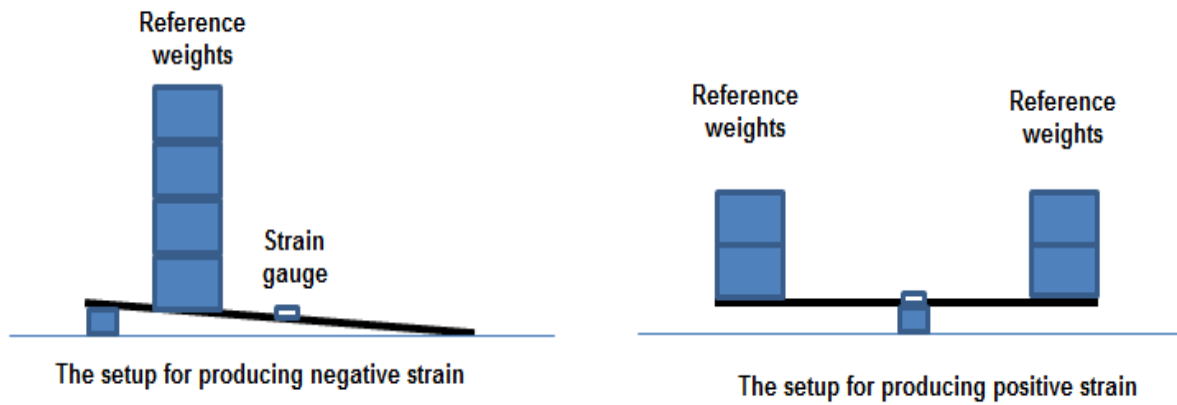
**C. Test results:** The test specimen was put on a table and a vertical force was applied to it by incrementally adding 5Kg and 3.8Kg weights on it as shown in Figure 6. As shown in the figure, two different setups were used to produce positive and negative strain values. Upon placing each weight, the readout of the SenSpot sensor and the  $\mu$ volt meter were recorded. Using different reference weights, various strains from approximately  $-124 \mu\text{Strain}$  to  $107 \mu\text{Strain}$  were produced on the test specimen.

**Figure 6: the test setup for producing positive and negative strain values on the test specimen.**

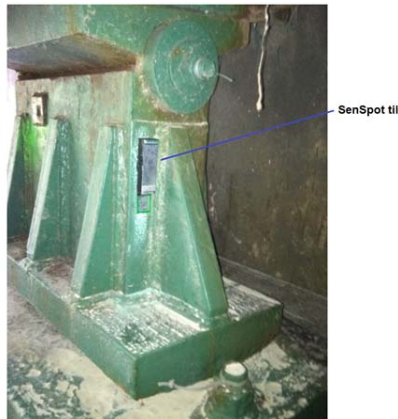
SenSpot tilt sensors can gather changes in the tilt of the bearing by angles as small as 12 arc seconds (or approximately 0.003 degrees). Tilt changes happen as a result of daily temperature variations. Such changes can be monitored by the installed tilt sensors. The installed tilt sensor on a rocker bearing is shown in Figure 8.

**Figure 8: Wireless tilt sensor on a rocker bearing of Northwest Branch Bridge on I-495**

The tilt data gathered by the sensor is wirelessly transmitted to a wireless data collector (SeniMax) at the bridge, which in turn transmits data wirelessly to a remote server for processing, visualization, and archiving. Installation is straightforward, and for best performance, it is recommended to install the sensors on the side of bearing as shown in Figure 8. Figure 9 shows a bearing's tilt readout provided by the installed SenSpot during 24-hour period from July 28th 2011 until July 29th 2011. As shown in the figure, the SenSpot reported tilt measurements ranging from 1.70 to 2.45 degrees. In other words, the change in tilt of the bearing was  $2.45 - 1.70 = 0.75$  degrees. In this case, the theoretical tilt change can be calculated by considering the temperature variation of the mentioned day. During this 24-hour period, the minimum temperature was 69 °F and the maximum was 89°F (source: <http://www.wunderground.com/history/>). Therefore, the variation of the temperature that day was 20 °F.

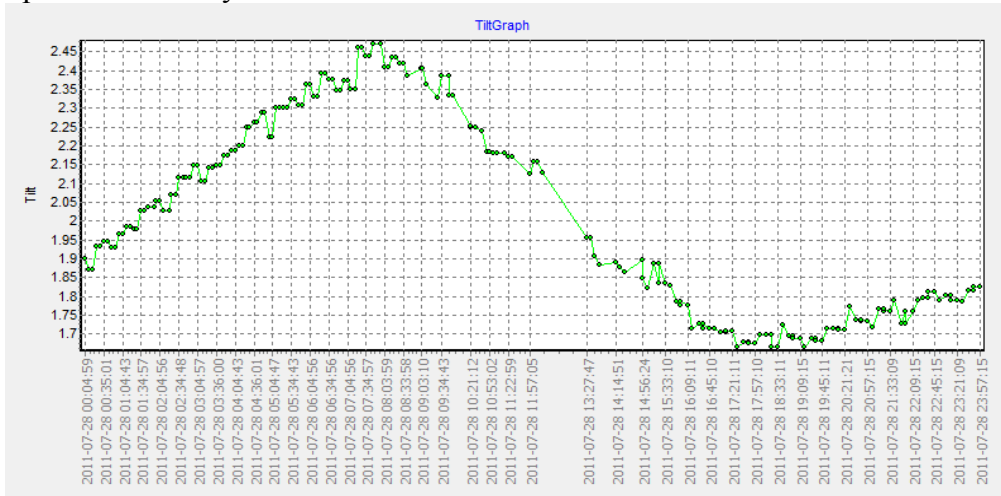
Figure 9: Bearings tilt variation during 24-hour period

The measured tilt variation: **2734 seconds = 0.7594 degrees**

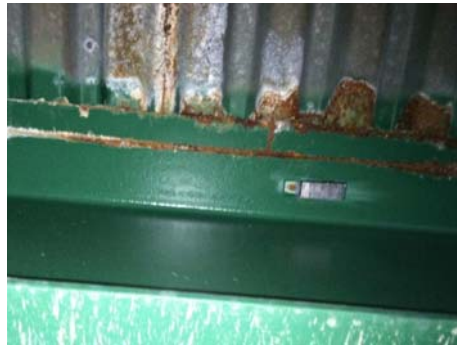
To evaluate the performance of SenSpot for monitoring strain, a sensor was installed on the deck of Northwest Branch Overpass on I-495. The installed SenSpot is shown in Figure 13.

Figure 13: Installed SenSpot strain under the deck of Northwest Branch Bridge on I-495.
