## **Chapter 1 INTRODUCTION**

### **1. What is the purpose of this Environmental Impact Statement?**

## Figure Eight Island Shoreline Management Project FEIS

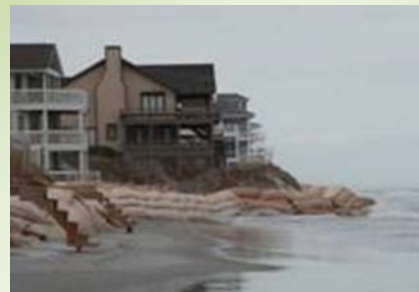
**Sandbag revetments along the northern portion of Figure Eight Island**

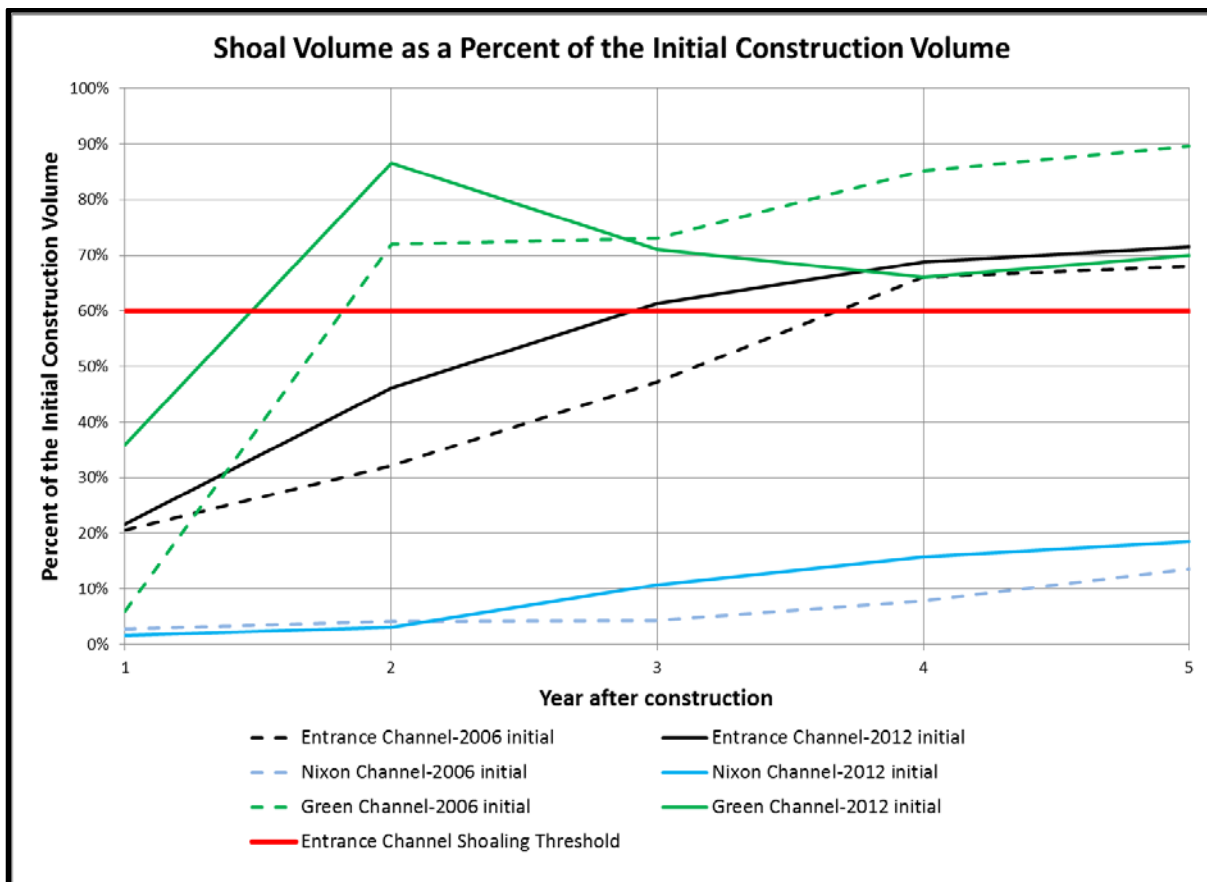
**Figure 3.5. Alternative 3 - Cumulative channel shoal volumes over the 5-year model simulation expressed as a percent of the initial construction volume.**

The initial size of all three channels was based on stability requirements and the need to initially capture flow in and out of the inlet. Once this flow pattern is established, restoration of the two connector channels to the original design dimensions may not be necessary as long as the flow through Nixon Channel does not induce erosion along the back side of Figure Eight Island and the flow distribution into Green Channel is comparable to existing conditions. However, since maintenance of the position and alignment of the bar channel is critical to the success of Alternative 3, the shoaling and migration of the bar channel derived from the results of the Delft3D model was used to formulate future maintenance requirements for Alternative 3.
