Appendix G

Geotechnical Engineering

GEOTECHNICAL APPENDIX
South San Francisco Bay Shoreline Study (SSFBS)

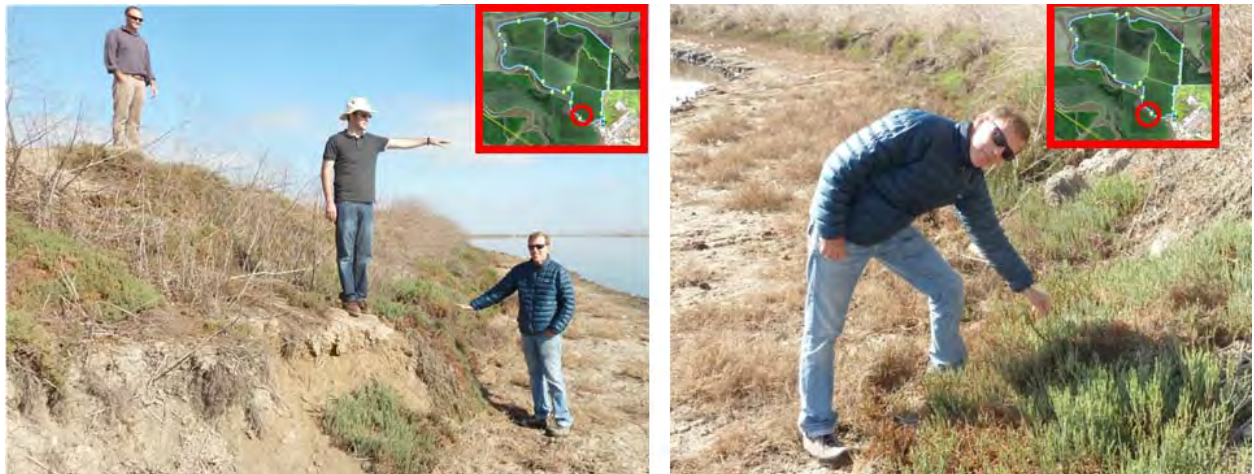
Much of this dike system is covered with various types of grass cover. While grass can resist water flow the problem is that the coverage for this dike is not 100% as shown in Figure 15, there is better coverage on the bay side of the dike. There are several elevation zones of vegetation along the face of the dike likely due to the availability of water and specific soil type (see left side of Figure 16). Pickle weed was identified along upper reaches of the dike near the crest (shown at the right of Figure 16). While vegetation can resist small wave action this resistance is not absolute as shown in the upper left of Figure 15.

Figure 16 – Elevations of vegetation

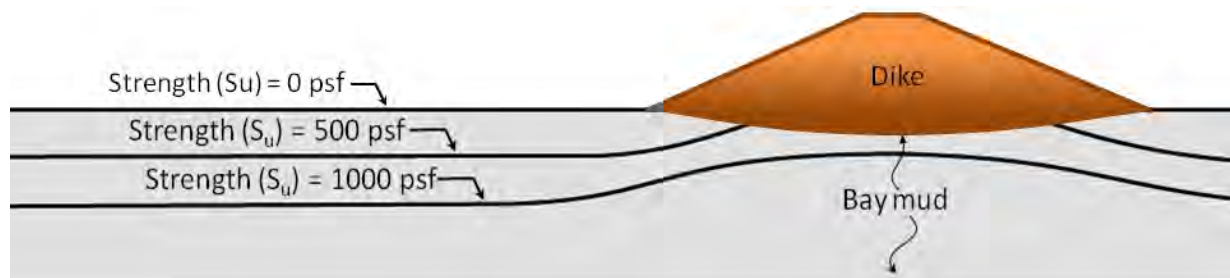
San Francisco bay mud strength characteristics have been well studied academically. The project geotechnical reports describe evaluation of bay mud strength based on laboratory strength tests (from boring retrieved soil samples) and predicted strengths from CPT. The soft bay mud under the dikes have experienced clay consolidation causing settlement of the dikes. This consolidation results in a strength increase under the dikes compared to bay mud deposits at same elevation beyond the dike, as shown in Figure 19. The reports don't show any analytical effort comparing strength for bay mud under the dikes to a soil column in the water beyond the dikes. It's unclear if and how the bay mud layers shown in Figure 20 were used to assign undrained strengths. A technique called the equivalent depth method could be used for comparing undrained strength versus vertical effective stress below the dike to adjacent underwater deposits. From review of the reports it cannot be discerned if the established project soil strength for the bay mud is realistic, conservative, or unconservative.

Figure 19 - Bay Mud strength beneath dike (due to consolidation and settlement) and beyond the dike

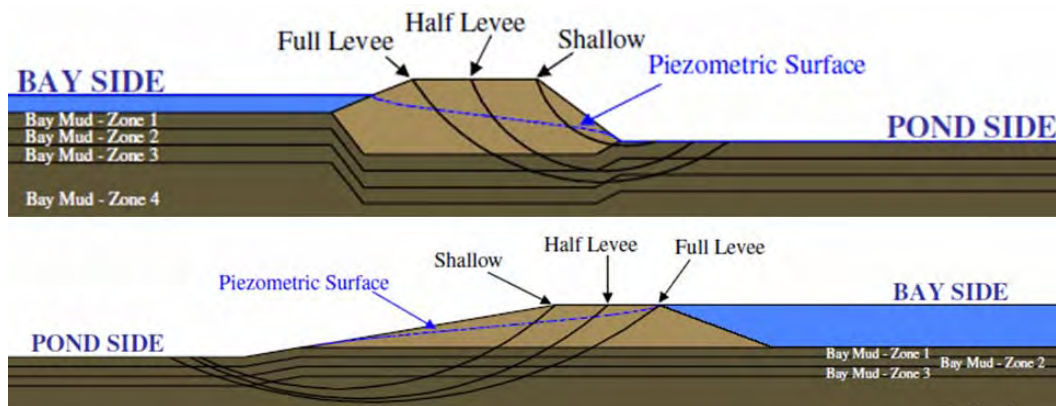
Figure 20 - Geotechnical Consultant's representing of the Bay Mud strength in terms of Bay Mud zones?
