# Strategies to Reduce Burro-Vehicle Collisions in the Lake Pleasant Area

SPR-753  
June 2022

**Published by:**  
Arizona Department of Transportation  
206 South 17th Avenue  
Phoenix, AZ 85007  
in cooperation with  
Federal Highway Administration

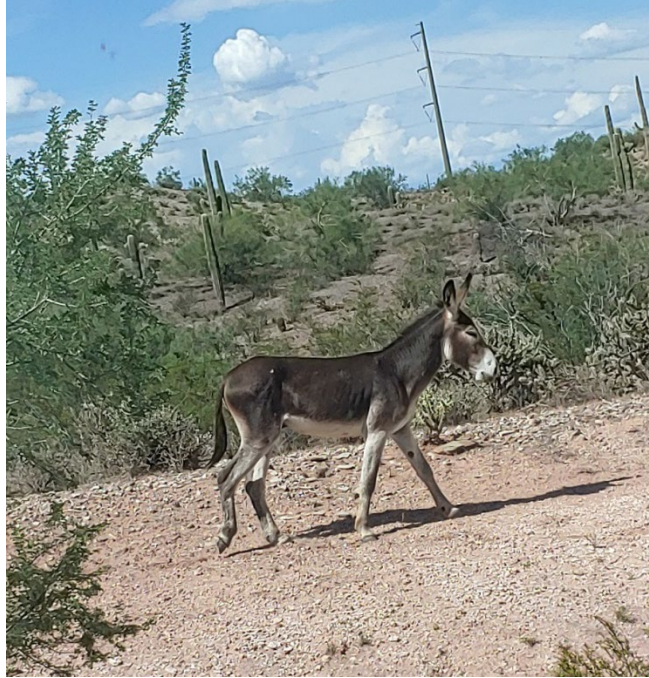
BVCs hot spots are strongly associated with ROW access points (Figure 56), which allow burros to cross fences and enter ROW. Burros were shown to access ROW through unfenced sections of highway, through gaps in ROW fence, under raised bottom wires, through unguarded driveways and intersections, and across sediment-filled crossing guards. Each of these access points is discussed below followed by a discussion of gate design and burro interactions.

**Figure 56. Burro Jack That Entered a Fenced ROW Through an Access Point**

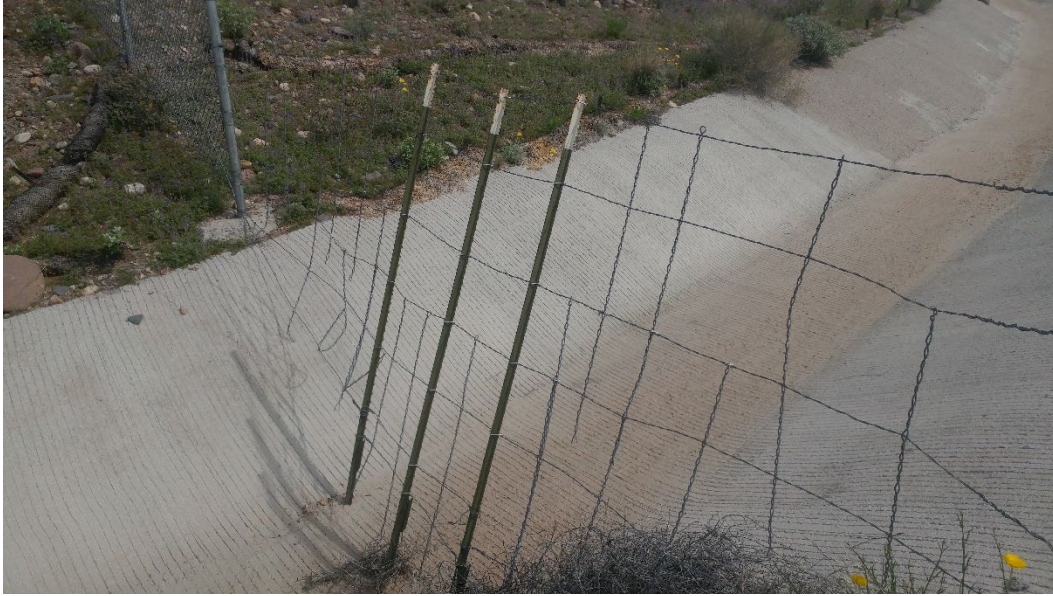
As of the 2017 fence inventory, fence gaps on ADOT highways were twice as common along barbed wire ROW fence than along chain-link fence (0.14 fence gaps per mile of barbed wire fence and 0.07 gaps per mile of chain-link fence). Cutting barbed wire fence is relatively easy compared to cutting chain-link fence. Also, short sections of barbed wire fence are often incorporated within stretches of chain-link to bridge drainage features, exposing them to greater risk of fence blowout (Figure 60). Finally, chain-link fence within the study area is located in areas difficult to access from the paved ROW and with fewer unpaved roads nearby, reducing the incentive to cut chain-link fence.

**Figure 60. Section of Barbed Wire Fence Within a Chain-Link ROW Fence to Bridge a Drainage Feature**

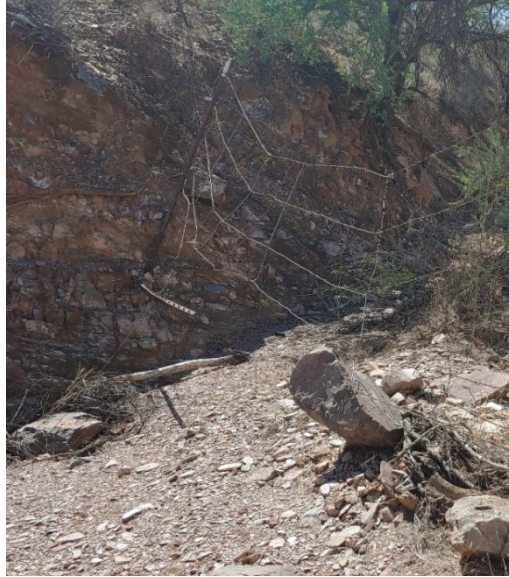
Raised bottom wires in the study area were exclusive to barbed wire fence designs and were most common where topography changed dramatically over short distances. Within the study area this situation was most common where ROW fence entered steep-sided washes, creating a raised gap beneath the more elevated side of the fence span (Figure 61). Since barbed wire fence is often incorporated into chain-link fence to bridge drainage features, installing chain-link or woven wire fences is not expected to reduce the incidence of raised bottom wire access points.

**Figure 61. Raised Bottom Wire Access Point  
Where Fence Enters a Wash**

- Install a deadweight hang (a heavy object attached to the fence) intended to pull the fence closer to ground level and anchor fence posts (Figure 68).
- Install additional wires beneath the standard four strands (Figure 69).
- Span the gap with a single fence span and hanging material cut to length beneath the fence (Figure 70).
- Shorten fence spans that traverse steep topography so the fence posts are installed and anchored as close to the top and toe of a slope as possible and wire hung between the posts runs parallel to the ground.

Whichever configuration is used, the modified bottom wire height should not exceed 18 inches above ground level. Wherever nonstandard fence additions are installed, document them in a referenceable format to ensure future repairs at the location incorporate similar measures.

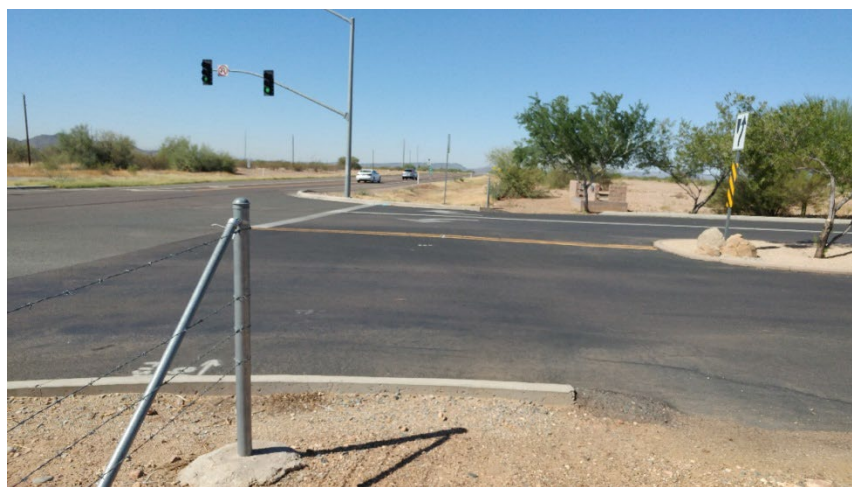
Burros crossed ROW fence through driveways without crossing guards (Figure 62), however, passage rates for these access points were only 20 percent. Burros more commonly used these features to escape ROW. Nonetheless, where surrounding ROW fence is well maintained, these features present a risk of burro-ROW entry, which may result in BVCs.

**Figure 62. An Unguarded Driveway**

- Install crossing guards at unguarded driveways associated with BVCs.
- Use round bars instead of flat bars or use a grate material instead of bars (Gagnon et al. 2020).

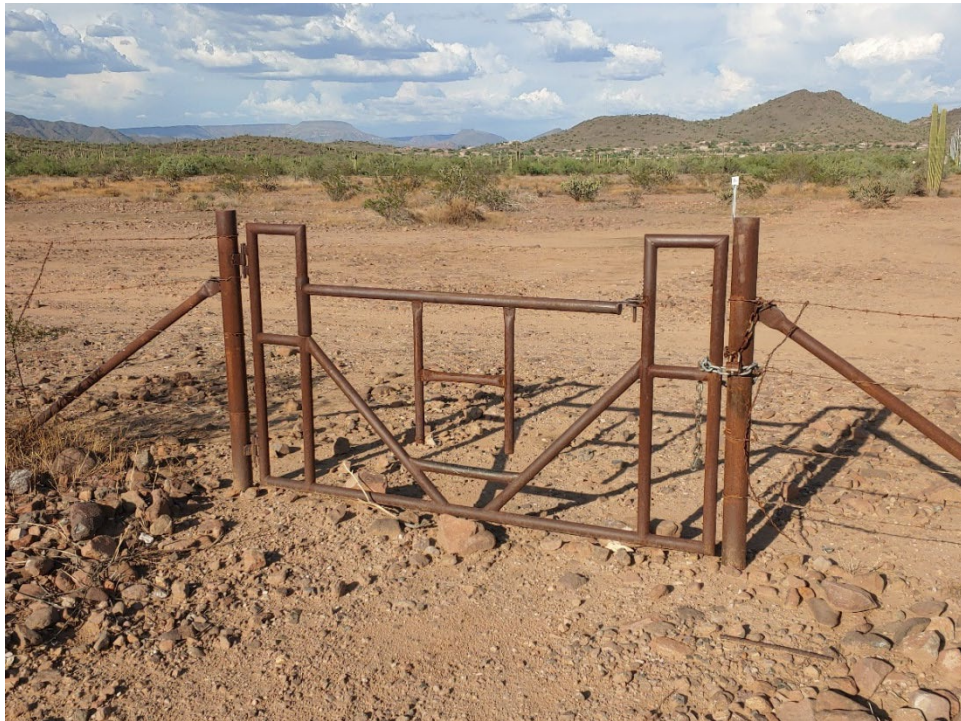
Single-arm gate designs (Figure 64) or designs including large apertures within the structure such as equestrian gates (Figure 65) present a potential burro passage route similar to a raised bottom wire. Anecdotally, a research biologist from AGFD noted that equestrian gate designs with a bar close to ground level and an aperture directly above were observed to allow burro passage (Colin Beach, personal communications, October 5, 2018). Staff at the Ben Avery Shooting Facility added welded metal to two equestrian gates previously observed to allow burro passage to close these apertures (Figure 66). As noted in the case study in Chapter 4, no collared burros were documented crossing the fence after modification.

**Figure 66. Modified Equestrian Gate to Prevent Burro Passage Through Aperture**

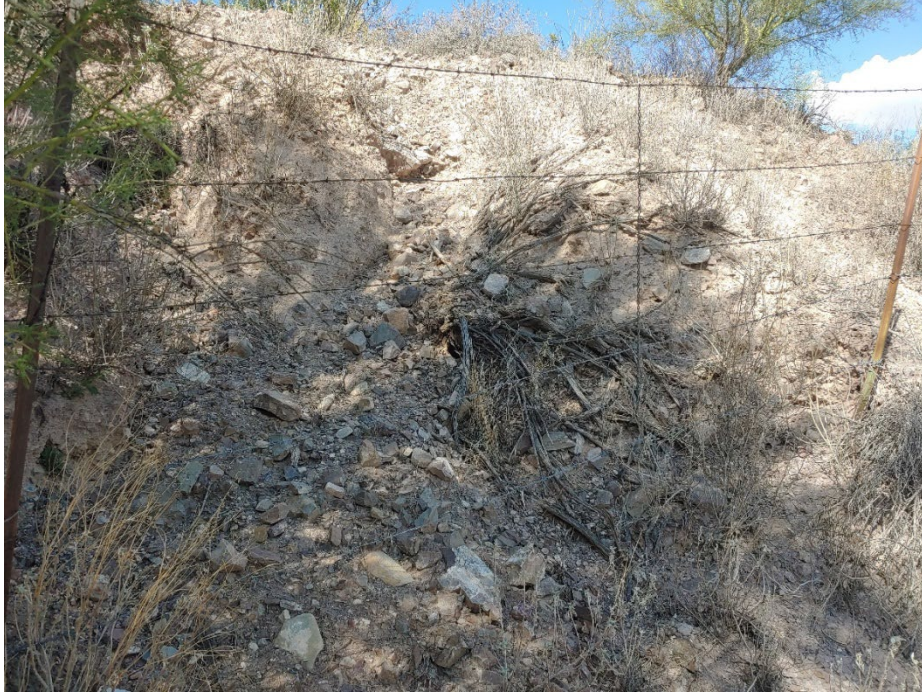
**Figure 69. Additional Strand of Wire Beneath a Four-Strand ROW Fence**

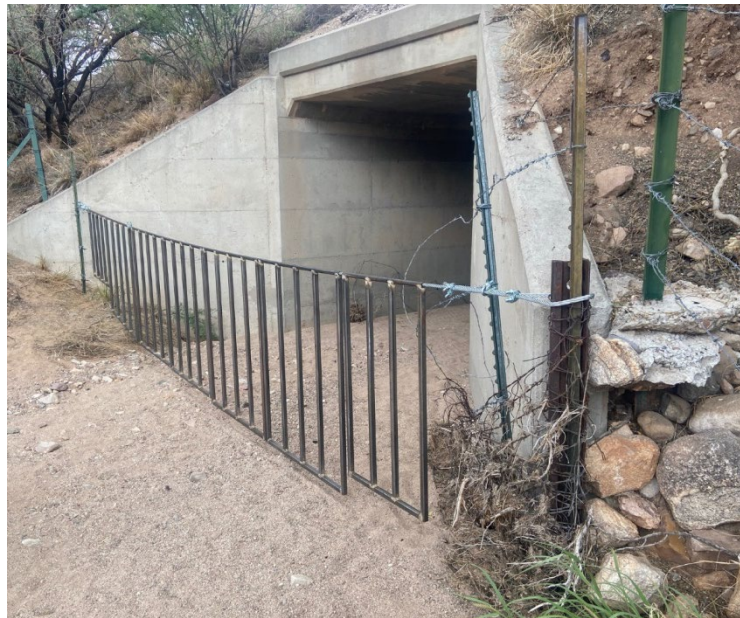
**Figure 71. Swinging Gate Design to Prevent Burro Passage But Allow Hydrological Flows**

- Incorporate flood gate designs where ROW fence crosses a wash. Figure 71 represents a design that is currently under evaluation. In recurring problem areas, consider fence designs that can withstand hydrological flows either by using more robust materials or by incorporating hinged designs that can swing away under force rather than break. Ideally, such solutions would be set back from drainage structures and tied in with wildlife fence to support wildlife connectivity goals while excluding burros.
- Install one of the mitigations described in the ROW Fence Design section where fences traverse dramatic topographical changes.

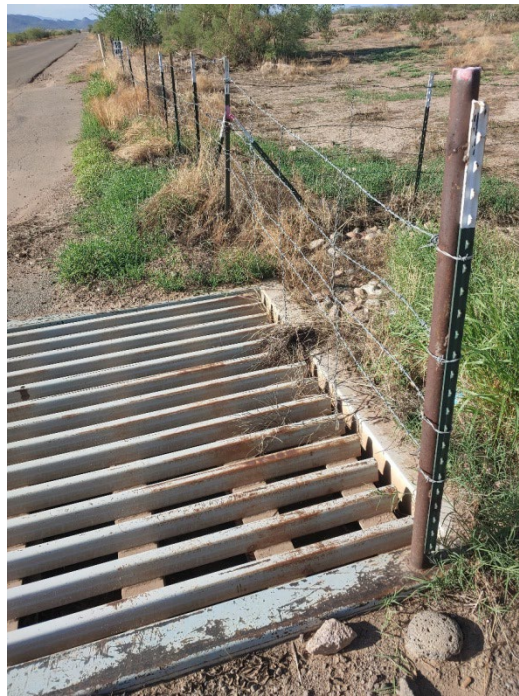
**Figure 72. Wing Fence at a Crossing Guard Tie-In**

- Install wing fencing along the edge of crossing guards to minimize the possibility of cross-jumps (Gagnon et al. 2020) (Figure 72).
- Tie in ROW fence and wing fence within crossing guard vaults to prevent burros from traversing vault ledges (Gagnon et al. 2020) (Figure 73).
- Add angle iron along the vault ledge or use rubber bumpers to reduce access to the vault ledge (Gagnon et al. 2020).
- Clear crossing guard vaults before sedimentation levels reach 50 percent depth.
- Survey crossing guard sedimentation levels annually.

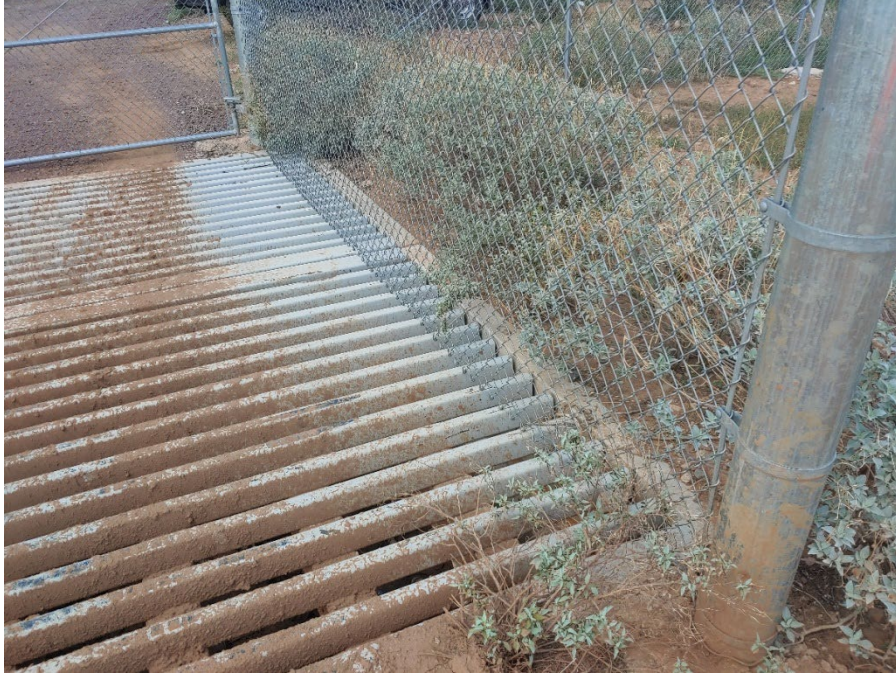
**Figure 73. Chain-Link Wing Fence Tied in Within Crossing Guard Vault**

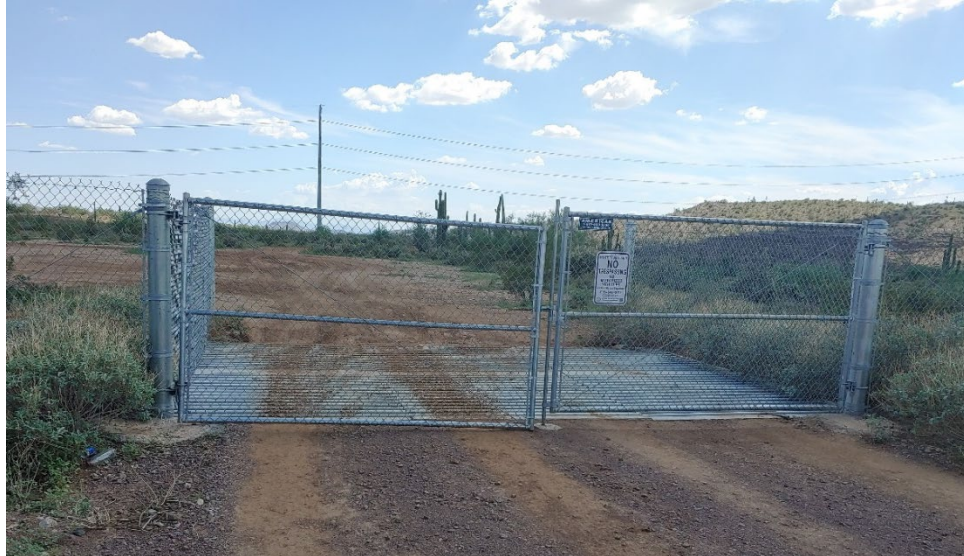
**Figure 77. Gate Modified with Signage, a Crossing Guard, Wing Fence Tied in Within the Vault Ledge, and Spans of Chain-Link Flanking Fence on Both Sides of Driveway to Deter Trespassing**

- Flank problem gates with short sections of cut-resistant chain-link fence (Figure 77).
- Install vehicle barriers, Jersey barriers, cable barriers, boulders, or vegetation barriers in front of or behind ROW fence to reduce vehicle accessibility.
