Shawnee Fossil Plant Coal Combustion Residual Management Final Environmental Impact Statement

Prepared by:
TENNESSEE VALLEY AUTHORITY
Knoxville, TN

December 2017

Type of document: Final Environmental Impact Statement (EIS)

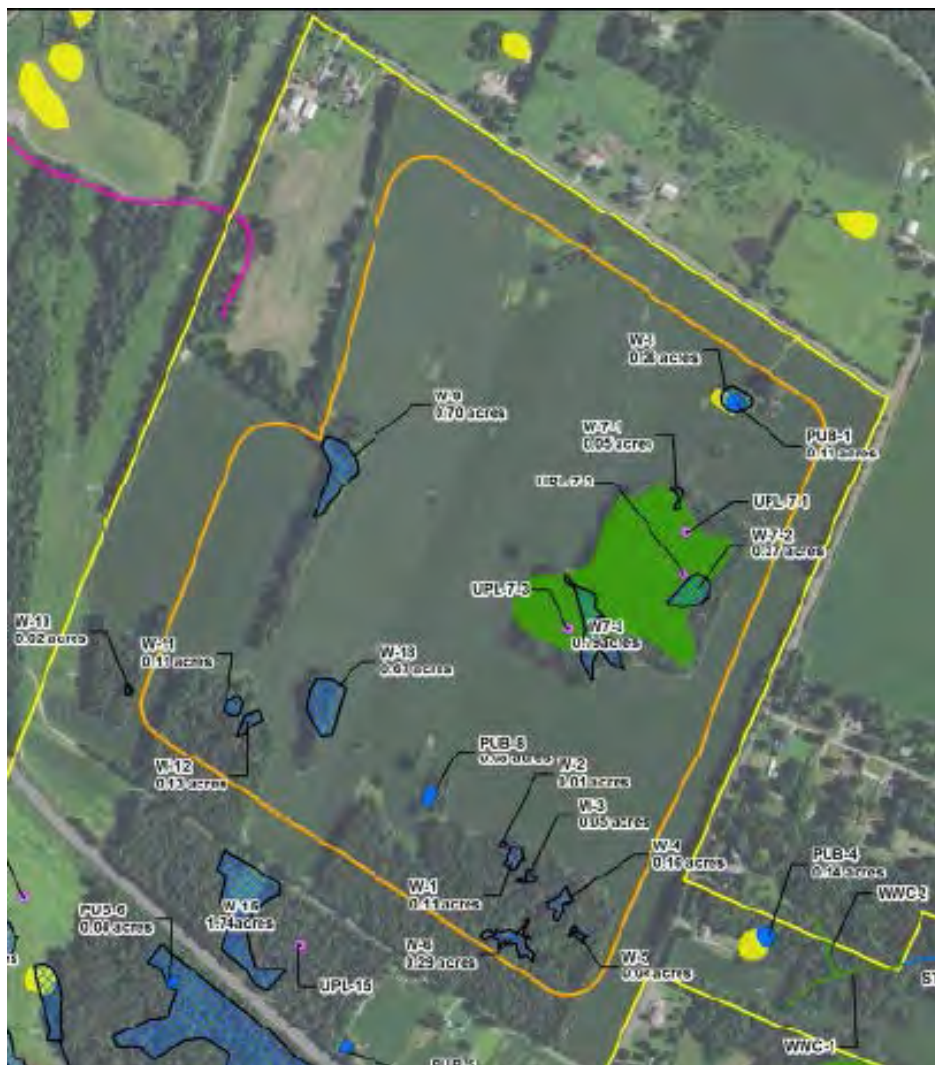
c. Graphic 11: Wetlands and ponds at the Shawnee East Site

46 With these wetlands on the Shawnee East Site in mind, TVA has failed to make a showing in the DEIS that might overcome the CCR Rule’s rebuttable prohibition against CCR landfills and impoundments on wetlands. See 40 C.F.R. § 257.61
