Desert Tortoise Consultation and Plans

N1 Biological Opinion

Subject: Formal and Informal Consultation under Section 7 of the Endangered Species Act for the Gemini Solar Project, Clark County, Nevada

Biological Opinion for The Gemini Solar Project

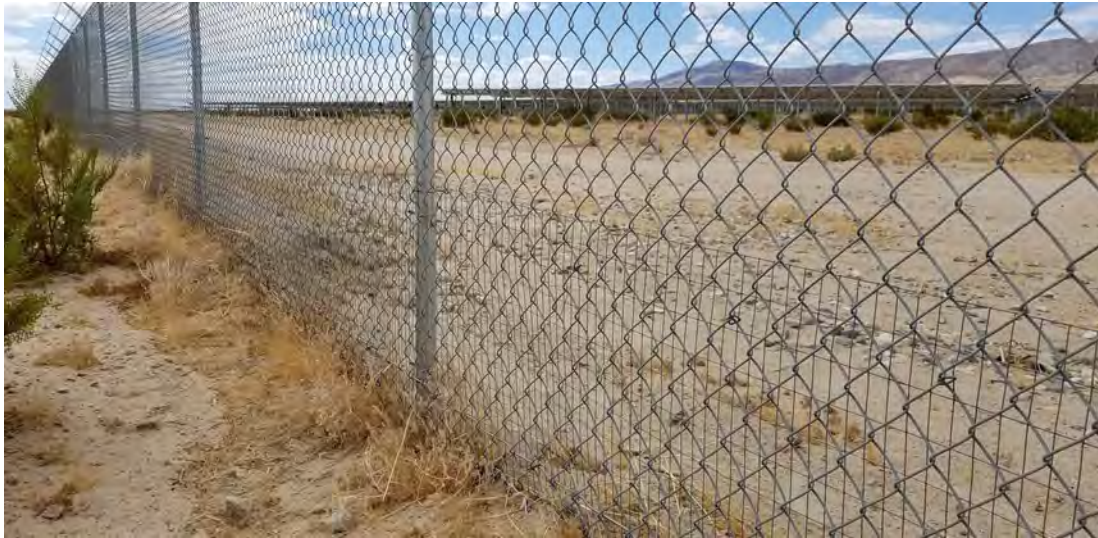
Figure 11. Example tortoise and security fencing.

potential for glare and reduces contrast. The perimeter security fencing would have an eight-inch opening between the bottom of the fence and the ground around mowed areas to allow desert tortoises to reenter and exit the area after construction. For the 35 percent of the facility developed using traditional methods where permanent tortoise exclusion is needed, tortoise exclusion fencing would be installed on the external perimeter security fence (Figure 11). Along internal fencelines, permanent desert tortoise fencing would be installed on T-posts. A tortoise barrier guard would be required across every access road traveling between areas constructed via mowing and traditional methods. Tortoise exclusion fencing would also be maintained around the substations.

at the site entrance. The perimeter fence would be an approximately 6- to 7-foot-high (1.8- to 2.1-meter-high) chain link fence, installed on posts, with 1-foot-high (0.3-meter-high) three-strand barbed-wire at the top (the security fence in proximity to the gen-tie lines would be properly grounded). The fence would be treated with a chemical dulling agent that reduces the galvanized steel's potential for glare and reduces contrast. The perimeter security fencing would have a gap of approximately 8 inches (20 centimeters) between the bottom of the fence and the ground around mowed areas to allow desert tortoise to reenter and exit the area after construction. For the approximately 35 percent of the facility developed using traditional methods where permanent tortoise exclusion is needed, tortoise exclusion fencing would be installed on the external perimeter security fence (Figure 11) and, along internal fencelines, permanent desert tortoise fencing would be installed on T-posts. A tortoise barrier guard would be required across every access road traveling between areas constructed via mowing and traditional methods. Tortoise exclusion fencing would also be maintained around the substations.

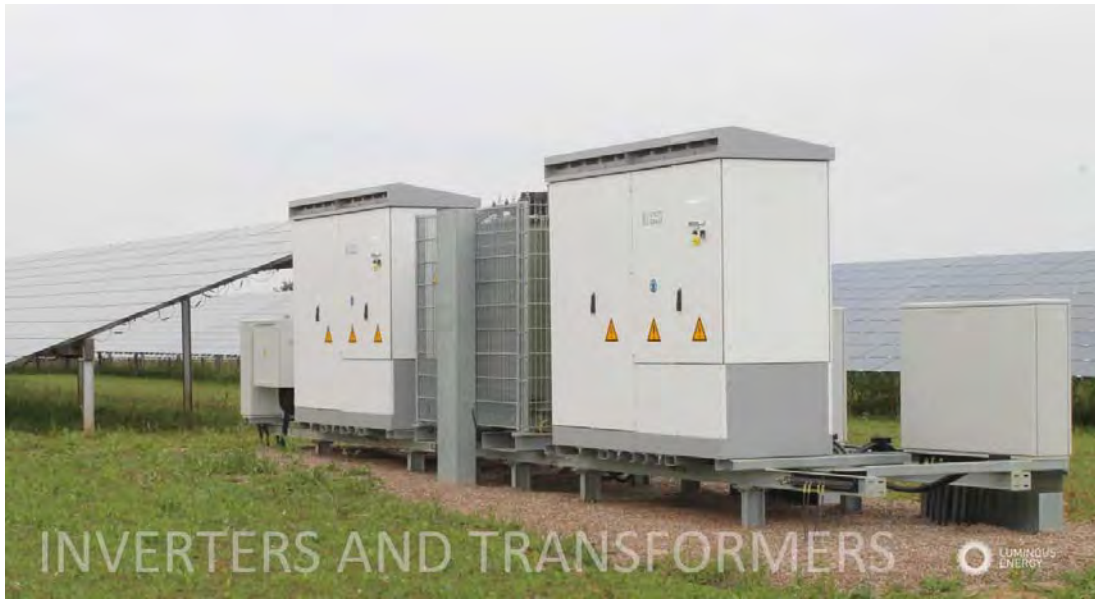
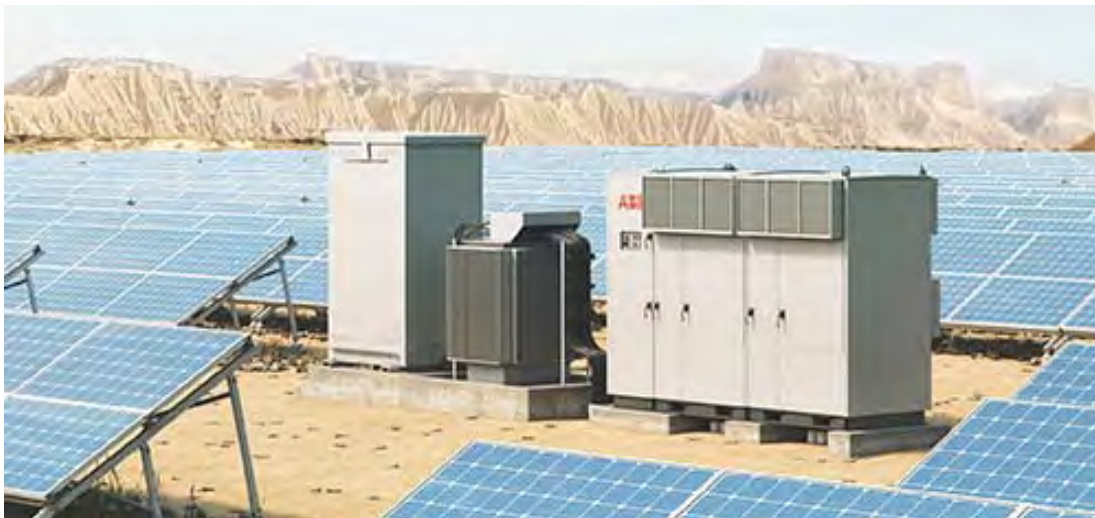
Figure 6 Photographs of a Typical Power Conversion Station/Inverter

followed by an explanation of the DC to alternating current (AC) power system. A PCS containing inverters and medium voltage transformers (as shown in the diagram), as well as other electrical equipment would serve approximately every four array blocks, as previously described. The inverter converts DC generated by the solar arrays and collected at the combiner box into the AC. Each inverter would also be coupled to a battery (described in more detail, below) with the capacity to store energy produced. From the inverter or battery, power is then passed through transformers to convert the low voltage output from the inverters to high voltage (34.5 kV AC) that is suitable for exporting onto the electricity distribution network. Each PCS also would contain communication equipment to wirelessly communicate with the tracker units to control operation and detect anomalous conditions. All electrical equipment would be housed in protective containers typically 10 feet (3 meters) wide by 20 feet (6.1 meters) long, on concrete pads. A photograph of a typical PCS is shown in Figure 6. The PCSs for the Gemini Project would be painted colors determined by the BLM.

PV modules convert sunlight into direct current (DC) electricity. One or more combiner boxes would be located in the array block to collect the DC electricity from PV modules. Figure 5 shows how power would be transferred from the solar array blocks to the grid. A PCS containing inverters and medium voltage transformers, as well as other electrical equipment, would serve approximately every four array blocks. The inverter converts DC generated by the solar arrays and collected at the combiner box into the AC. Each inverter would also be coupled to a battery with the capacity to store energy produced. From the inverter or battery, power is then passed through transformers to convert the low voltage output from the inverters to high voltage (34.5 kV AC) that is suitable for exporting onto the electricity distribution network. Each PCS also would contain communication equipment to wirelessly communicate with the tracker units to control operation and detect anomalous conditions. All electrical equipment would be housed in protective containers typically 10 feet wide by 20 feet long on concrete pads. A photograph of a typical PCS is shown in Figure 6.

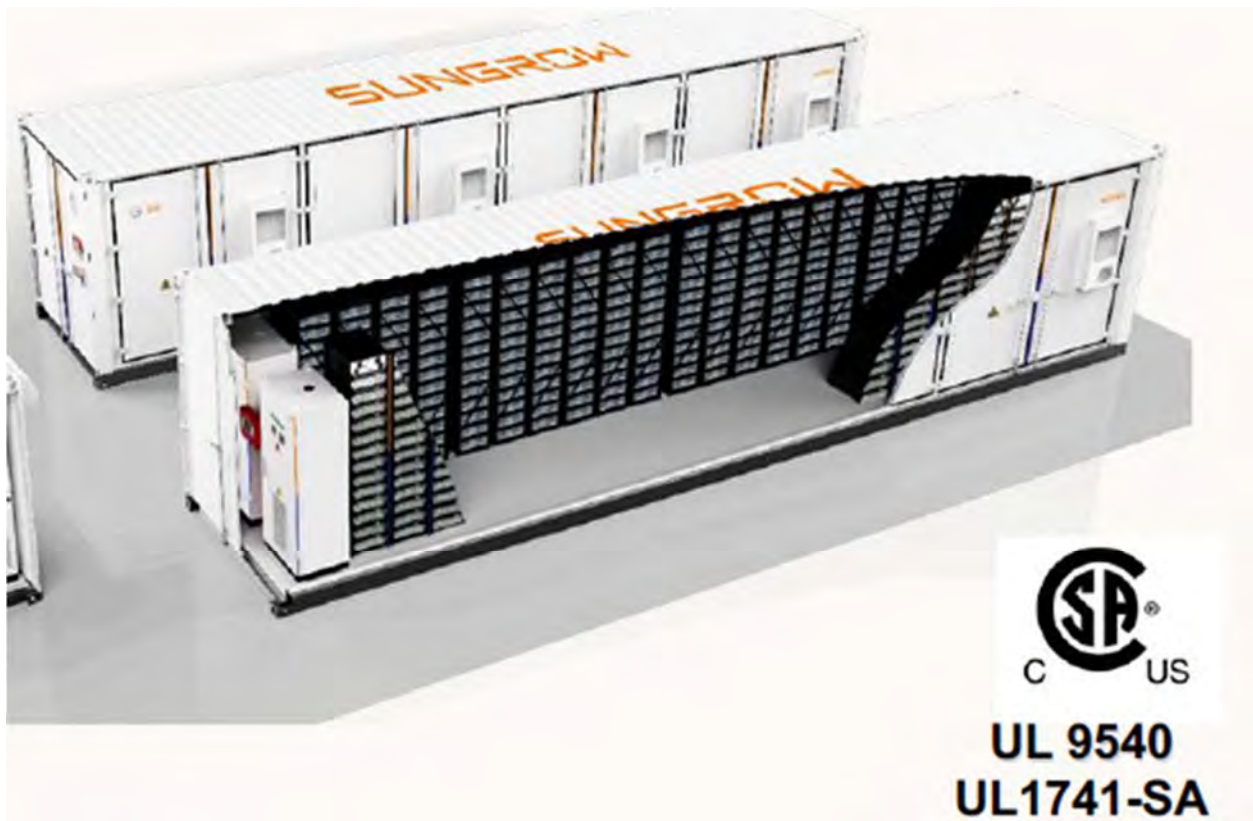
Figure 9 Photograph of a Battery Energy Storage System
